XAB – Rattle Noise from Diagonal Strut in Front Cowl

Models	Model Year	Model Type	VIN Range	Vehicle-Specific Equipment
Macan Electric	2024	XAB	N/A	N/A

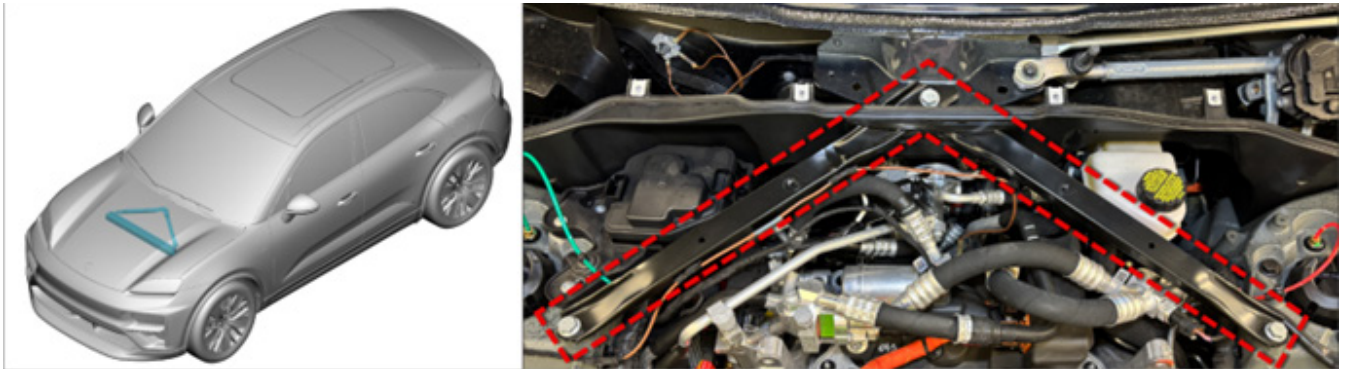
Figure 1

Noise from relative movement of the diagonal struts in the front cowl area is transmitted into the vehicle. This movement may be due to improperly torqued fasteners for the diagonal struts, or the body was under tension when the diagonal struts were torqued down.

Inspect the mounting of both the top/passenger's side and bottom/driver's side diagonal struts (Figure 1).

Ensure the vehicle is on level ground and supported by the vehicle's wheels and tires when the diagonal strut fasteners are torqued to specification.

Diagonal strut fasteners [N 10629602] which were loose or removed must be replaced and torqued to specification (50 Nm + 90° torque angle at time of publication). Refer to *WM 408619 "Remove and install strut"* for instructions.

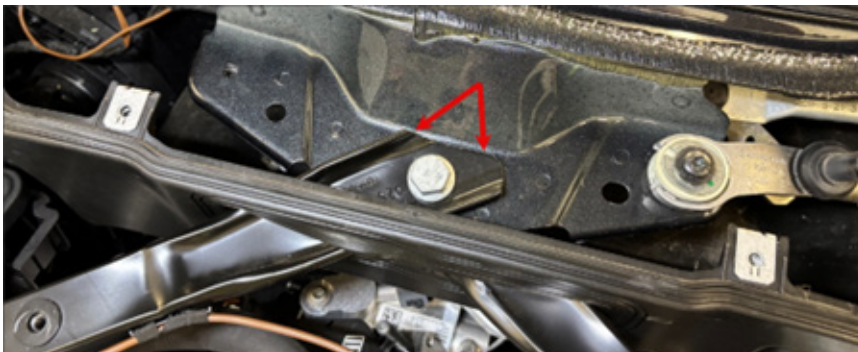
Ensure the diagonal struts do not make unwanted contact with the body shell in the lower cowl area (for example, points indicated by red arrows in Figure 2 and Figure 3).
