Technical Service Bulletin

01 MIL on, Whistling noise, leaking air Bank 2 - DTC P2ADF00, Engine Crankcase breather

01 24 42 2071318/5 October 8, 2024. Supersedes Technical Service Bulletin Group 01 number 23-92 dated November 6, 2023 for reasons listed below.

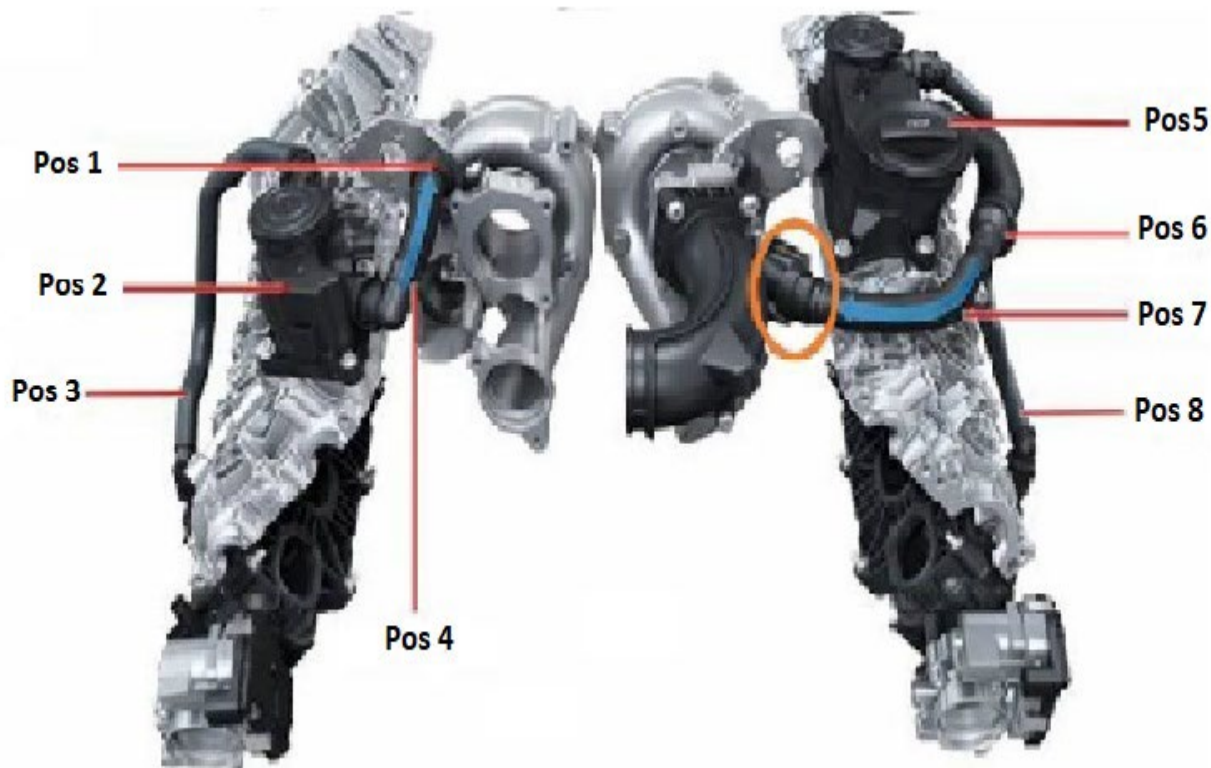
Below is an illustration of the crankcase breather from the SSP 676/ SSP 920493.

- Entry P2ADF (Intake Air System Leak (bank 2)) is logged in the event memory of the engine control unit.
- Event memory entries on misfiring on bank 1 are also logged.

- Item 1: Non-return valve
- Item 2: Oil separator for bank 1

- Item 3 Part load breather line for bank 1
- Item 4: Full load breather line for bank 1
- Item 5: Oil separator for bank 2
- Item 6: Non-return valve (*Not applicable for engine codes CWWB, and DWKA, because Non-return valve is integrated into the intake manifold*)
- **Item 7: Full load breather line for bank 2**
- Item 8: Part load breather line

In this case, replace the full load breather line for **cylinder bank 2**. Do not replace the oil separator for bank 1 and bank 2 or the part load breather lines. Please note that the connection for the full load breather line (cylinder bank 2) to the air pipe (see orange marking in illustration below) is a “not to open” connection. This means that the full breather line (bank 2) cannot be detached from the air pipe without being irreparably damaged. Please note the relevant information in the Workshop Manual (chapter: Engine Lubrication/ crankcase breather).
