Technical Service Bulletin

35 Gearbox Malfunction warning on, DTC P17F900 is stored in the TCM

35 24 53 2064312/6 October 29, 2024. Supersedes Technical Service Bulletin Group 35 number 23-47 dated December 11, 2023 for reasons listed below.

Model(s)	Year	VIN Range	Vehicle-Specific Equipment
A4, A4 allroad, A5, A5 Cabriolet, A5 Sportback, A6, A6 allroad, A7, and Q5	2020 – 2023	All	DL382 Transmission
Q5 Sportback	2021 – 2023

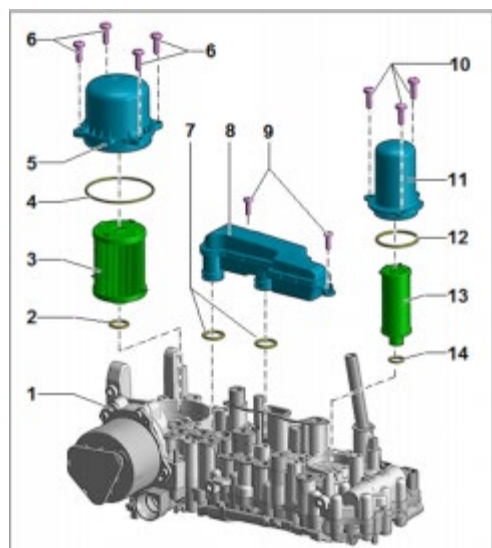
Figure 2. Mechatronics parts.

2. If the result of the Guided Fault Finding test plan was to replace Parking Lock Solenoid N486 the next step is to remove the Mechatronics unit per the Elsa Repair Manual.
3. After removing the Mechatronics unit remove the intake filter (Figure 2, positions 8 and 9) to access one of the filter bolts and perform a visual inspection of the installation of the bolts for pressure filter 2 (Figure 2, position 10 and 11). This is the smaller of the 2 canister filters installed to the mechatronics unit with 3 bolts attaching the filter to the unit (Figure 3).

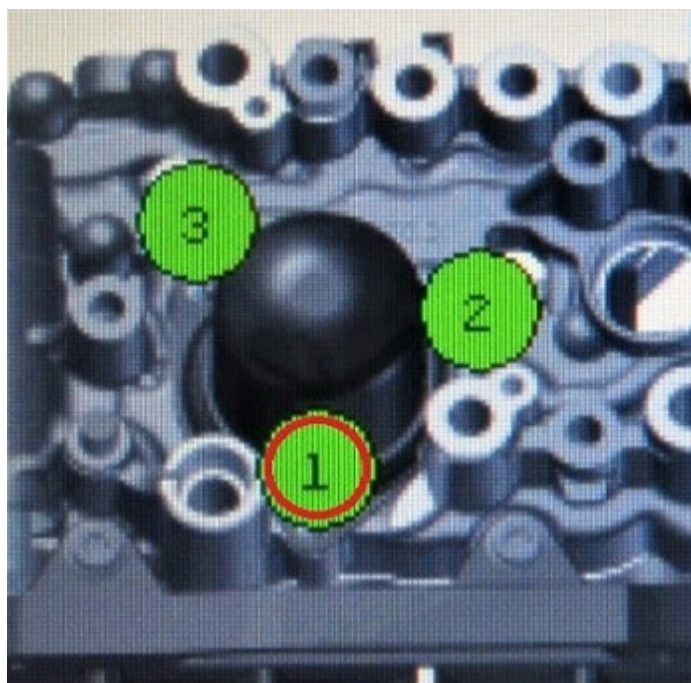
Figure 3. Bolt locations.

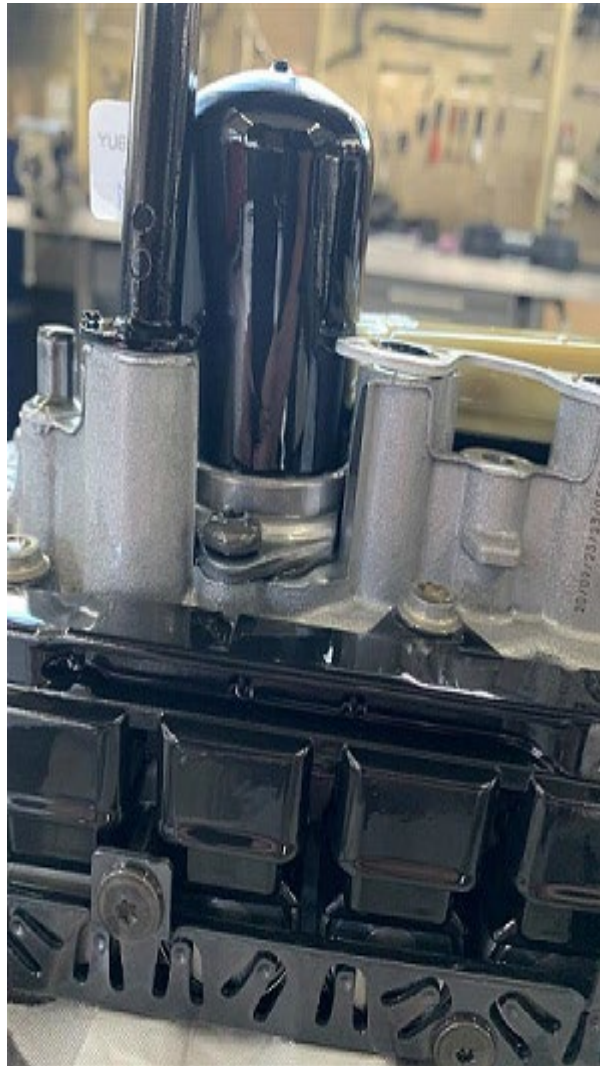
One or more bolts are loose (Figure 4).

You may also see the securing ring is not flush to the valve body which would mean the bolts are loose.

Figure 4. Loose bolts.

If the bolts are loose, replace the cover (with seal) along with the bolts as described in ETKA and the Workshop Manual. Claim Option 1 in the Warranty Table below.

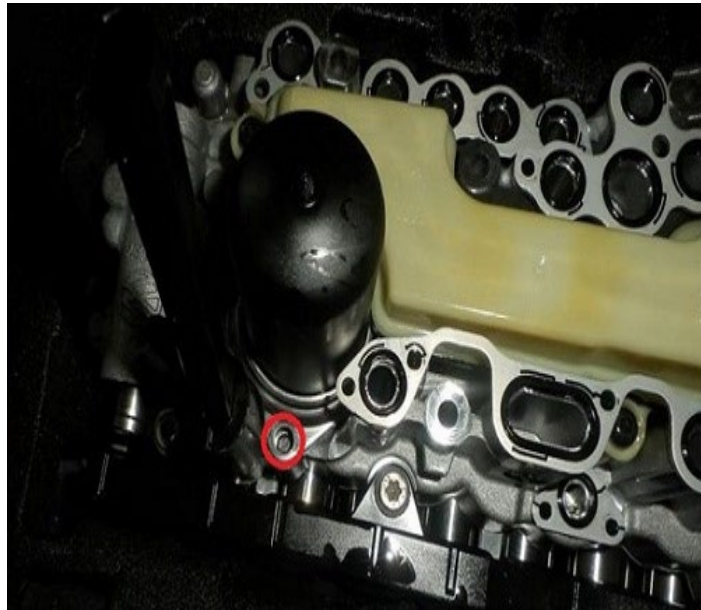
One or more bolt heads are broken off or missing (Figure 5).

Figure 5. The bolt head is missing.

Remove the cover for the high-pressure filter. Attempt to remove the remaining pieces of the bolts by hand (without tools). If possible, then install a new cover (with seal) and the three securing bolts as specified in ETKA and the workshop manager. Claim option 1 in the warranty table below.

Only if any of the bolts cannot be removed by hand, replace the Valve Body per the Elsa Repair Manual. Claim Option 2 in the Warranty Table below.

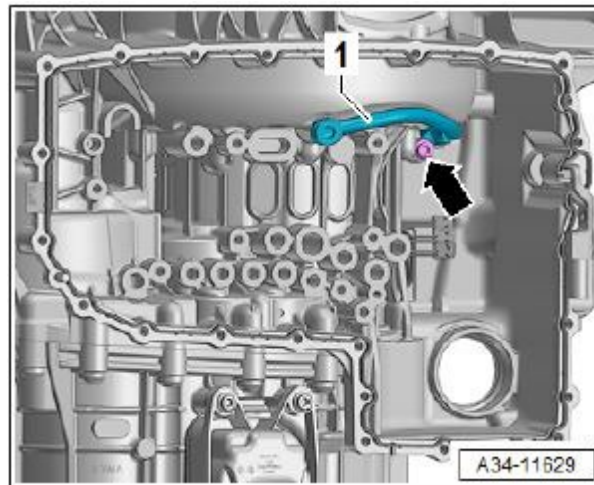
Figure 4. Pressure pipe for the parking lock solenoid.

All 3 bolts are tight. Replace the Parking Lock Solenoid N486 **and the Pressure pipe for the N486** (Figure 4) per the Elsa Repair Manual. Claim Option 3 in the Warranty Table below.
