Technical Service Bulletin

66 Wheel arch trim on front fender loose

66 24 13 2067881/3 October 8, 2024. Supersedes Technical Service Bulletin Group 66 number 24-05 dated February 9, 2024 for reasons listed below.

Model(s)	Year	VIN Range	Vehicle-Specific Equipment
Q3	2019 – 2024	All	Not Applicable

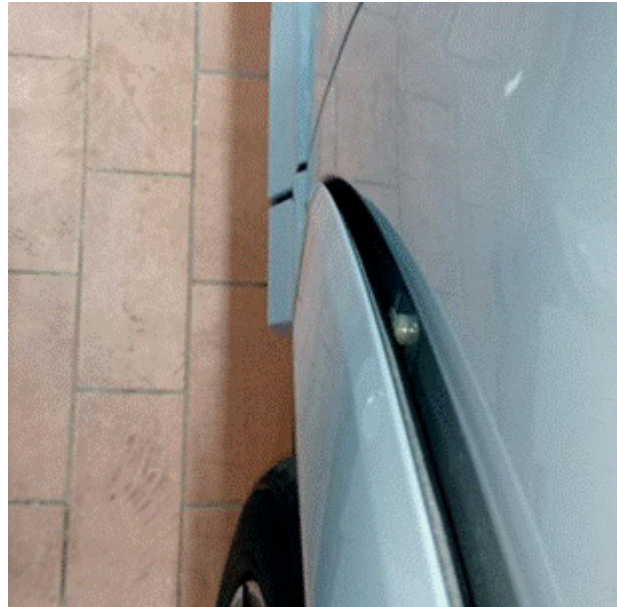
During the trim installation process in production the female grommet that retains the male clip on the trim engages the male clip before it is fully seated to the fender surface creating a visible gap between the front wheel arch molding and the fender surface (Figures 1 & 2).

Figure 1. The front wheel arch trim is not flush to the fender surface.

- Replace all the clips on the affected front wheel arch trim. The wheel arch trim does not need to be replaced (Figure 5).

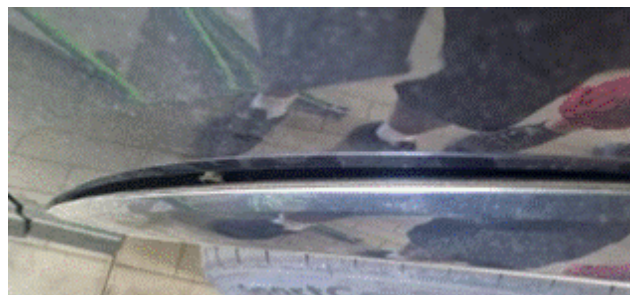
Figure 2. The front wheel arch trim with the retaining clips only partially engaged.

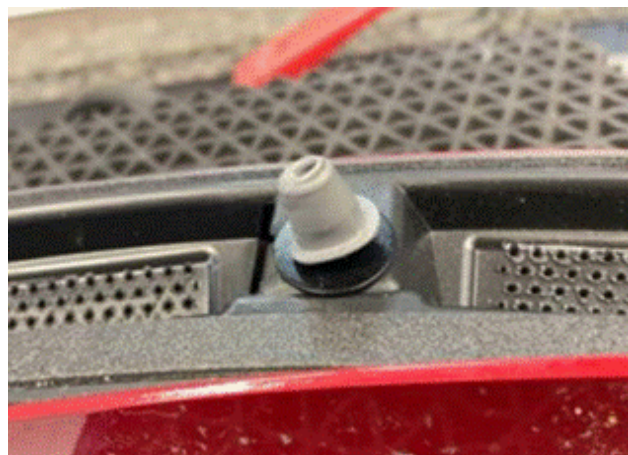
When the front wheel arch trim is removed damage to the female clip grommet is apparent (Figure 3).

Figure 3. Front wheel arch trim with retaining clip grommet damaged.

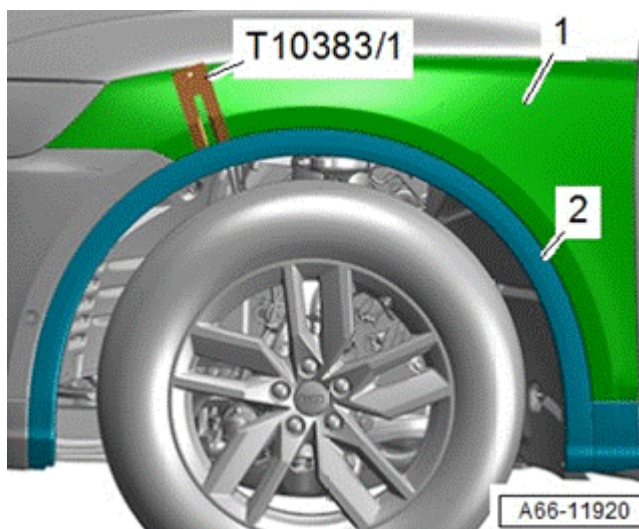
Figure 4. Front wheel arch trim removal.

1. Using the T10383 wedge set remove the front wheel arch trim (Figure 4).

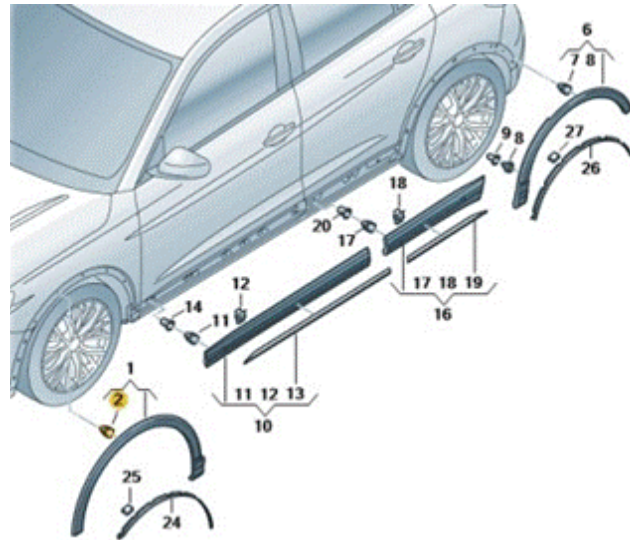
Figure 5. Front wheel arch trim clip location.
