Technical Service Bulletin

91 PSS MIB3: Main menu tiles are missing

91 24 75 2075629/2 October 30, 2024. Supersedes Technical Service Bulletin Group 91 number 24-66 dated October 16, 2024 for reasons listed below.

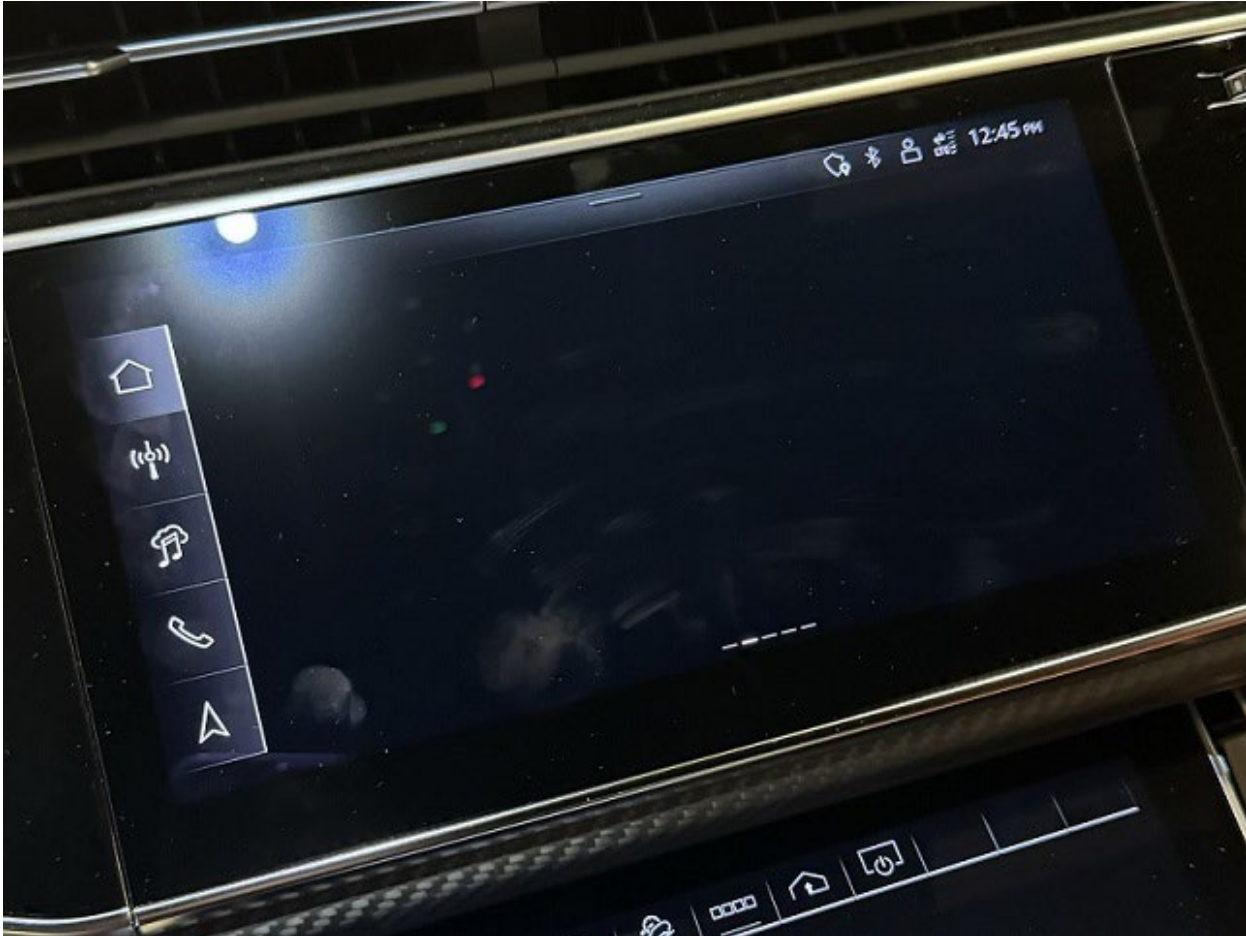
The MMI does not display any app tiles in the main menu. The center display only shows the following content:

- Top bar with time and icons.
- Left menu (shortcut) bar.

- Bottom center page markings (“slider”).

Figure 1. If icons are selected in the left menu bar when the display looks like this, the system may respond sluggishly.

Software issue.

1. Explain to the customer that the implementation of a measure is currently being analyzed. This analysis is expected to be completed in the December 2024 (subject to change).
2. No repairs are necessary at this point. **Do not replace any components for this condition** since this will not resolve the customer's concern.
3. Create a PSS record in the PSS application through the Pending Service Solutions (PSS) link in AccessAudi (under *Related Links >> Service*).
