# Technical Service Bulletin

## 93 A7/Q5 PHEV Gearbox: drive system fault displayed in instrument cluster (P0A4000)

93 24 20 2074662/2 October 1, 2024. Supersedes Technical Service Bulletin Group 93 number 24-01 dated July 31, 2024 for reasons listed below.

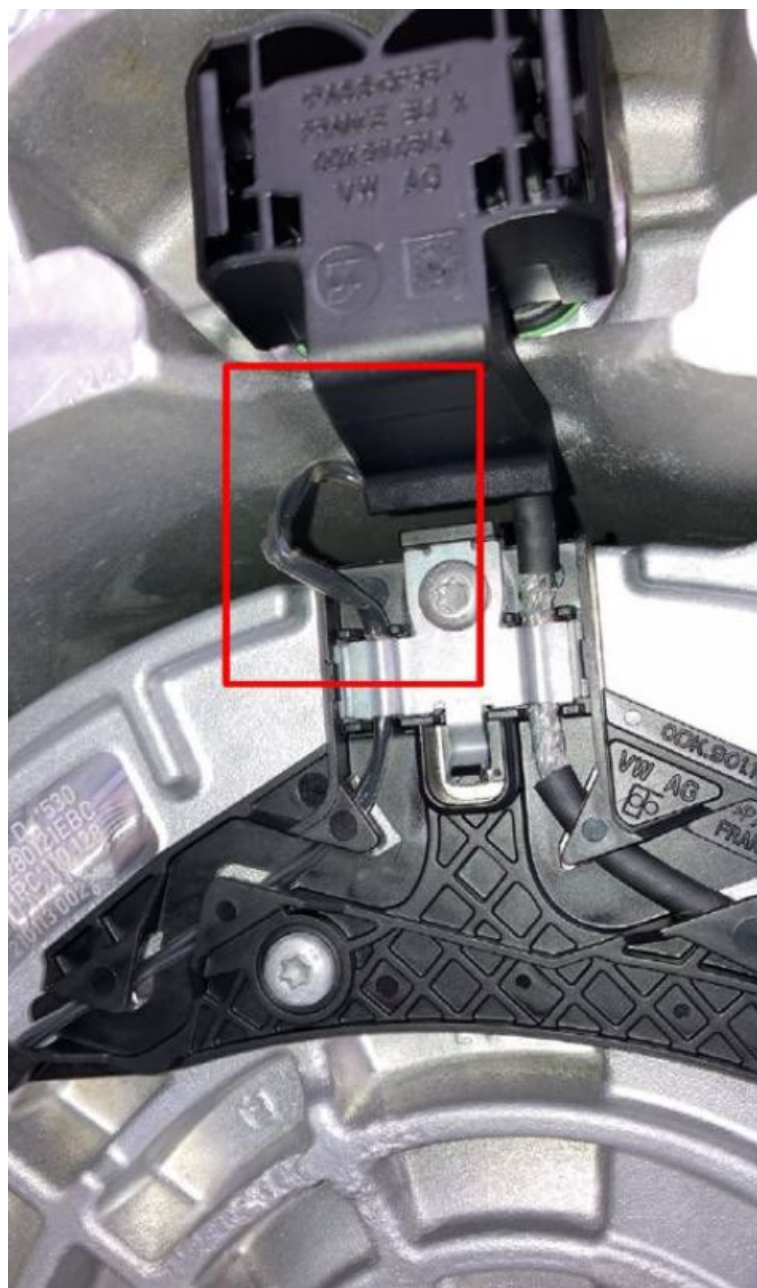
**Please work with great care when installing the rotor position sensor so that the sensitive wires on the gearbox housing are positioned correctly.**

*Figure 1. Wire not fitted correctly*

If DTC **P0A4000** with symptom 50954 is present as the only fault in the electric drive control unit J841 (diagnostic address 0051), replace the drive motor position sender 1 G713 (rotor position sensor) according to ELSA.

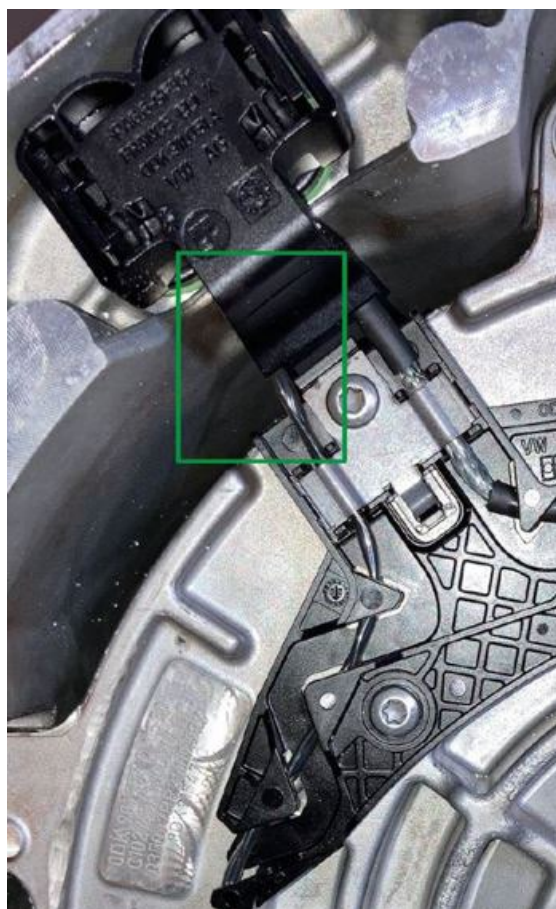
*Figure 2. Installation according to Workshop Manual*
