Technical Service Bulletin

93 e-tron GE electric drive motor leak P0AA600

93 24 22 2073858/2 October 8, 2024. Supersedes Technical Service Bulletin Group 93 number 24-82 dated July 27, 2024 for reasons listed below.

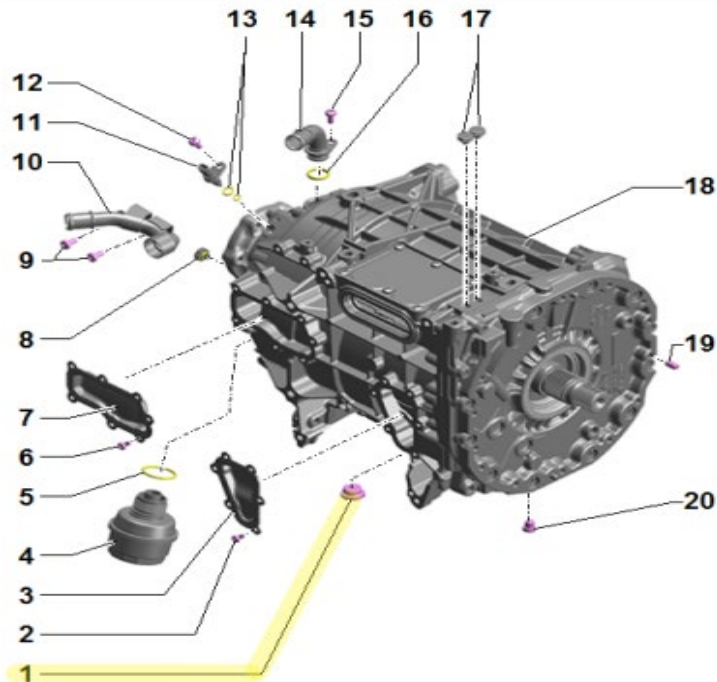
Figure 2: (1) Drain plug.

Rear axle (Figure 2):

- Drip container is overflowing:

Coolant leaking from active chamber.

- Drip container is empty:

Coolant leaking from active chamber, particularly on vehicles with low mileage.

In this case, check the seal on the coolant expansion tank beforehand and re-secure it after performing any required work. Vehicles should never be operated without a correctly filled cooling system.

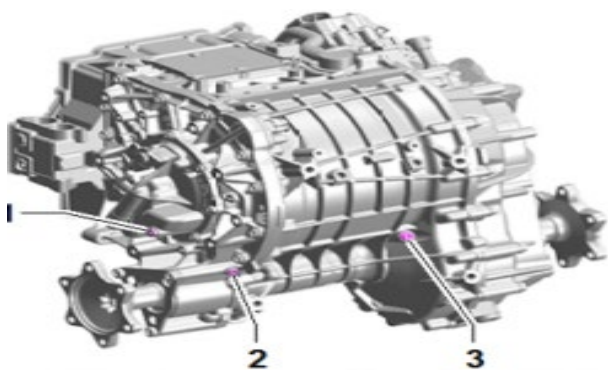
Front axle (Figure 3):

Coolant leaking from active chamber.

Figure 3: 1) Resolver cover: A few milliliters of coolant leakage is not an issue from a technical perspective. 2) Active chamber: No coolant may escape from the bores.

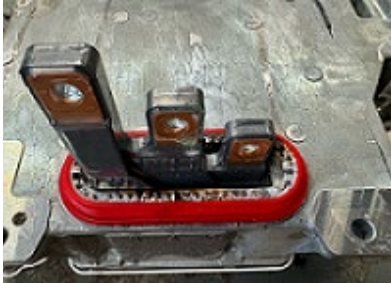
1) Corrosion on the high-voltage system connection for power and control electronics for electric drive (Figure 4).

Figure 4: Corrosion on high-voltage system connection for power and control electronics for electric drive.

The power electronics for electric drive must not necessarily be replaced if the electric drive motor is leaking (refer to images 4 and 5).

In this case, the power and control electronics for electric drive must not be replaced.

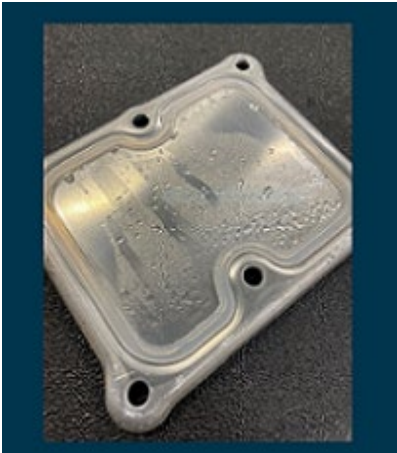
2) Condensation on high-voltage system connection cover (Figure 5).

Figure 5: Condensation on high-voltage system connection cover.
