<b>Release Date</b>	09/04/2024	<b>Technical Service Bulletin</b>	
<b>91VT UPDATE</b>

<b>Audi</b>
<b>Customer Satisfaction Package – (NVLW)</b>

## Customer Satisfaction Package – (NVLW)

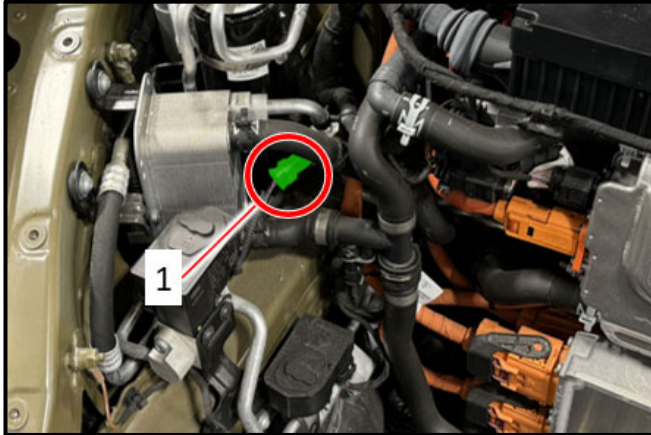
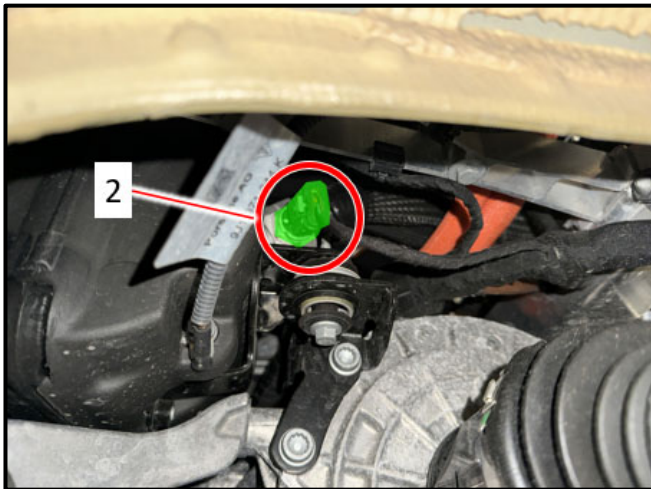
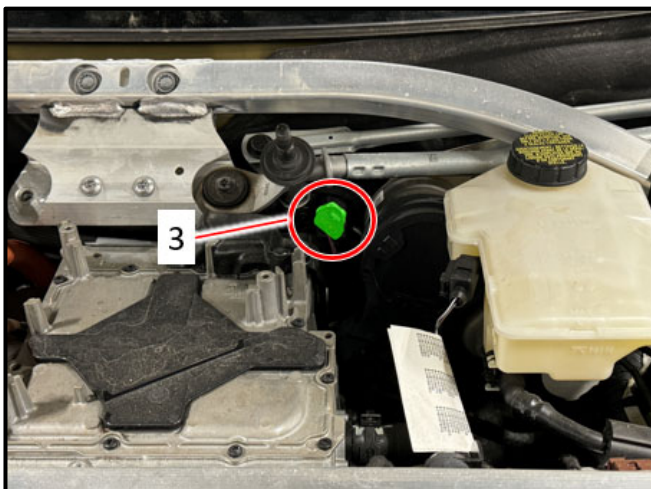
The refrigerant pressure/temperature sensors do not require removal for inspection. **Do not** recover the refrigerant charge during the inspection section.

- Access, but do not remove, the G395, G826, and G827 refrigerant pressure/temperature sensors per the ELSA repair manual:
  - **G395 sensor <1>**: Repair manual > Heating, Ventilation & Air Conditioning > Heating, Ventilation and Air Conditioning > 87 Air Conditioning > Refrigerant Circuit > A/C Pressure/Temperature Sensor G395, Removing and Installing.
  - **G826 sensor <2>**: Repair manual > Heating, Ventilation & Air Conditioning > Heating, Ventilation and Air Conditioning > 87 Air Conditioning > Refrigerant Circuit > A/C Pressure/Temperature Sensor 2 G826, Removing and Installing.
  - **G827 sensor <3>**: Repair manual > Heating, Ventilation & Air Conditioning > Heating, Ventilation and Air Conditioning > 87 Air Conditioning > Refrigerant Circuit > A/C Pressure/Temperature Sensor 3 G827, Removing and Installing.

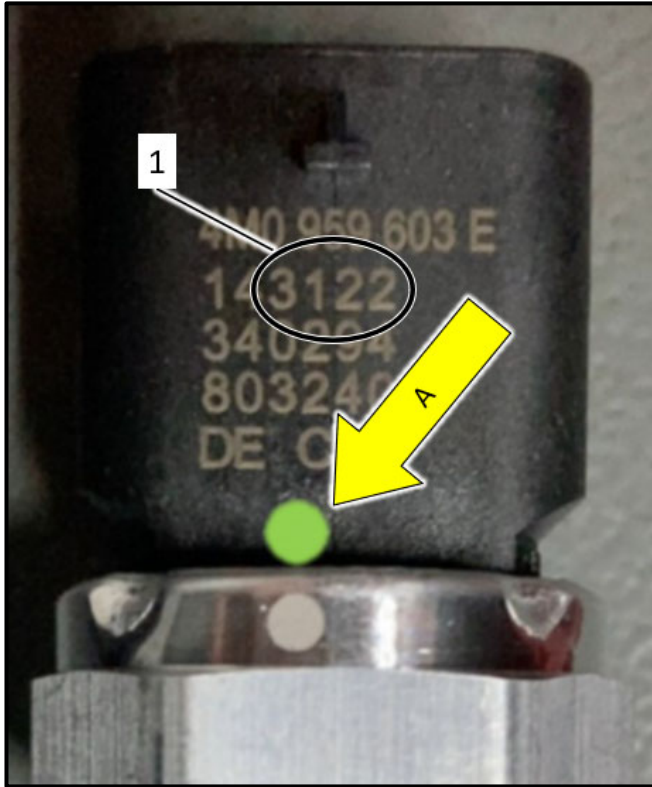
- Check for a green dot <arrow A> on the G395, G826, and G827.
- If the green dot is present on **all three** sensors:
  - The sensors do not require replacement.
  - Continue with the reassembly instructions in this section.
- If the green dot is **NOT** present on the sensors:
  - Check the production date <1> of the sensor.
  - If the sensor was produced on or before calendar week 31 of 2021, the sensor requires replacement.

The production date <1> of the sensor pictured is calendar week 31 of 2022. This sensor does not require replacement. The date format is week/year.

- If a sensor requires replacement:
  - **Proceed to section C.**
- If **all three** sensors are ok and do not require replacement:
  - Continue with the reassembly instructions in this section.
