Service Action Code: 90X1

Subject Instrument Cluster

Volkswagen is providing a hardware and/or a software update to address an issue in selected vehicles where the fuel gage may show a lower fuel level than what is actually remaining in the vehicle.

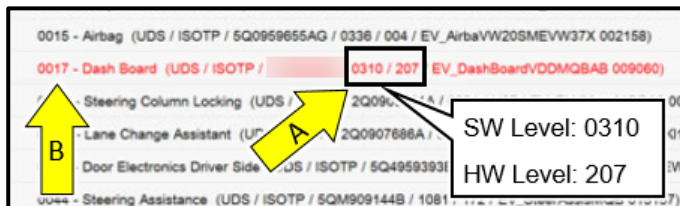
- Using ODIS, check the software and hardware levels <arrow A> of the Instrument cluster, DA 0017 <arrow B>.

The instrument cluster pictured would require replacement as the hardware level is below 503.

- If the software level is equal to or higher than 4194 with a hardware level of 503:
 - No further work is necessary.
 - Proceed to section E.
- If the software level is below 4194 with a hardware level of 503:
 - The instrument cluster software must be updated.
 - Proceed to section C.
- If the hardware level is below 503:
 - The instrument cluster must be replaced.
 - Proceed to section D.
