Rear Bumper Outer End Covers Loose Causing Excessive Gap

Service Category Vehicle Exterior

YEAR(S)	MODEL(S)	ADDITIONAL INFORMATION
2022 - 2024	Tundra, Tundra HV

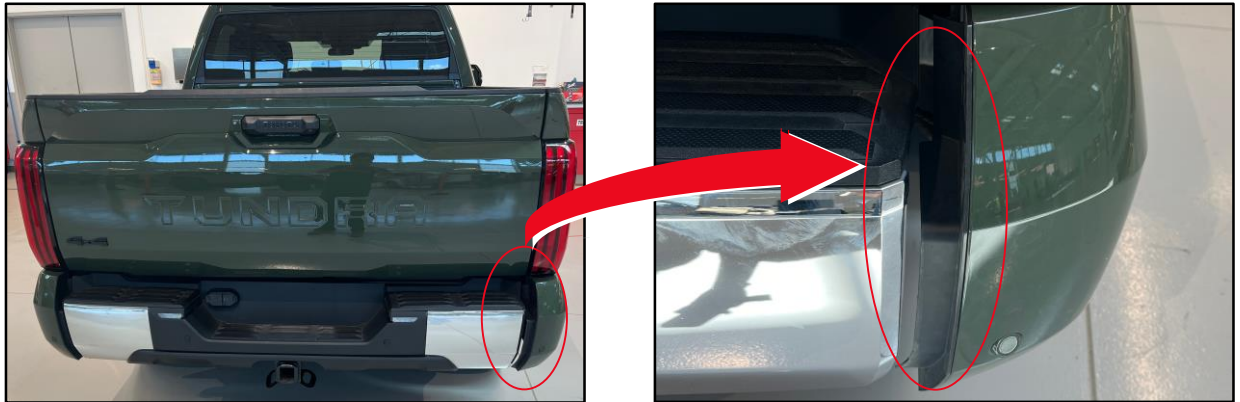
Some 2022 – 2024 model year Tundra and Tundra Hybrid vehicles may exhibit a condition in which the rear bumper outer end covers have become loose causing an excessive gap on the right-hand and/or the left-hand side. The attaching flange bolts have been updated to address this condition. Follow the Repair Procedure in this bulletin to address this condition.

Does the vehicle exhibit a condition in which the rear bumper outer end covers have become loose causing an excessive gap on the right-hand and/or the left-hand side as shown in Figure 1?

Figure 1. Example of Condition on Right-hand Side

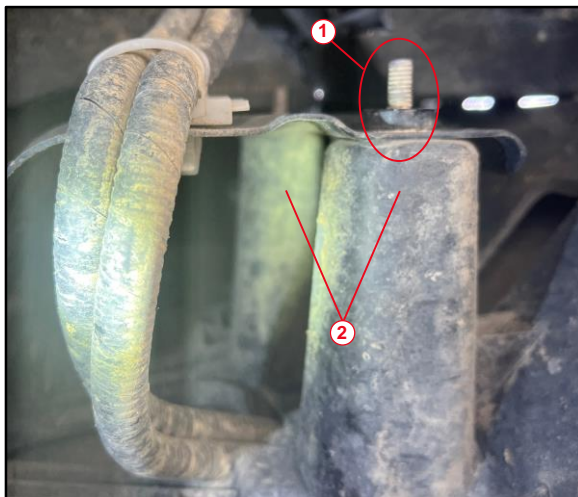
Bolt heads should NOT be visible if the rear pillar lower garnish attachment points are properly retained.

Figure 2. Rear Pillar Lower Garnish, Properly Retained at Attachment Points

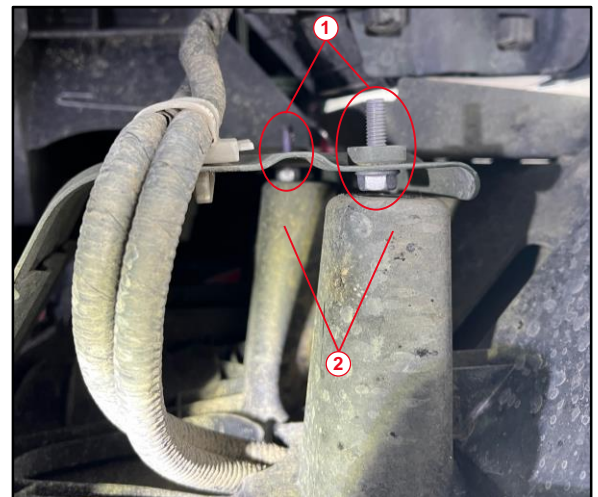
Figure 3. Rear Pillar Lower Garnish, Not Properly Retained at Attachment Points

1	Bolts
2	Rear Pillar Lower Garnish

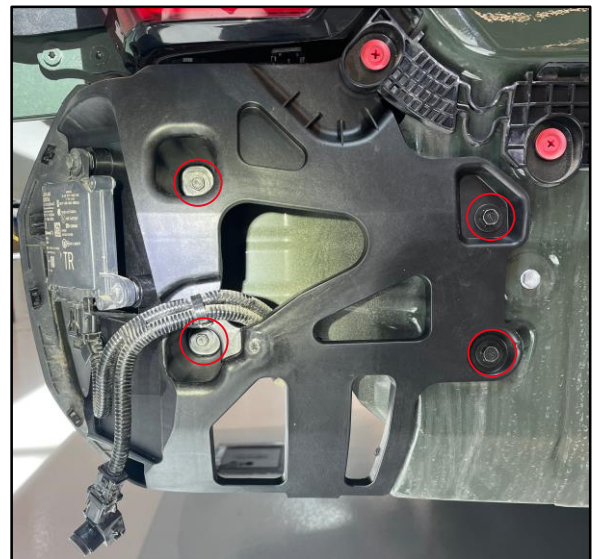
Figure 4.

New Flange Bolts

- Install the NEW rear pillar lower garnish using NEW flange bolts.
