**TECHNICAL INSTRUCTIONS**  
**FOR**  
**CUSTOMER SUPPORT PROGRAM 22TE09**  
**HV FLOOR UNDER WIRE HARNESS AND REAR TRACTION MOTOR CABLE**  
**CORROSION**  
**CERTAIN 2021 – 2022 MODEL YEAR VENZA HYBRID**

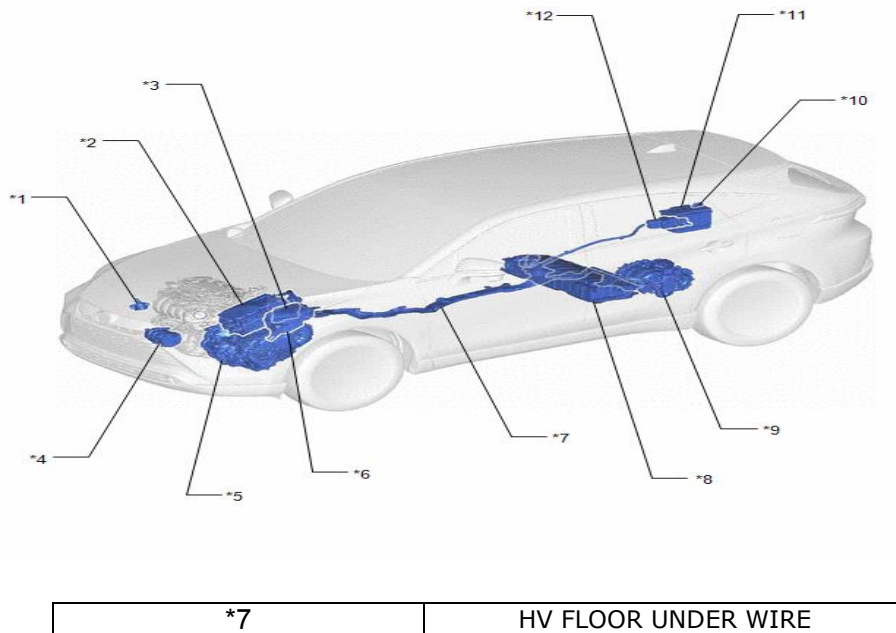
Although the HV Floor Under Wire Harness and Rear Traction Motor Cable is covered by Toyota's New Vehicle Limited Warranty for 3 years or 36,000 miles (whichever comes first), we at Toyota care about the customers' ownership experience. Toyota is providing coverage for repairs related to excessive corrosion to the wire harness connections at the Rear Motor Generator. Excessive corrosion can cause AM Radio Static during certain drive cycles, or the vehicle may not start.

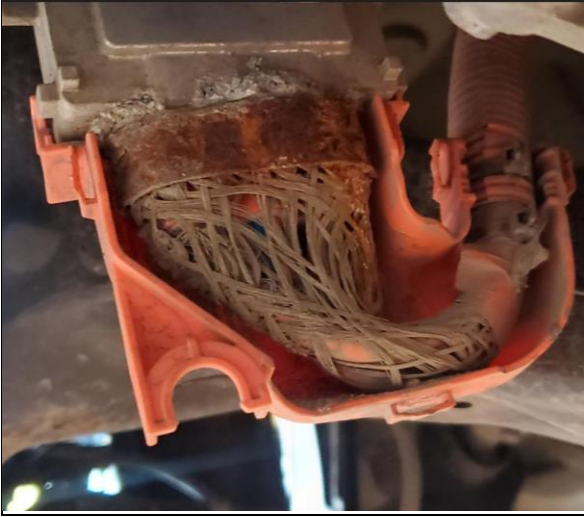
**Y6 connector under the vehicle at MGR**

- 5) Inspect the Y6 connection for corrosion.  
f) Disconnect the Y6 connector at the MGR and inspect for corrosion, dirt, or debris.

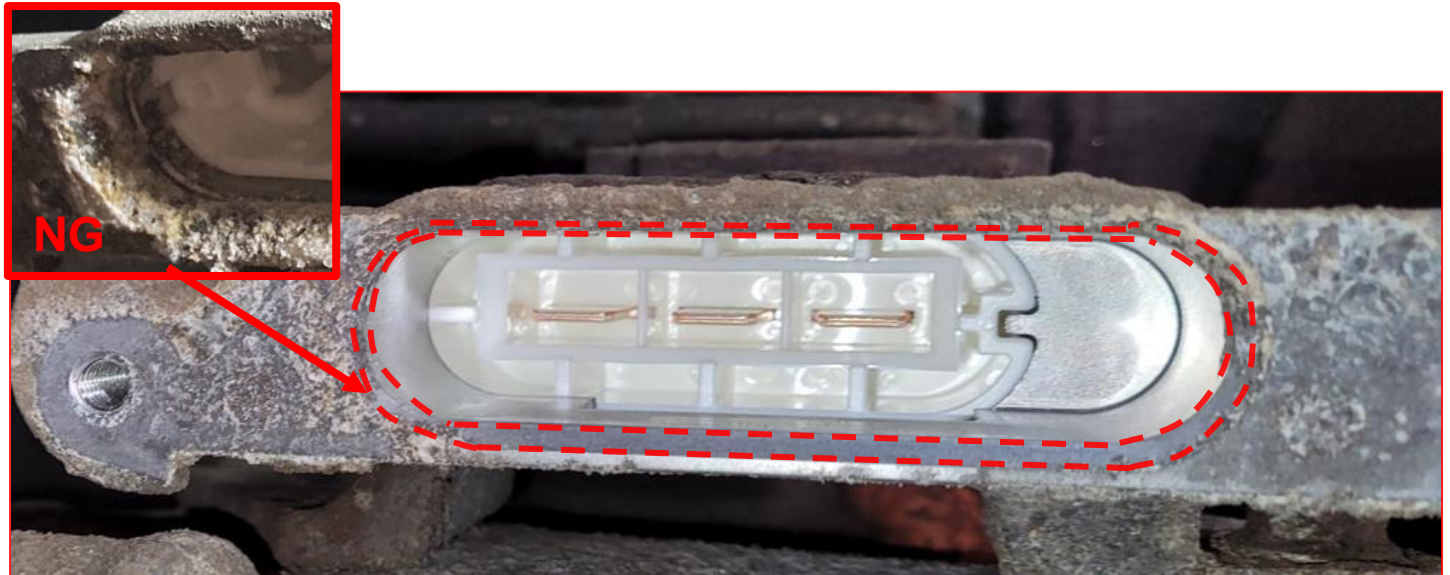
- a) Inspect the chamfer of the MGR connector housing for pitting and corrosion on the sealing surface. Corrosion in this area will cause the seal to leak. Are pitting and corrosion present?

**YES** – Rear Traction Motor Cable requires replacement continue to Section VI.
