**TECHNICAL INSTRUCTIONS**  
**FOR**  
**CUSTOMER SUPPORT PROGRAM 22TE09**  
**HV FLOOR UNDER WIRE HARNESS AND REAR TRACTION MOTOR CABLE**  
**CORROSION**  
**CERTAIN 2021 – 2022 MODEL YEAR RAV4 PRIME**

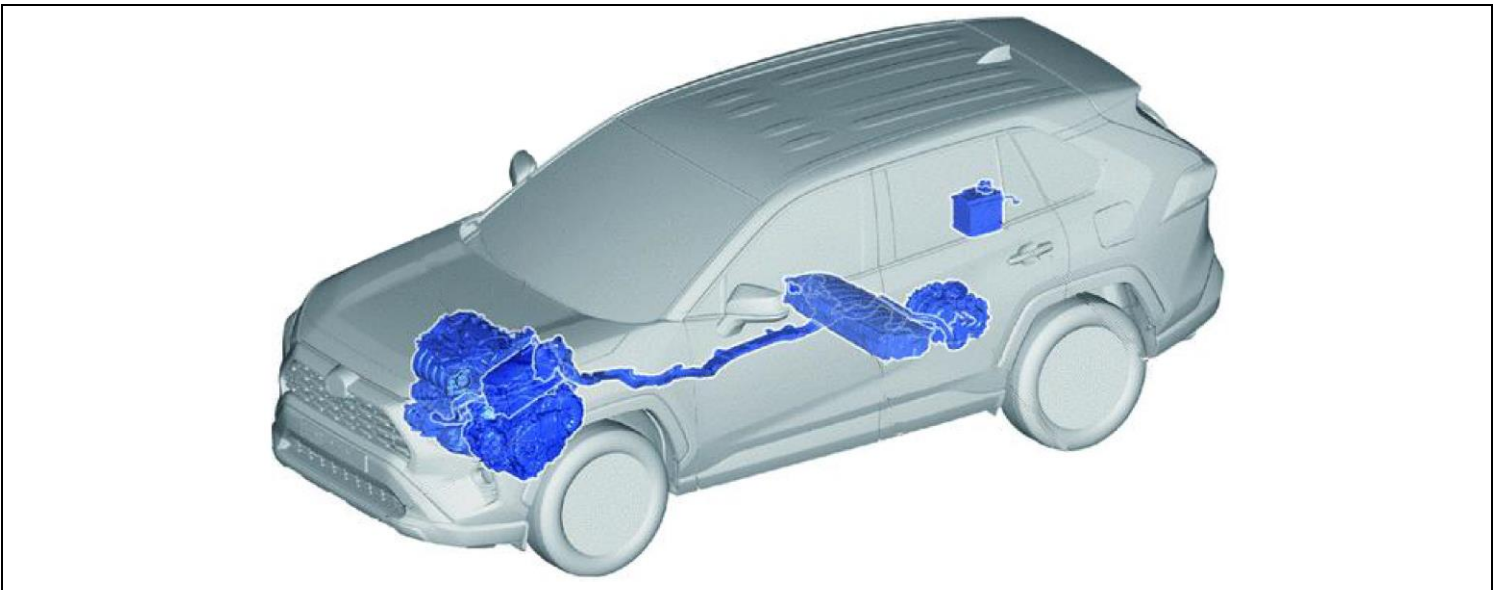
Although the HV Floor Under Wire Harness and Rear Traction Motor Cable is covered by Toyota's New Vehicle Limited Warranty for 3 years or 36,000 miles (whichever comes first), we at Toyota care about the customers' ownership experience. Toyota is providing coverage for repairs related to excessive corrosion to the wire harness connections at the Rear Motor Generator. Excessive corrosion can cause AM Radio Static during certain drive cycles, or the vehicle may not start.

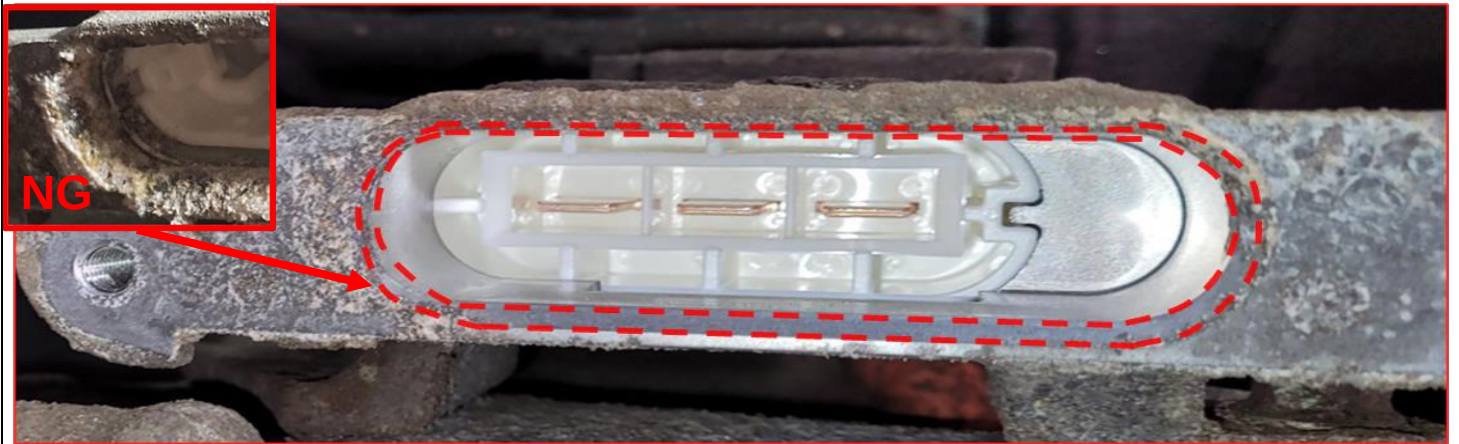
**6) Inspect the connector housing of the MGR.**

- a) Inspect the chamfer of the MGR connector housing for pitting and corrosion on the sealing surface. Corrosion in this area will cause the seal to leak. Are pitting and corrosion present?

**YES** – Rear Traction Motor Cable requires replacement continue to Section VI.
