**TECHNICAL INSTRUCTIONS**  
**FOR**  
**CUSTOMER SUPPORT PROGRAM 22TE09**  
**HV FLOOR UNDER WIRE HARNESS AND REAR TRACTION MOTOR CABLE**  
**CORROSION**  
**CERTAIN 2020 –2022 MODEL YEAR HIGHLANDER HYBRID**

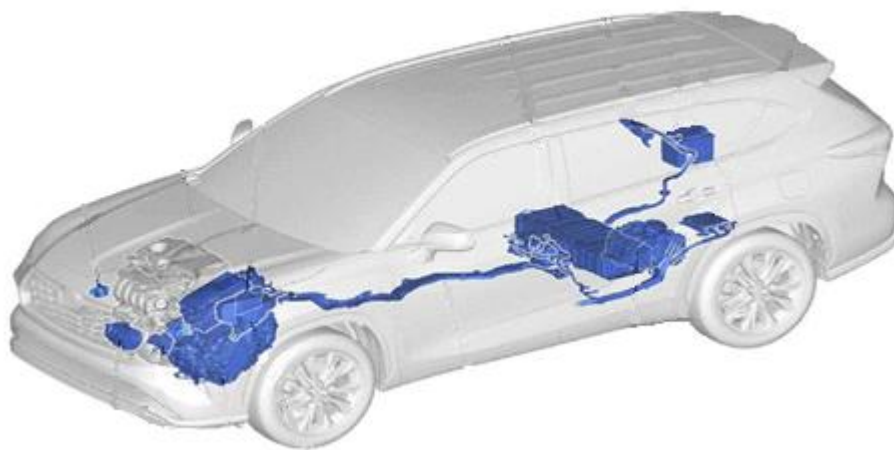
Although the HV Floor Under Wire Harness and Rear Traction Motor Cable is covered by Toyota's New Vehicle Limited Warranty for 3 years or 36,000 miles (whichever comes first), we at Toyota care about the customers' ownership experience. Toyota is providing coverage for repairs related to excessive corrosion to the wire harness connections at the Rear Motor Generator. Excessive corrosion can cause AM Radio Static during certain drive cycles, or the vehicle may not start.

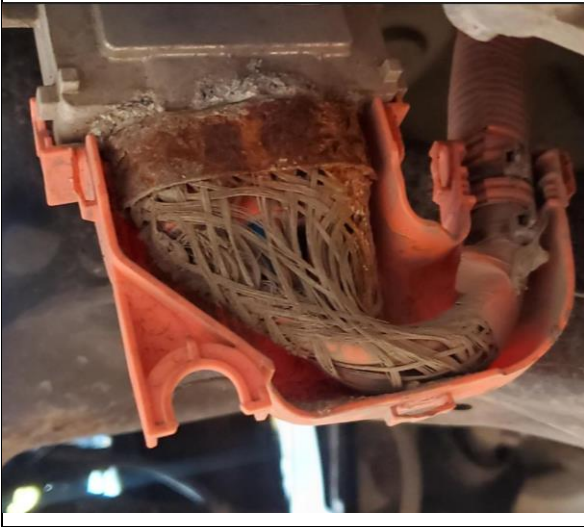
**Y6 connector under vehicle at MGR**

- 4) Inspect the Y6 connection for corrosion.
- f) Disconnect the Y6 connector at the MGR and inspect for corrosion, dirt, or debris.

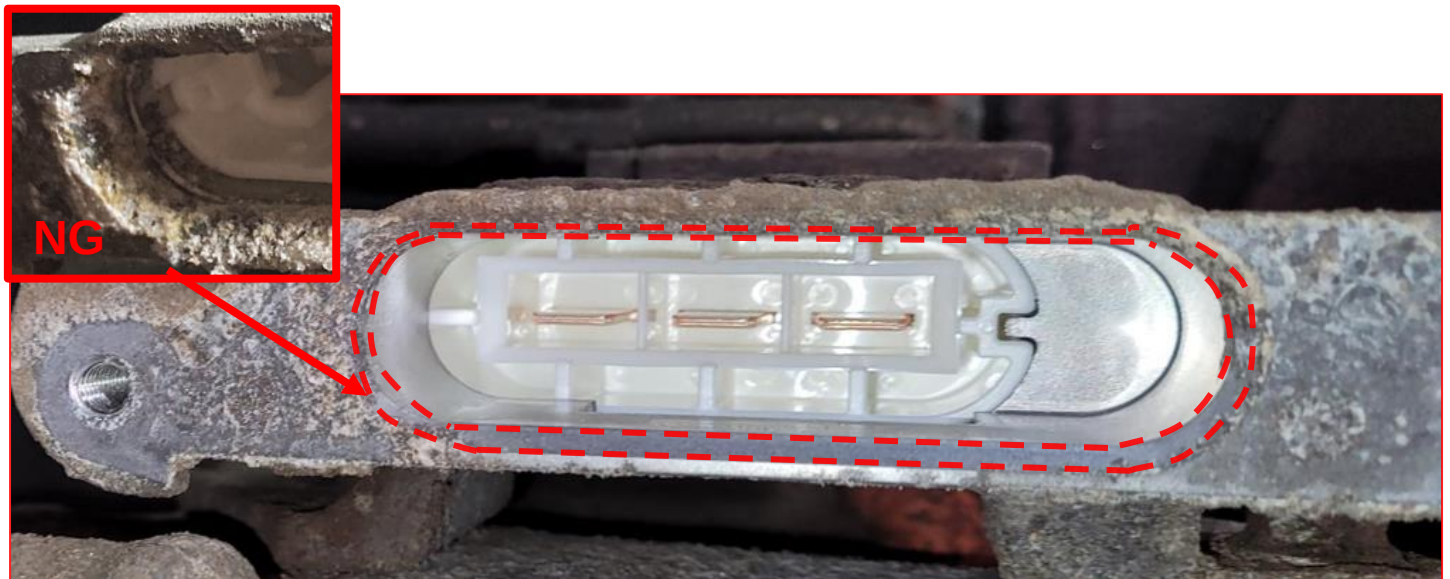
- a) Inspect the chamfer of the MGR connector housing for pitting and corrosion on the sealing surface. Corrosion in this area will cause the seal to leak. Is pitting and corrosion present?

**YES –** Rear Traction Motor Cable requires replacement, continue to Section VI
