Rotational Clicking Noise From Front Drive Shaft Assembly on Acceleration

Service Category Drivetrain

Section Drive Shaft/Propeller Shaft

YEAR(S)	MODEL(S)	ADDITIONAL INFORMATION
2024	Grand Highlander, Grand Highlander HV

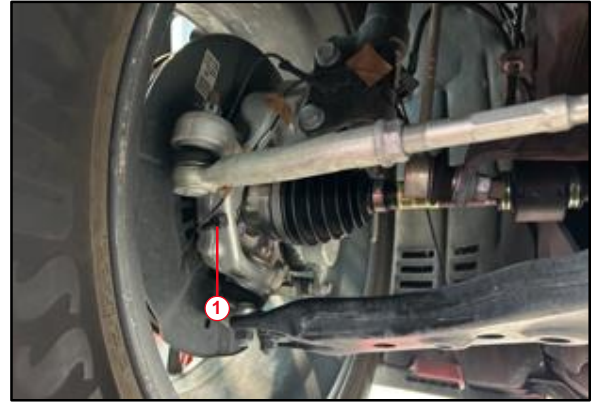
Figure 1.

1	ChassisEAR™ on the Front Knuckle Assembly
---	---

2. Place the vehicle on a lift and install the ChassisEAR™ (or equivalent) on the front knuckle assembly, as shown in Figure 1, to help isolate the source of the noise.
