TECHNICAL INSTRUCTIONS
FOR
CUSTOMER SUPPORT PROGRAM 22TE09
HV FLOOR UNDER WIRE HARNESS AND REAR TRACTION MOTOR CABLE
CORROSION
CERTAIN 2019 –2022 MODEL YEAR RAV4 HYBRID AWD

II. BACKGROUND

Although the HV Floor Under Wire Harness and Rear Traction Motor Cable is covered by Toyota's New Vehicle Limited Warranty for 3 years or 36,000 miles (whichever comes first), we at Toyota care about the customers' ownership experience. Toyota is providing coverage for repairs related to excessive corrosion to the wire harness connections at the Rear Motor Generator. Excessive corrosion can cause AM Radio Static during certain drive cycles, or the vehicle may not start.

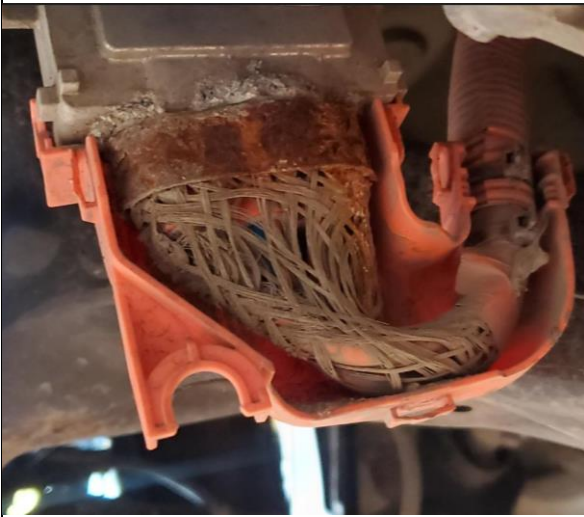
Y6 connector under vehicle at MGR

- 5) Inspect the Y6 connection for corrosion.
f) Disconnect the Y6 connector at the MGR and inspect for corrosion, dirt, or debris.

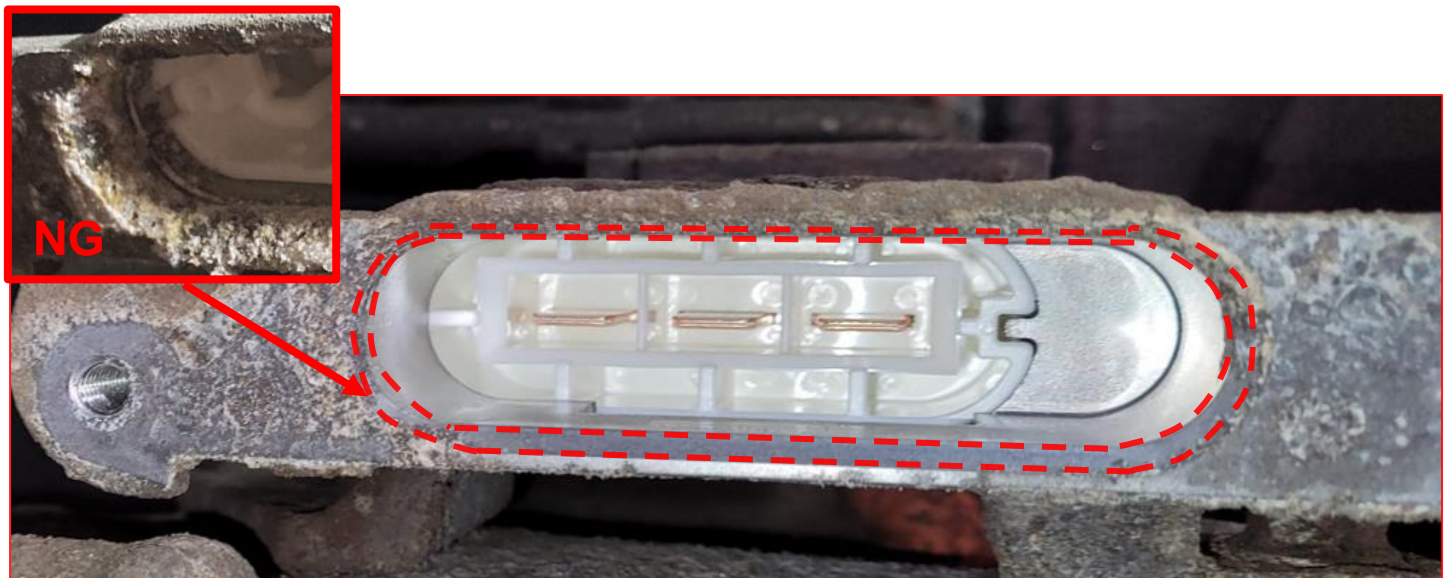
6) Inspect the connector housing of the MGR.

- a) Inspect the chamfer of the MGR connector housing for pitting and corrosion on the sealing surface. Corrosion in this area will cause the seal to leak. Is pitting and corrosion present?

YES – Rear Traction Motor Cable requires replacement continue to Section VI
