Custom Drive Mode Missing from Vehicle Customize - Settings Menu

YEAR(S)	MODEL(S)	ADDITIONAL INFORMATION
2024	Tacoma, Tacoma HV	VDS(s): LB5JN, LC5LN, LE5JN, LF5LN

Some 2024 Tacoma and Tacoma Hybrid vehicles equipped with an adaptive variable suspension may exhibit a condition where the custom drive mode is missing from the *Vehicle Customize – Settings* menu. The air conditioner supply amplifier software has been updated. Follow the Repair Procedure in this bulletin to address this condition.

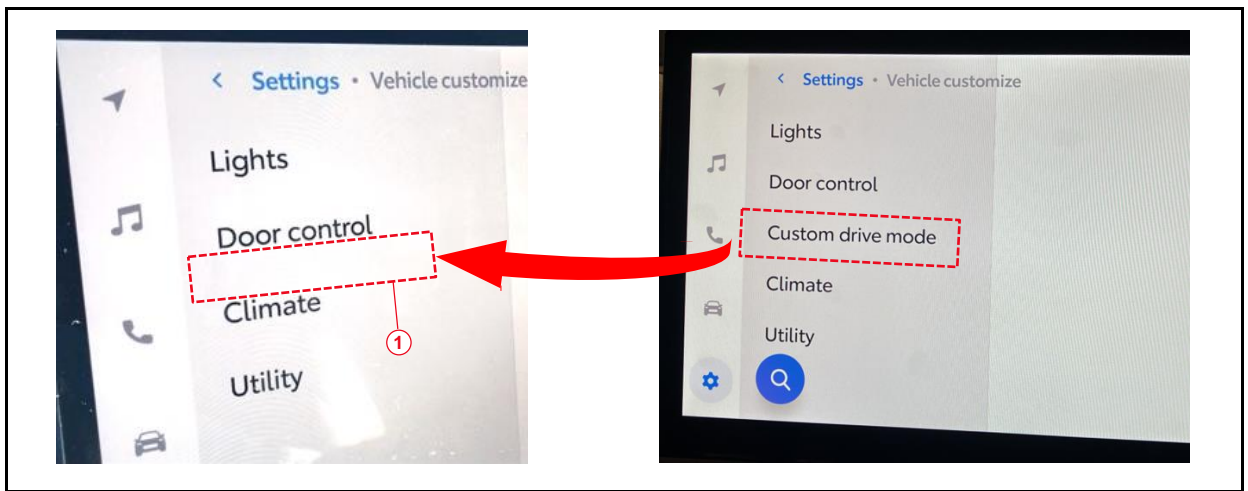
Figure 1.

Is the custom drive mode missing from the *Vehicle Customize - Settings* menu, as shown in Figure 1?

1	Custom Drive Mode Missing
----------	----------------------------------

Follow the procedures outlined in [T-SB-0107-20](#), *GTS+ ECU Flash Reprogramming With Security Signature*, and flash the air conditioning amplifier assembly with the NEW calibration file update.

- Using GTS+, perform a Health Check and clear ANY stored DTCs.
- Confirm the custom drive mode is present on the *Vehicle Customize - Settings* menu.
