No.: 24CSA-20
October 2024

TO: Service Locations
FROM: Powertrain Service Engineering
SUBJECT: **Discolored Coolant Surge Tank on Heavy Duty Engine Product (HDEP)**

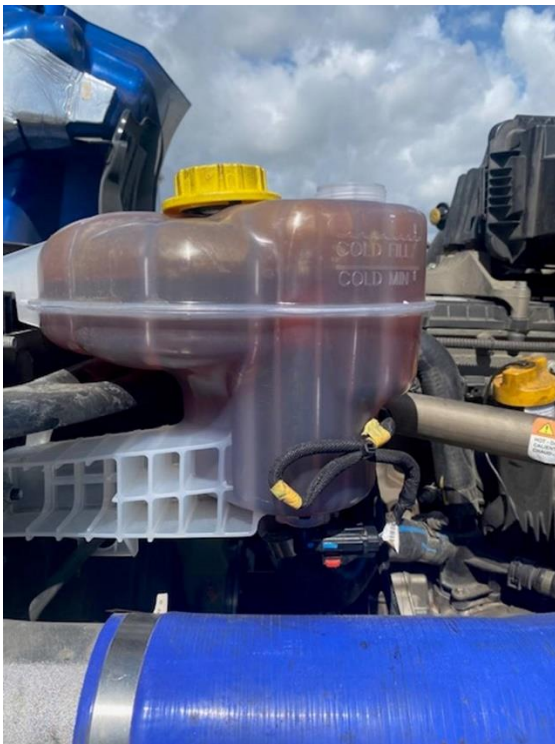
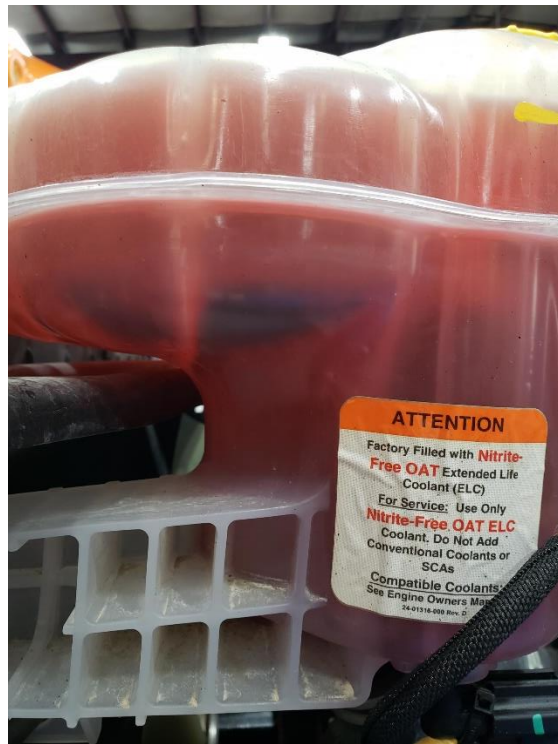
Examples of discolored surge tanks

The coolant filter was removed from the oil coolant module in early 2015 (review 15TS-10Rev). With the removal of this filter, any cooling system dropout may accumulate in the coolant surge tank. The low speed of coolant flow through the surge tank allows sediment to build up in various areas of the tank and can lead to a film on the inside of the tank walls. This dropout can range from a very small amount of sediment/debris, up to the inability to see the coolant level through the outside of the surge tank.

If the coolant level can be read/is visible, coolant surge tank replacement is not necessary. If the customer is still concerned about the condition of the coolant surge tank, a coolant sample should be sent out locally for analysis.

If other operating complaints or cross contamination of the coolant with another fluid are not present, repairs and part replacement is not needed. Follow the appropriate troubleshooting procedures if cross-contamination is found in the coolant.

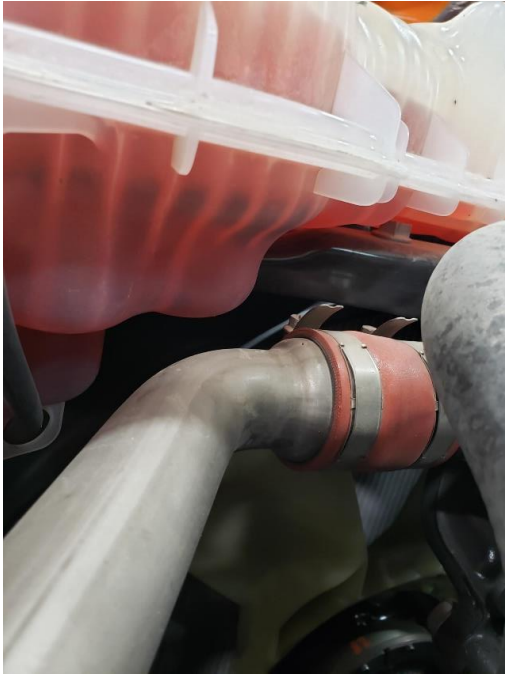
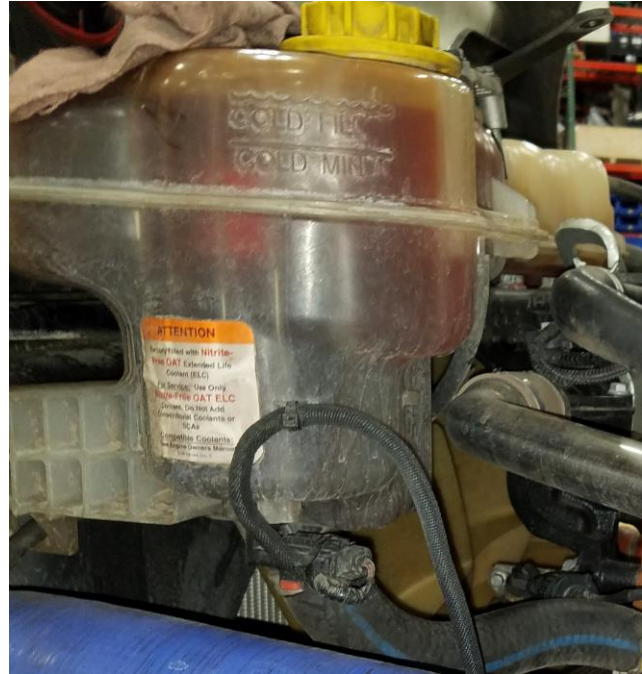
Examples of discolored surge tanks
