# SS 767 WST 47X Twin Steer Suspension Equalizer Beam Bushing

WST 47X Twin Steer

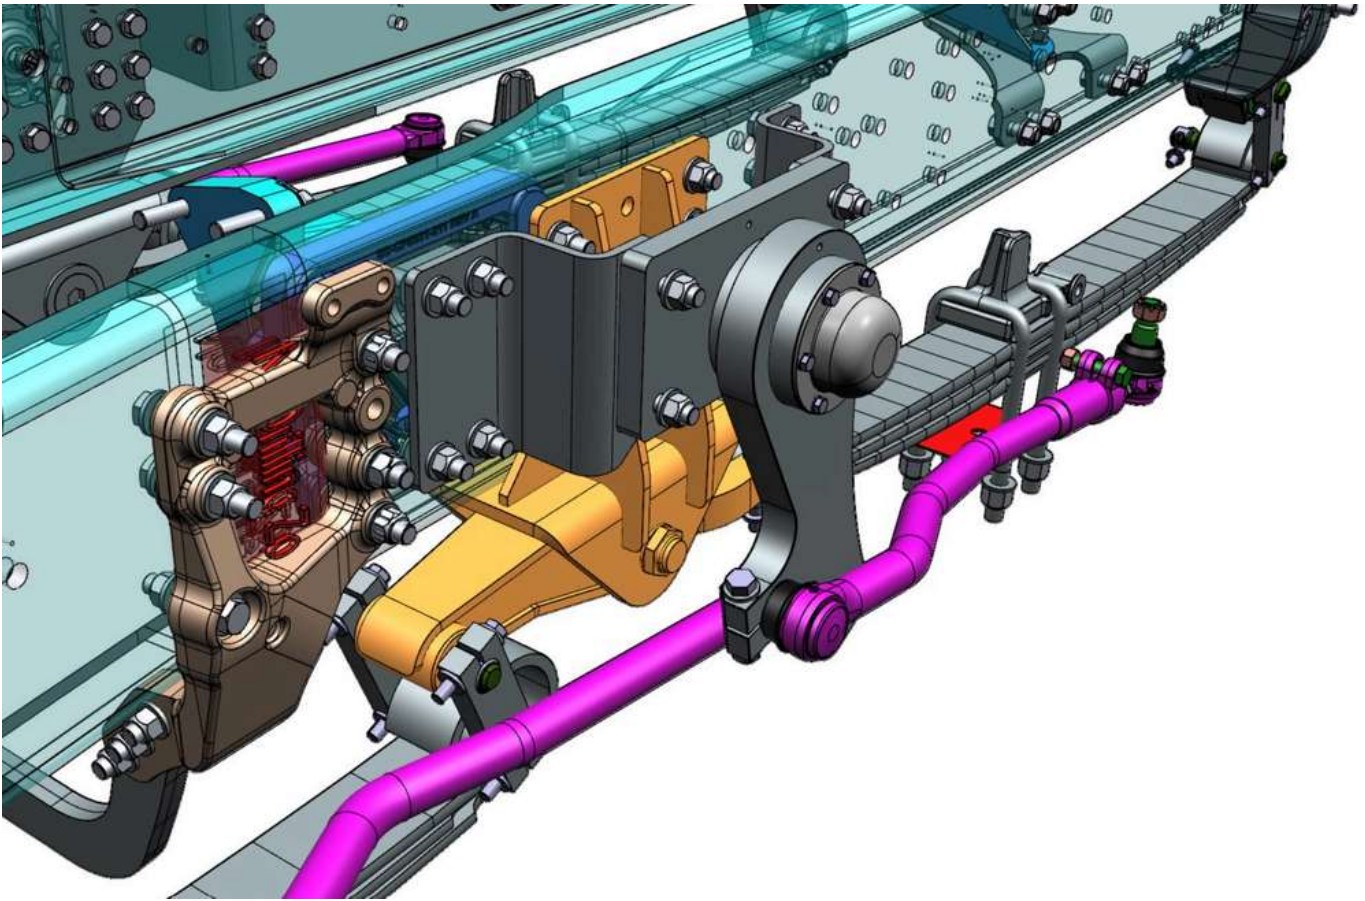
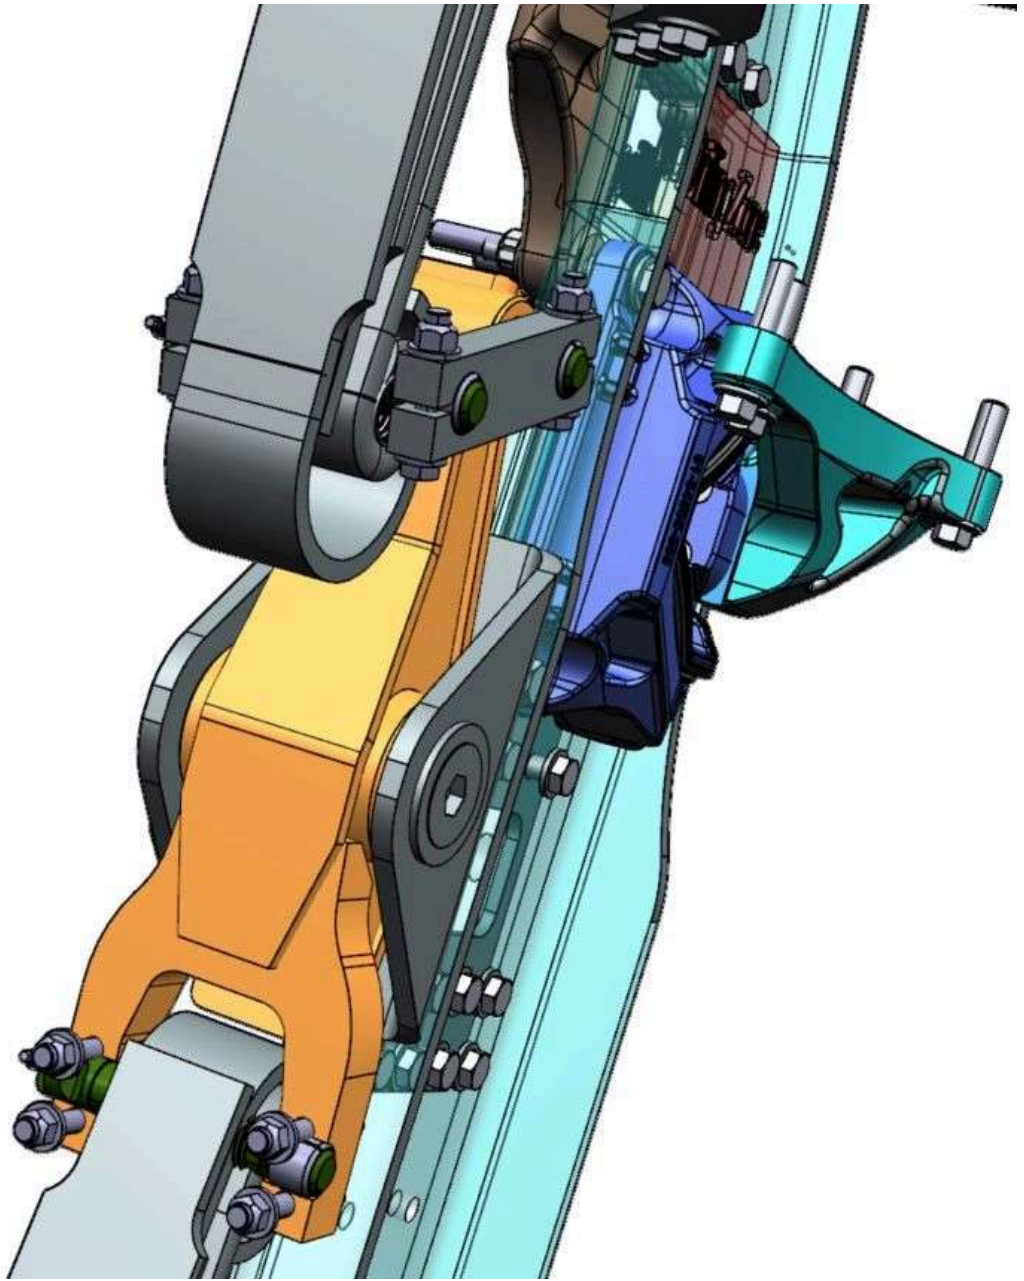
During routine maintenance inspection of twin steer front suspension equalizer beam assemblies, skimmed or torn rubber material from the pivot bushing may be observed. This may occur after several months in service where the bushing has been subjected to expected front suspension loads.

To prevent unnecessary replacement of equalizer beam assemblies, the correct diagnosis during inspection is required. The above pictures show a new equalizer beam bushing from factory and skimmed rubber material from bushings that have been in service.

For an equalizer beam rubber bushing to be diagnosed as worn/damaged, the following reported symptoms/complaint should be verified:

- Audible knocking sound from the front suspension, especially during vehicle turn events
- Change in ride or comfort level in front suspension area
- Obvious looseness of the equalizer beam within the bracket

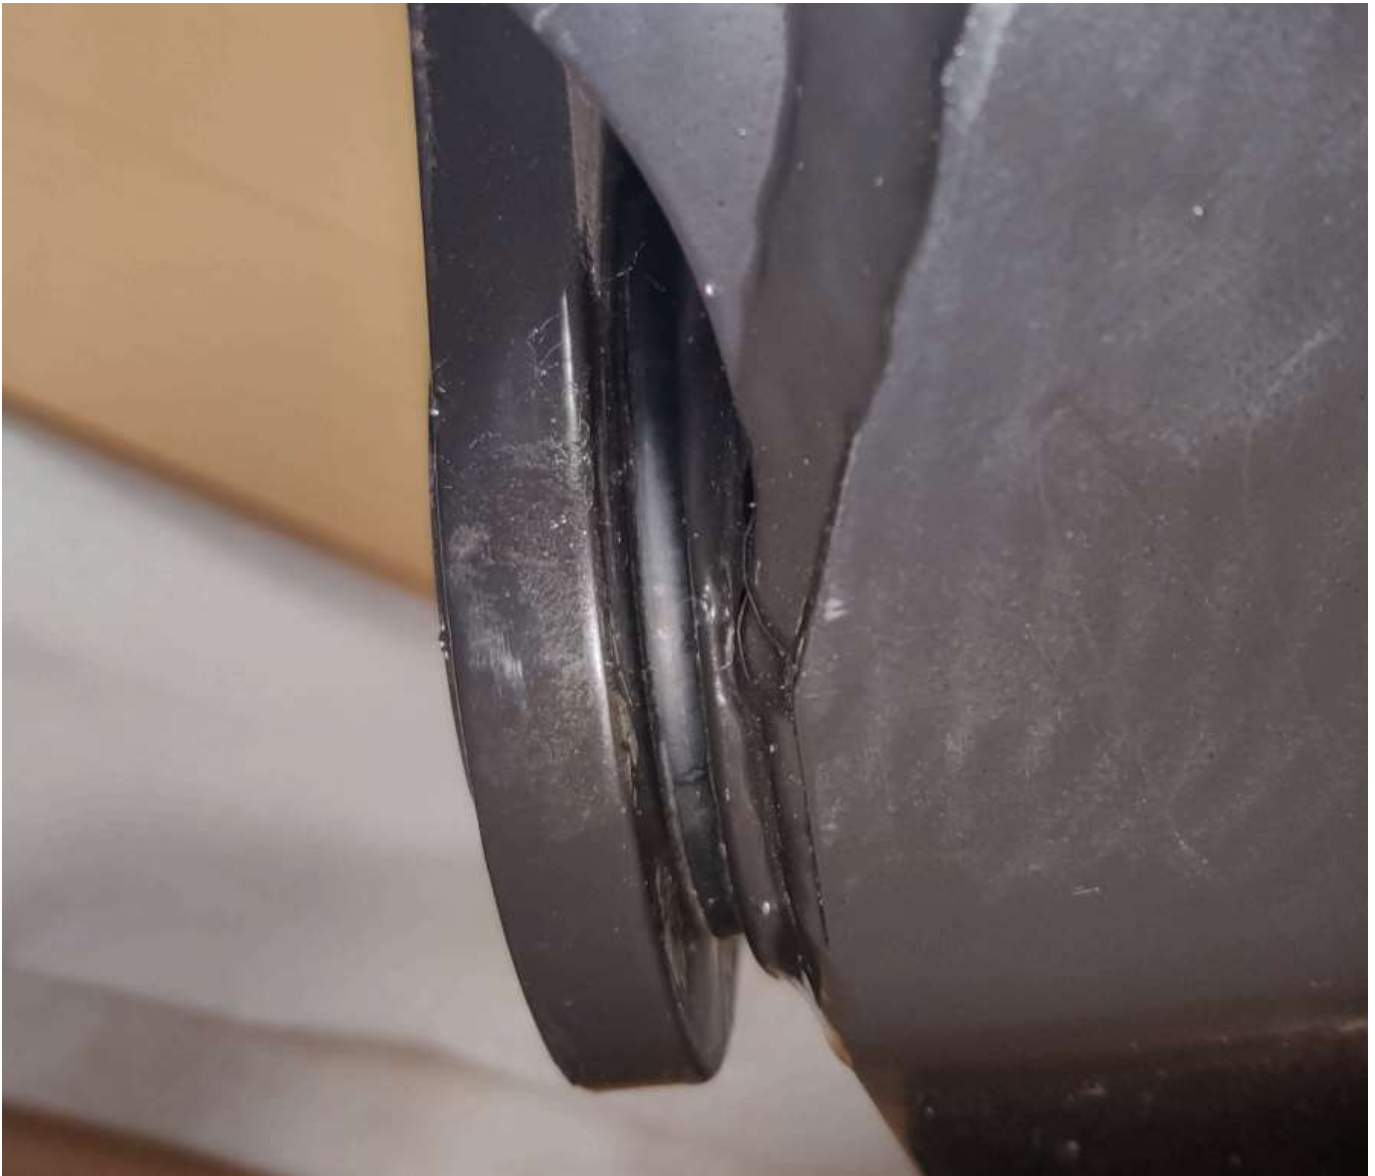
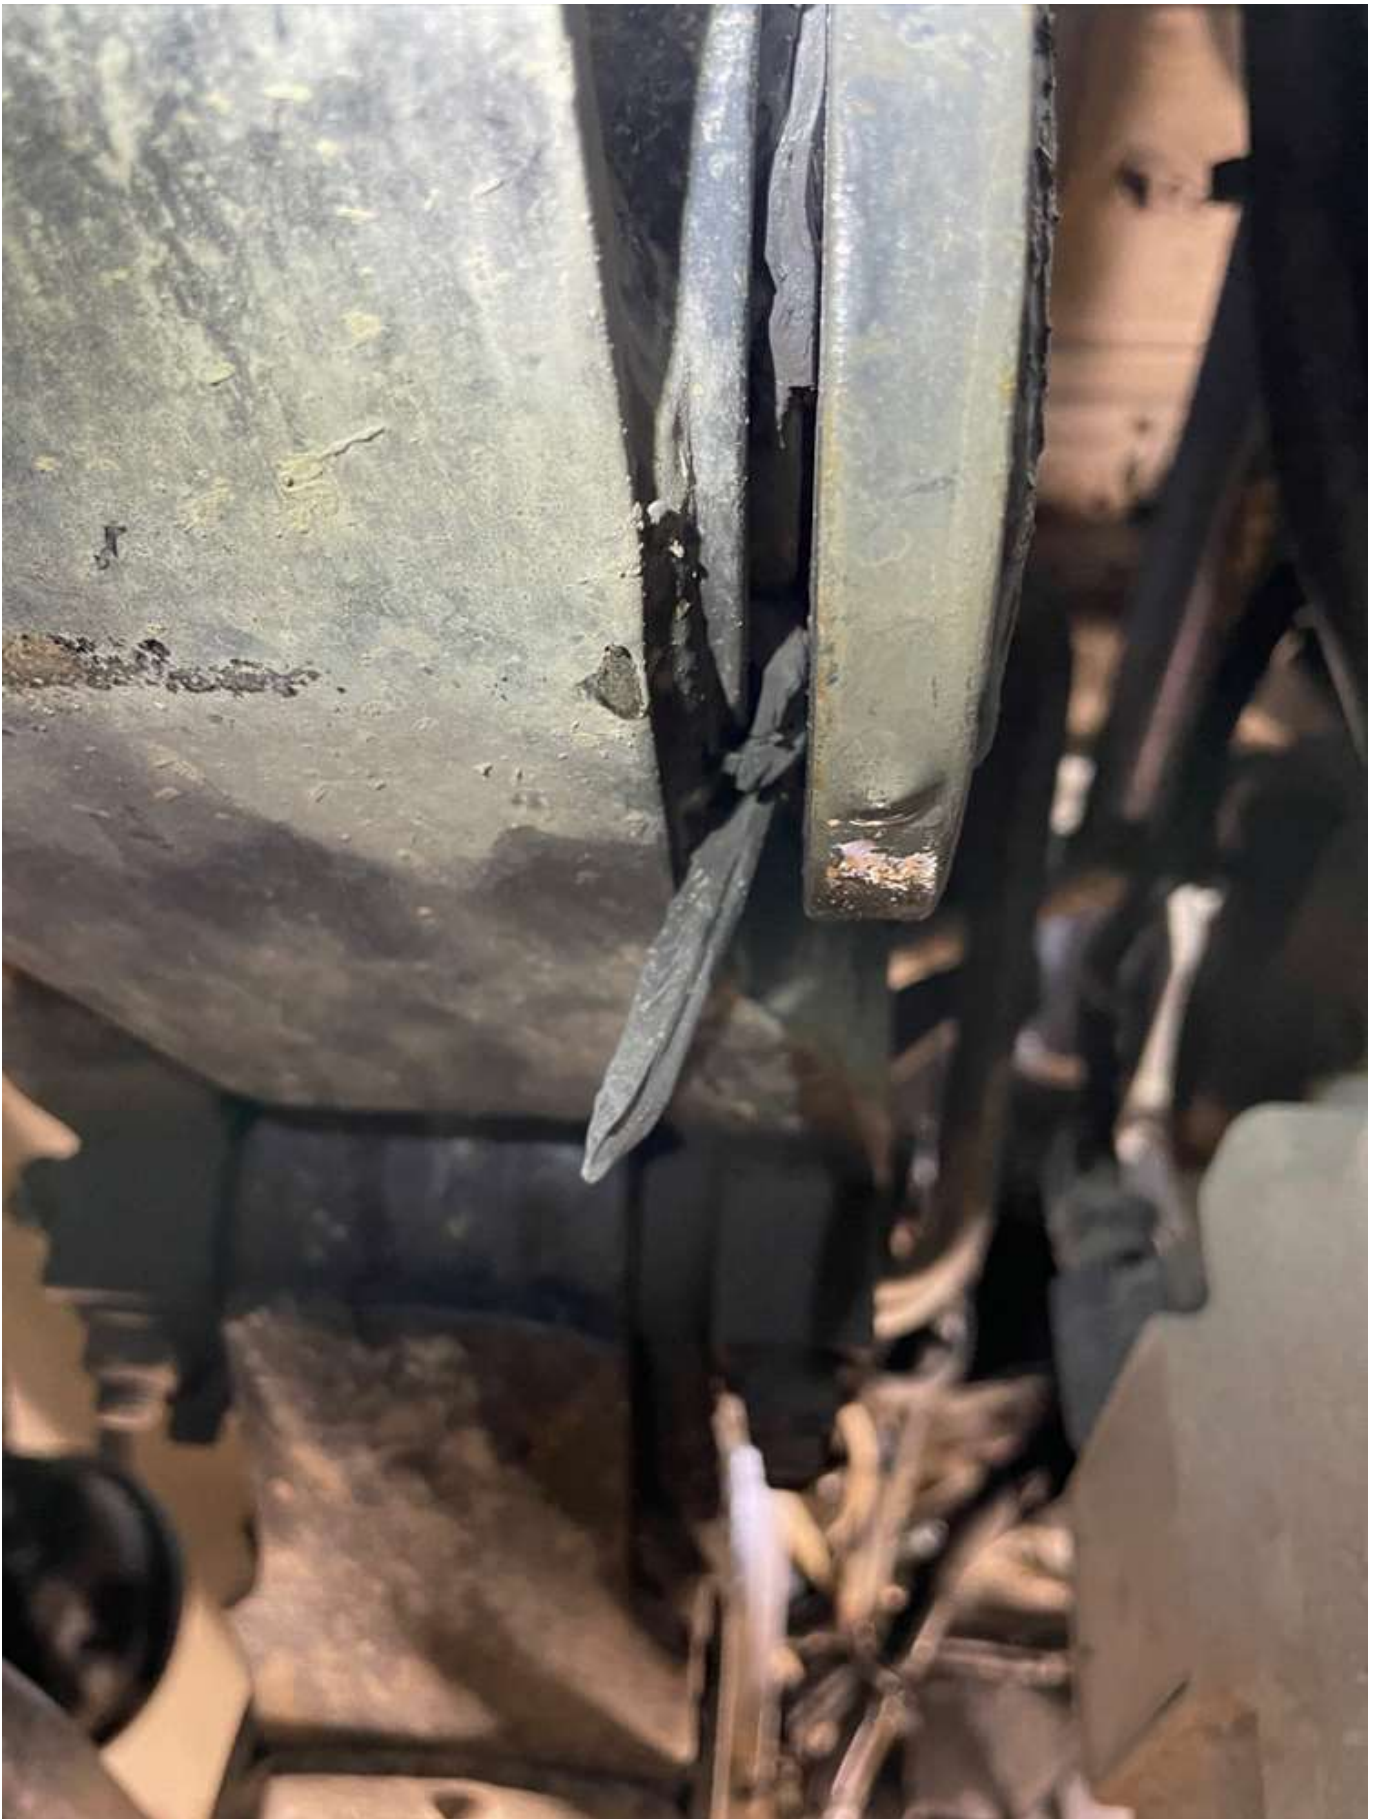
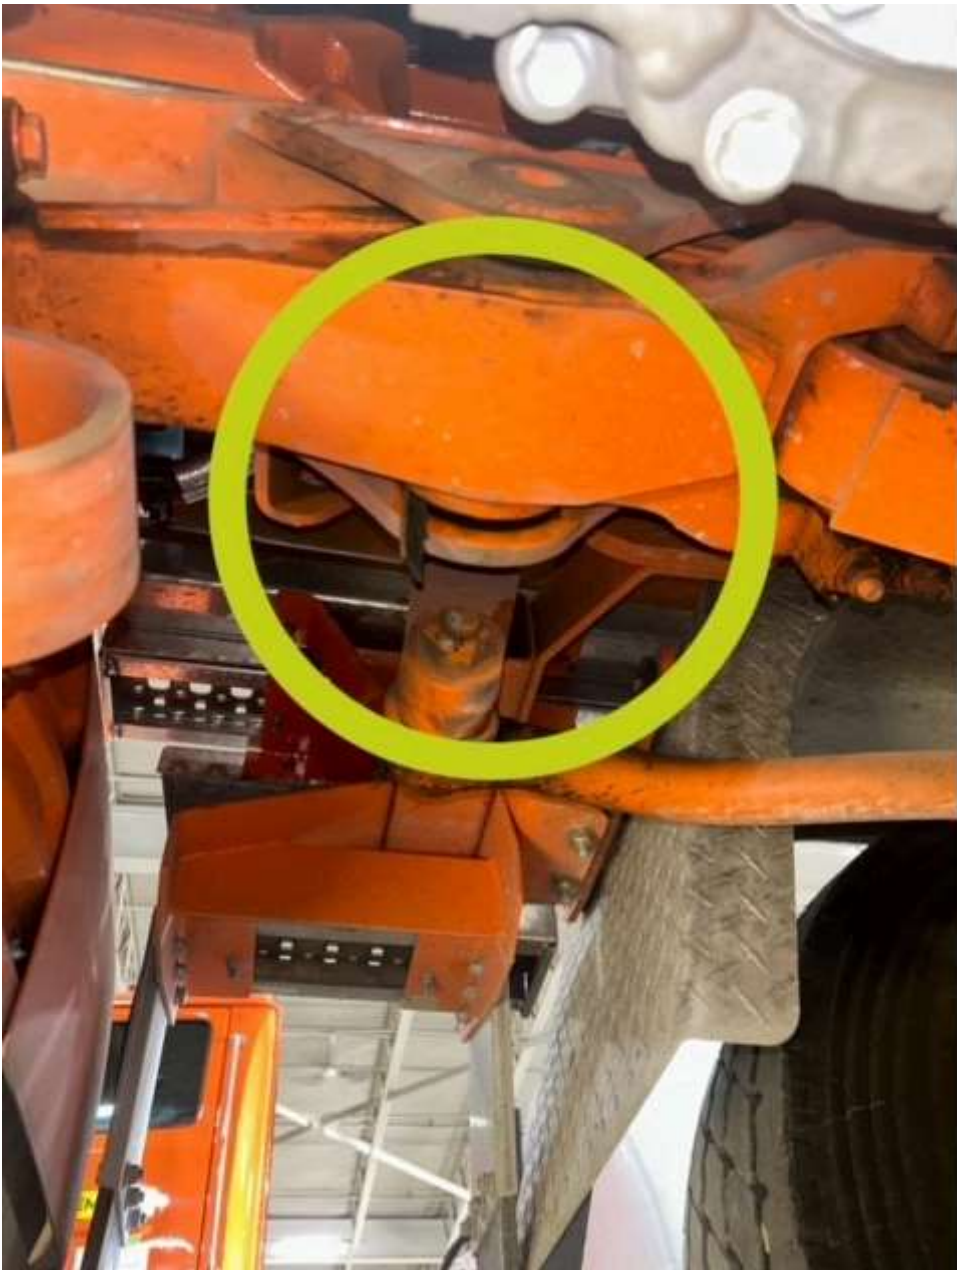
There is a dimension tolerance stack-up between the rubber bushing length and the equalizer beam width. The rubber bushing is pressed into the equalizer beam. This pressing operation can leave additional deformed rubber material at each end of the beam.

After the front suspension has been exposed to normal operating loads in service, the excess rubber material can be skimmed or trimmed by the motion of the beam within the bracket.

The skimmed rubber material can potentially cause an incorrect diagnosis of a damaged/worn equalizer beam bushing. This could result in unnecessary replacement of the equalizer beam assembly.
