# 42-080 ABS Wheel Speed Fault Code Correction for MBSP Equipped Vehicles

## TSB-42-080-FTL

► New Cascadia

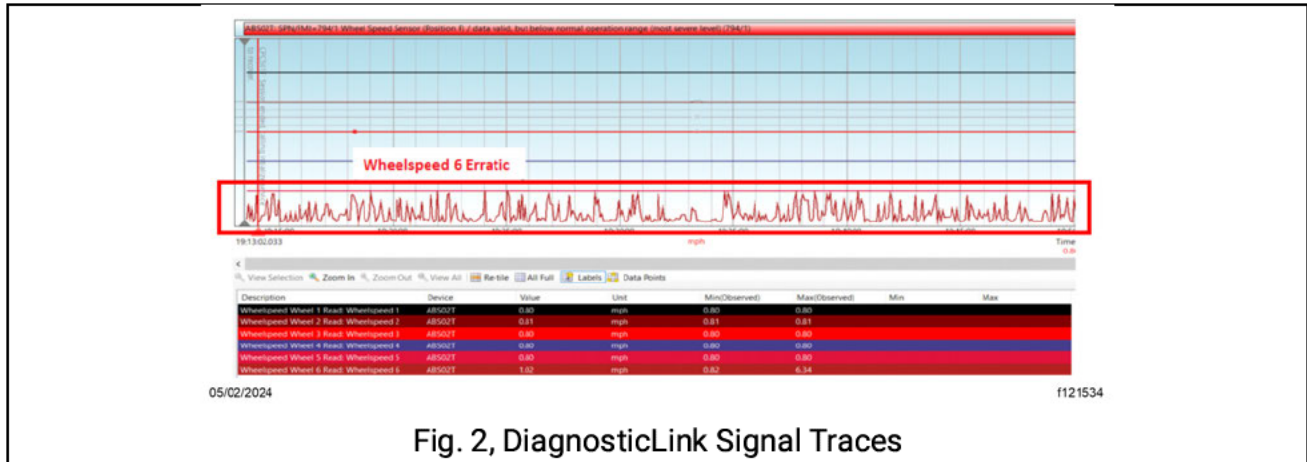
Fig. 2, DiagnosticLink Signal Traces

14.  See Fig. 2 for the traces of the selected wheel speed and relative speed signals. Note the erratic signal on wheel speed 6.

- a.  If the readings are erratic regardless of location, or if the issue only happens in damp or wet conditions, install the individual overlays for all four rear wheel ends. See Table [WABCO Harness Part Numbers 5](#) for length and part number of WABCO harnesses.

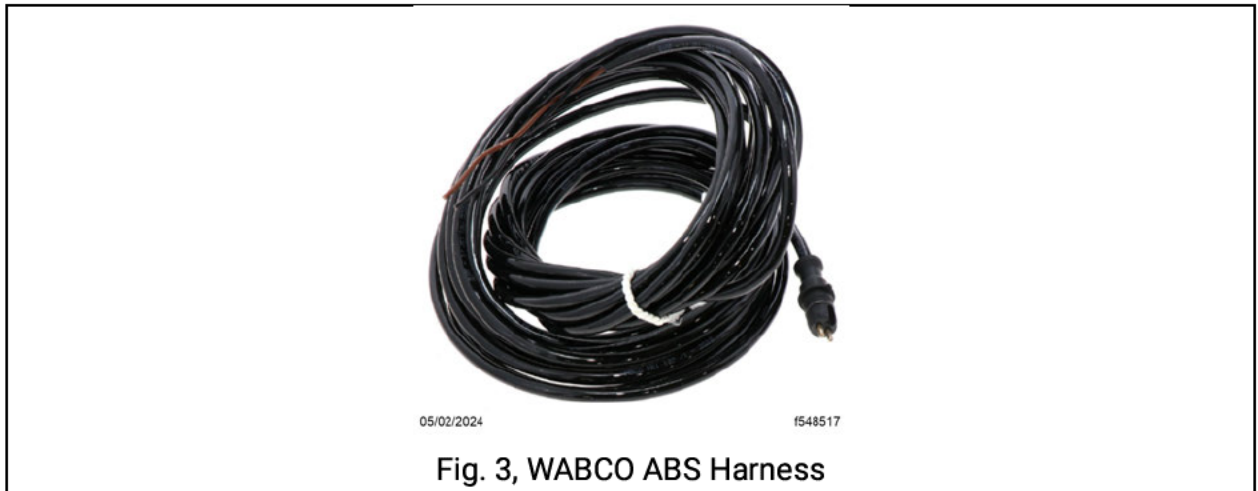
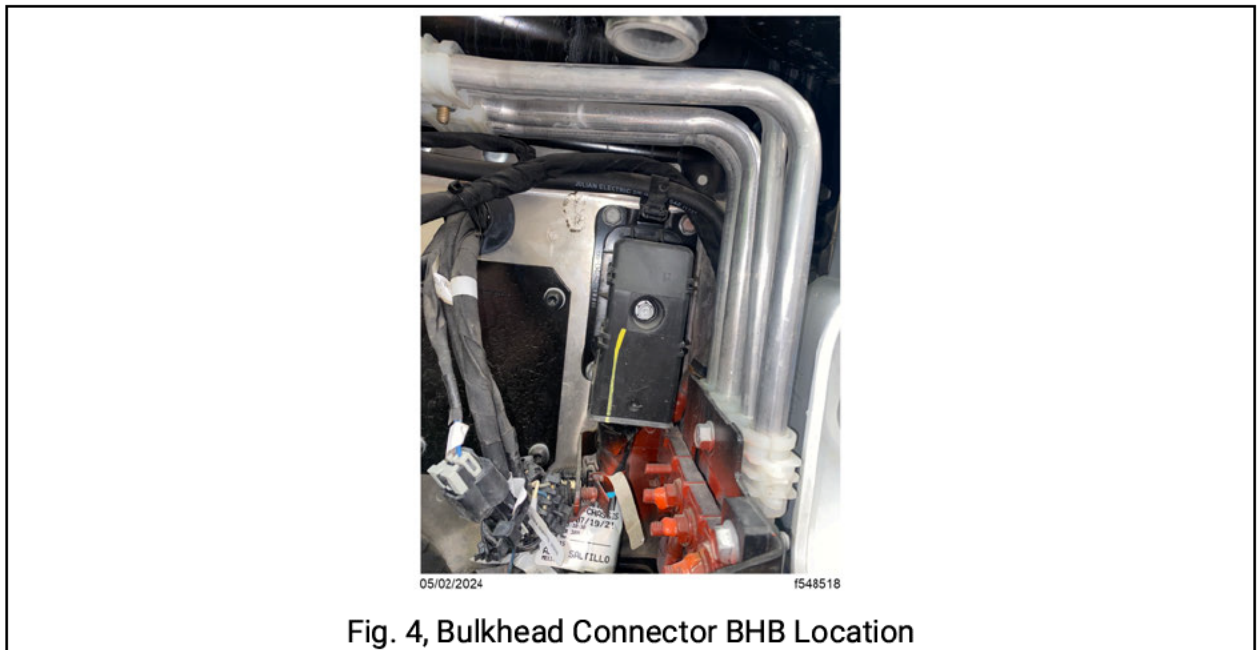
- b.  All harnesses listed above in Table [WABCO Harness Part Numbers 5](#) will require termination at the bulkhead connector BHB. See Fig. [3](#) and Fig. [4](#) for bulkhead connector BHB location.

- c.  The lengths of the WSS overlay harness required will vary based on the wheelbase of the vehicle. See 'Determine Vehicle Wheelbase' below.
- d.  All the harnesses listed in Table [WABCO Harness Part Numbers 5](#) will require trimming to length and termination at the 76-pin bulkhead connector BHB. See Fig. [3](#) for image of a typical WABCO ABS Harness and Fig. [4](#) for bulkhead connector BHB location.
- e.  Choose the closest available harness length in order to minimize harness waste when trimming to length.
- f.  Installation of the terminal part number 23-13211-410 (Qty: 8 Nos.) requires crimping tool SPX J-38125-6 (non-ratcheting) or SPX J-38125-7 (ratcheting).
