54–370 Minimum Cell Voltage of High-Voltage Batteries

TSB-54-370-FTL

Engine or Vehicle Affected:

- ▶ eM2
 - ▶ eCascadia
-

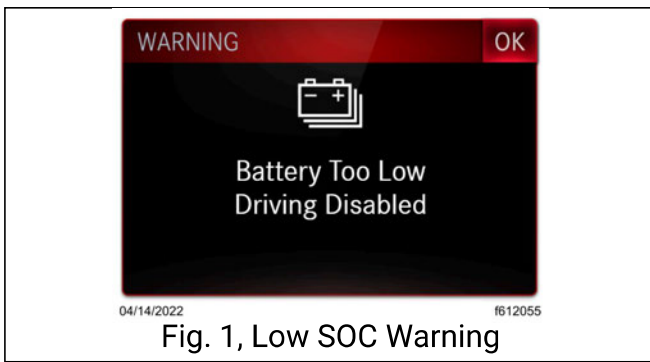
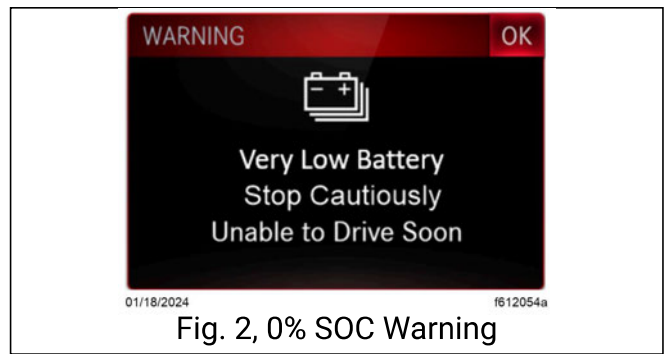
This bulletin applies to eCascadia and eM2 vehicles built between May 16, 2022 and June 30, 2025. When the keyswitch is left in the ON position, certain HV-powered accessories continue to draw the HV batteries down until the minimum cell voltage is reached. This occurs when all of the low battery warnings are ignored, the high-voltage (HV) battery indicated state-of-charge (SOC) has reached 0%, and the vehicle powertrain is shut down. See Fig. [1](#) and Fig. [2](#).

When the battery cell voltages drop below the minimum value, the HV battery contactors will open and will not close again, even if the vehicle is plugged into a charger, rendering the vehicle completely inoperable.

⚡ **Note:** To avoid this scenario, make sure to NEVER leave the ignition switch in the ON position when the vehicle's state-of-charge is at or close to 0%, except when moving the vehicle to a charger and connecting it.

If this occurs, a DTNA representative with special engineering tools will need to travel to the vehicle for the repair, or all the battery packs must be replaced.
