New CSA Letters

- 24CSA-17
- Gen 5 DD13 Turbocharger Oil Return Line Cracks
- 24CSA-19
- Heavy-Duty Engine Product (HDEP) Oil Separator Leaks
- 24CSA-20
- Discolored Coolant Surge Tank on Heavy Duty Engine Product (HDEP)

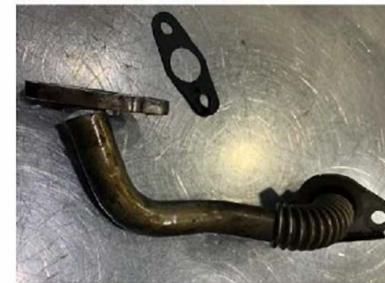
ISSUE
Some DD13 Gen 5 Turbocharger oil return lines have cracked, causing an oil leak. Engineering is requesting additional steps and the return of replaced parts to aid with understanding the root cause. If completed, please return the parts directly to DCC. This process is only to be performed until January 1, 2025, and only when the customer approves of the additional repair time that may occur.

Examples of a broken turbo oil return line
