Technical product information

Topic	Bentley Rotational Display (BRD) clashing with the switch pack during rotation
Market area	Bentley: worldwide (2WBE),China 796 VW Import Comp. Ltd (Vico), Beijing (6796)
Brand	Bentley
Transaction No.	2075711/1
Level	EH
Status	Approval
Release date

Bentley Rotational Display (BRD) clashing with the MMI switch pack during rotation

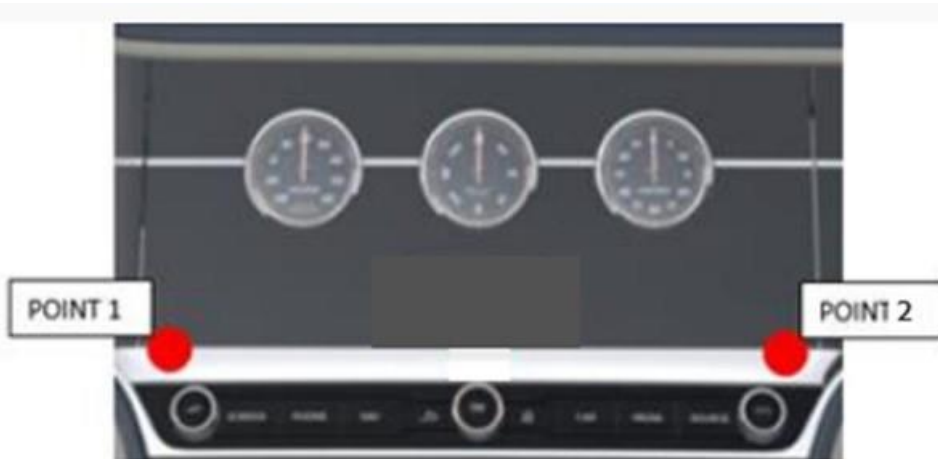
1) Conduct a visual inspection of all (3) BRD faces checking for any signs of clashing / damage at the locations shown in Figure 1 (POINT 1 and POINT 2)

Should any issues be evident with the BRD faces or MMI switch pack the operative must raise a technical DISS query and await feedback before conducting any further work

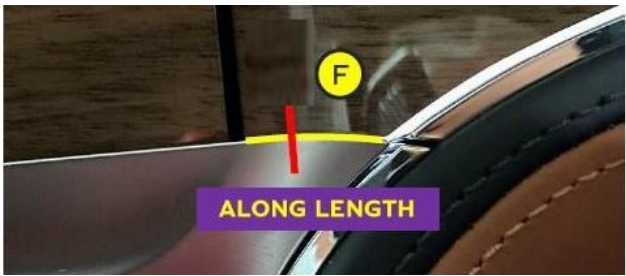
MMI switch to facias.
Overflush at nominal

F Max 3.0mm OF
Nom. 2.0mm OF
Min 1.0mm OF

5) Referring to Figure 3 - Measure the profile of the switch pack to confirm the correct tolerance has been achieved

- Should the required tolerance be achieved - Rotate the BRD with care to confirm the issue is resolved - If resolved no further action is required
