Technical product information

Topic	Front windscreen - Water ingress - Left or right hand side Or water ingress from the top of the front windscreen
Market area	Bentley: worldwide (2WBE),China 796 VW Import Comp. Ltd (Vico), Beijing (6796)
Brand	Bentley
Transaction No.	2075624/1
Level	EH
Status	Approval
Release date

Continental GT / C and Flying Spur

Front windscreen - Water ingress - Left or right hand side Or water ingress from the top of the front windscreen

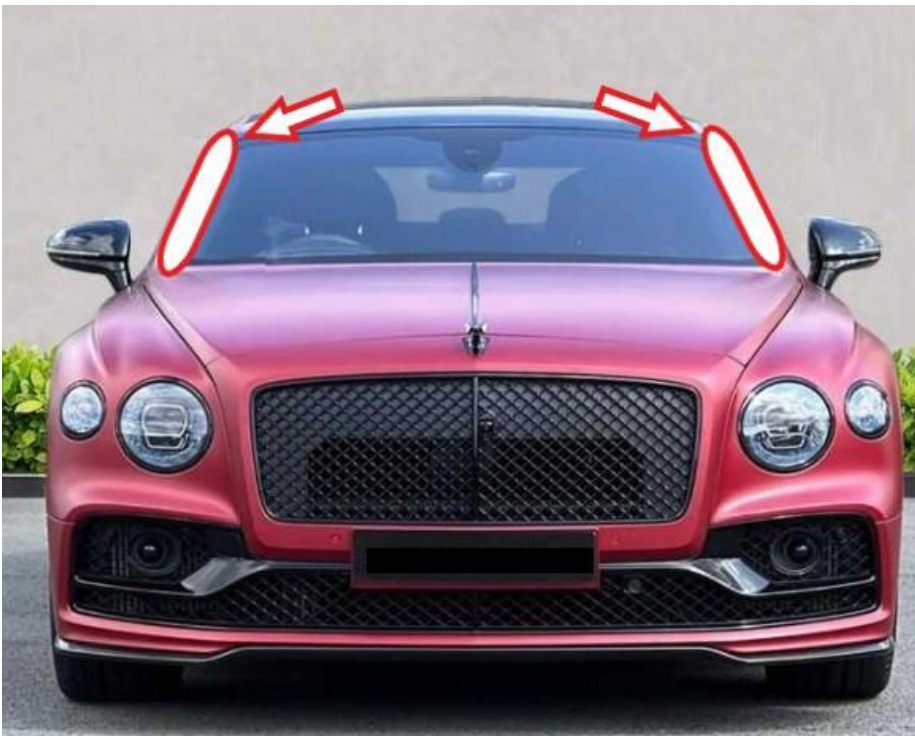
Water ingress into the cabin from the locations shown in Figure 1

Front windscreen water ingress (into cabin) - Left hand side

Front windscreen water ingress (into cabin) - Right hand side

In this scenario refer to Section 1

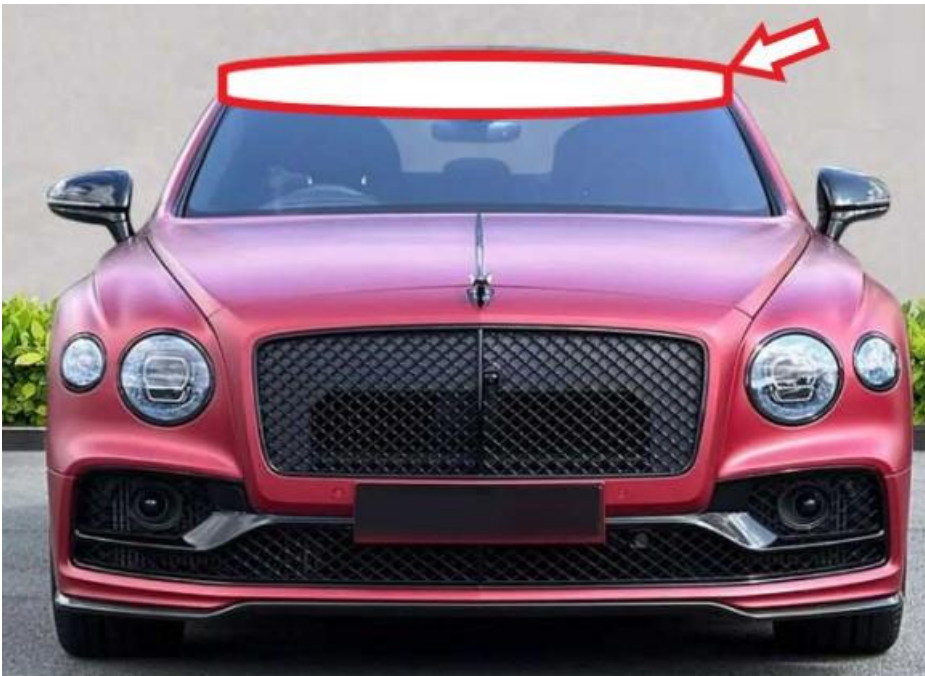
Referring to Figure 2 - Front windscreen water ingress (into cabin) from the top of the windscreen

In this scenario refer to Section 2
