Technical product information

Topic	Continental GT / C and Flying Spur - Rattle / Creak from the dashboard demister panel
Market area	Australia E04 Bentley rest Asia and Australia (6E04),China 796 VW Import Comp. Ltd (Vico), Beijing (6796),Germany E02 Bentley rest Europe (6E02),Japan E03 Bentley Japan (6E03),Korea, (South) E08 Bentley South Korea (6E08),United Arab Emirates E06 Bentley Middle East and Africa (6E06),United Kingdom E01 Bentley UK (6E01),United States E05 Bentley USA and rest America (6E05)
Brand	Bentley
Transaction No.	2073954/2
Level	EH
Status	Approval
Release date

New Continental GT / C and New Flying Spur

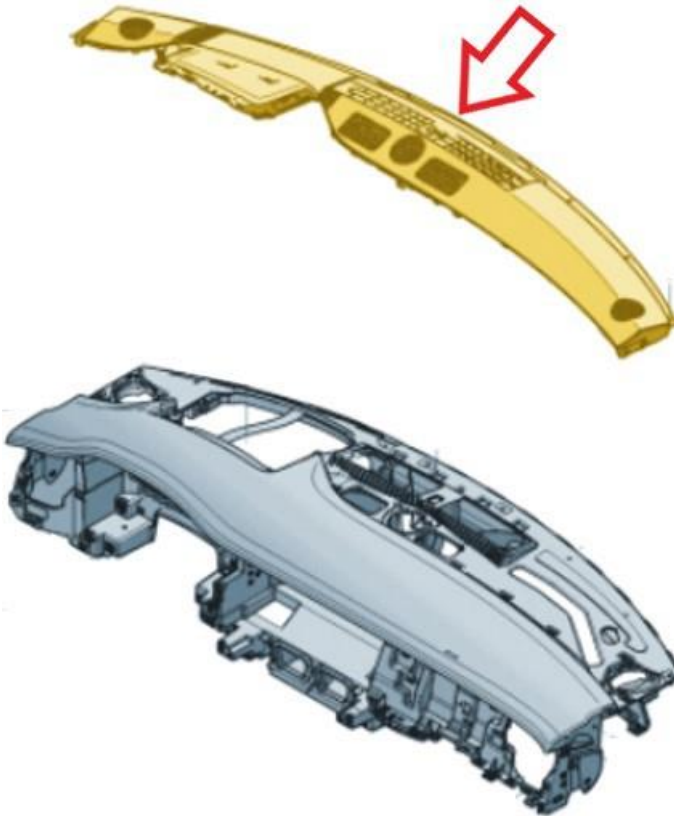
Figure 1

Rattle / Creaking noise from the dashboard demister panel (Figure 1)
