Technical product information

Topic	Water ingress into the front cabin footwell/bulkhead - Glass misting on the inside - Front carpets/mats wet
Market area	Bentley: worldwide (2WBE),China 796 VW Import Comp. Ltd (Vico), Beijing (6796)
Brand	Bentley
Transaction No.	2075699/1
Level	EH
Status	Approval
Release date

New Continental GT/C and New Flying Spur

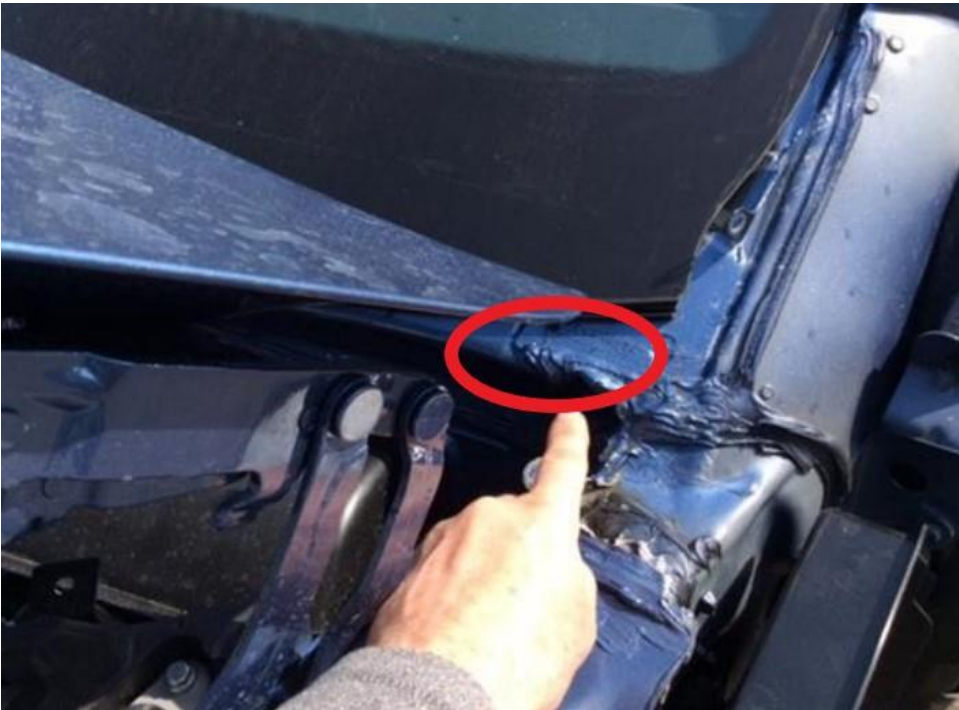
- After conducting TPI 2062622/- water ingress was found at the location shown in Figure1 (Left hand A - Pillar seam)

Figure 1 - Shows the front left hand wing removed please note this is not required for this procedure unless advised via a new or existing DISS query

Hint: The example shows a leak on the left hand side although a leak could be evident on the right hand side at the same location

- 1) Referring to Rep.Gr 55 - Remove the plenum cover
 - Check the condition of the seam sealant at the location shown in Figures 1 and 2
 - Check to confirm that sealant has been applied to the left hand A - pillar seam
 - Check to confirm that sealant has been applied to the right hand A - pillar seam

A different location the operative should clean/prepare the areas concerned and apply sealant (See parts information) to the applicable location(s)

- Once sealant has been applied conduct a local paint repair in the location in which sealant was missing
- 2) Once the sealant and paint repair has been completed and the sealant/paint has cured/dried - Check to confirm the leak has been successfully repaired
 - 3) Referring to Rep.Gr 55 - Refit the plenum cover

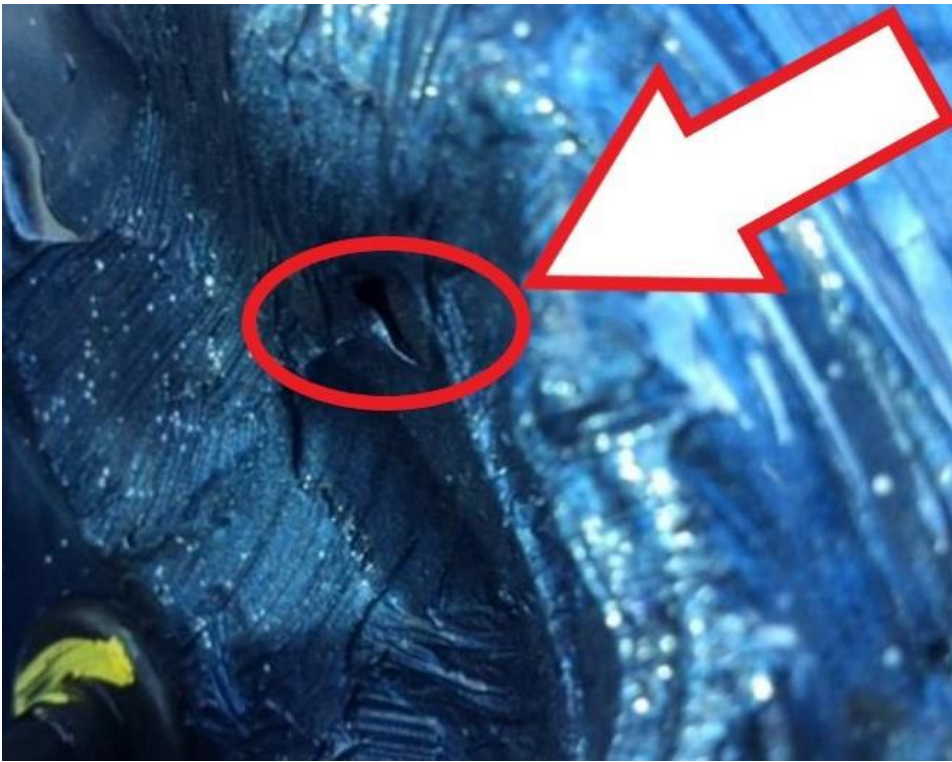
Figure 2

- The cause of the ingress can be caused by missing sealant on the A - post pillar seam
