Driver Assistance System Module Sensor Misalignment - DTC C14A4 - MY 2023 and 2024 Chrysler Pacifica (RU) / Jeep Compass (MP) and Dodge Durango (WD)

WARRANTY OPERATIONS NEWSLETTER

VOLUME 10, ISSUE 10

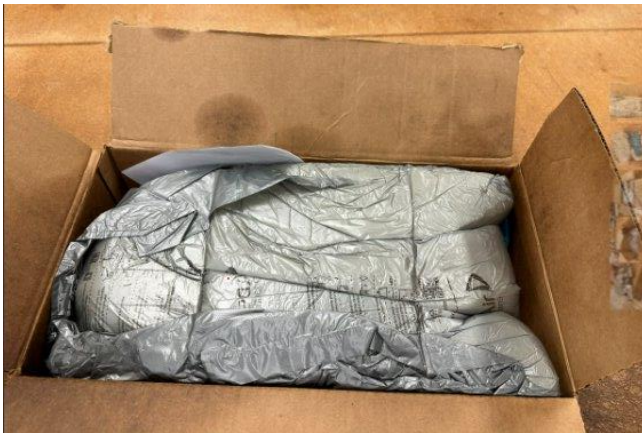
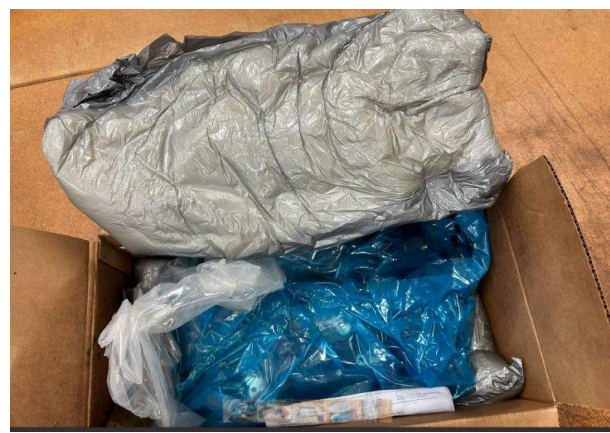
Above are photos showing the proper way to package returned parts. The part is packaged for return in the original box, as well as with the foam

protecting the part from shipping damage like the new part was received at the Dealership.

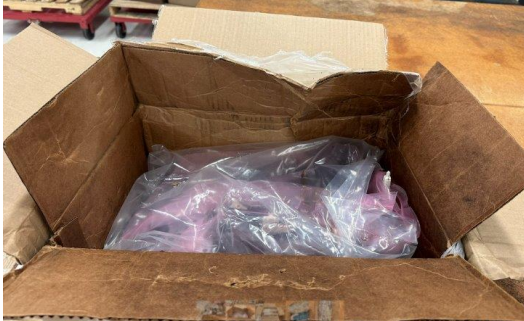
This is not the original packaging.

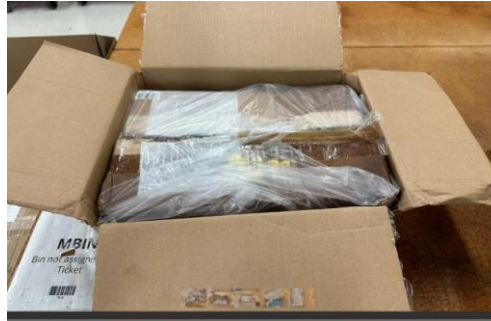
Part is not package in foam as the new part was received.

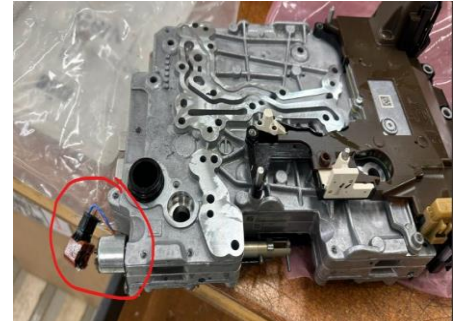
Part is broken as received at QEC due to improper part packaging.

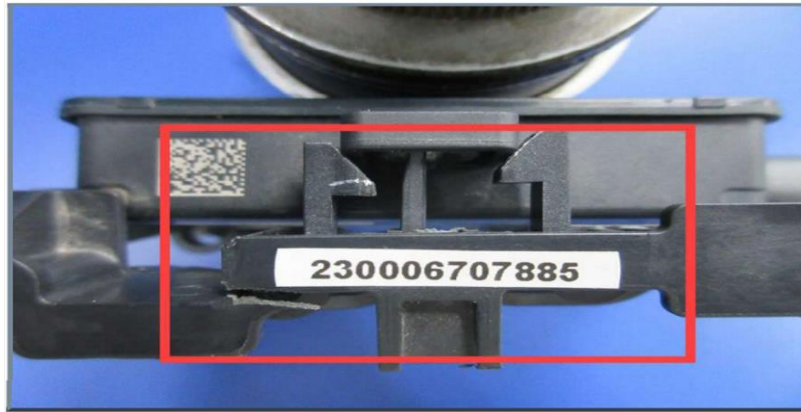
For visual reference, Figure 1 ,2,3 represent the damage to part.

NOTE: Physical inspection required. Any damage may cause radar mounting position to be incorrect. A damaged rear bumper may cause the mounting bracket, and valence to be pulled out of position. These conditions will generate an incorrect mounting position DTC (C14A4).

1. Perform a thorough inspection of the module, bracket, mounting location and alignment. Verify the following:
 - Sensor is not damaged, obscured or out of alignment.
 - Module housing is fully seated and secure.
 - Securing clips are not broken or missing.
 - Mounting bracket is not bent.
 - Verify the DASM Bracket Bolts are torqued to specification (4+-1 Nm.)

in a “Stored” status and no physical damage to Part Including Bracket, cover, and Mounting clips, this is normal operation that may require inspection and re-calibration of the sensor again to module that would compromise the function of these systems. If C14A4 is still present, perform the ACC module programming procedure, erase DTCs, and check for DTC to return.
