## **Driver Assistance System Module Sensor Misalignment - DTC C14A4 - MY 2023 and 2024 Chrysler Pacifica (RU) / Jeep Compass (MP) and Dodge Durango (WD)**

# FCA CARIBBEAN WARRANTY OPERATIONS NEWSLETTER

## VOLUME 10, ISSUE 10

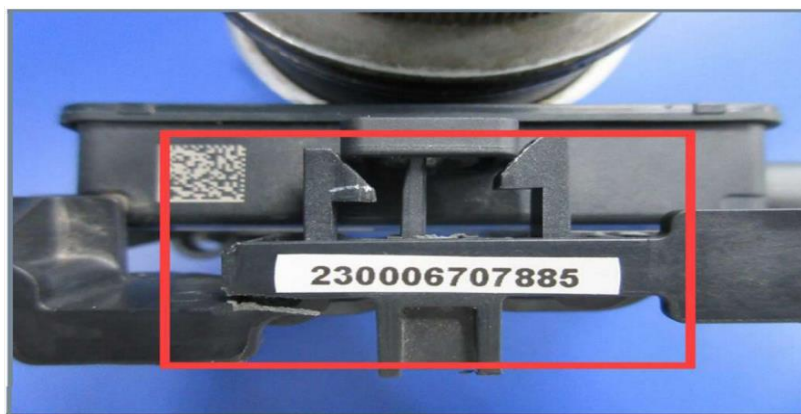
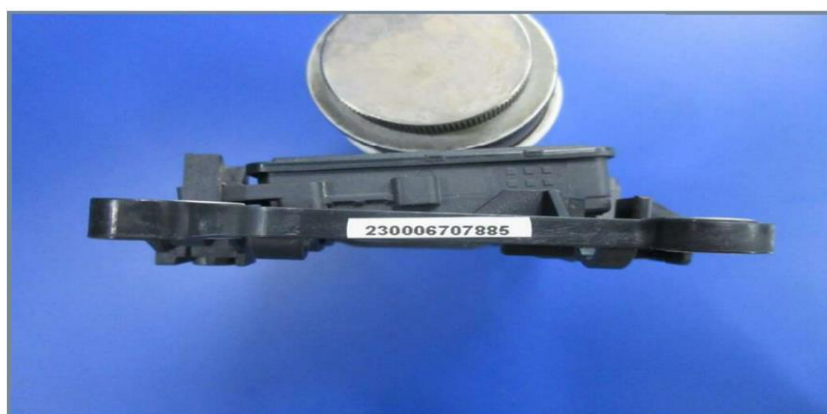
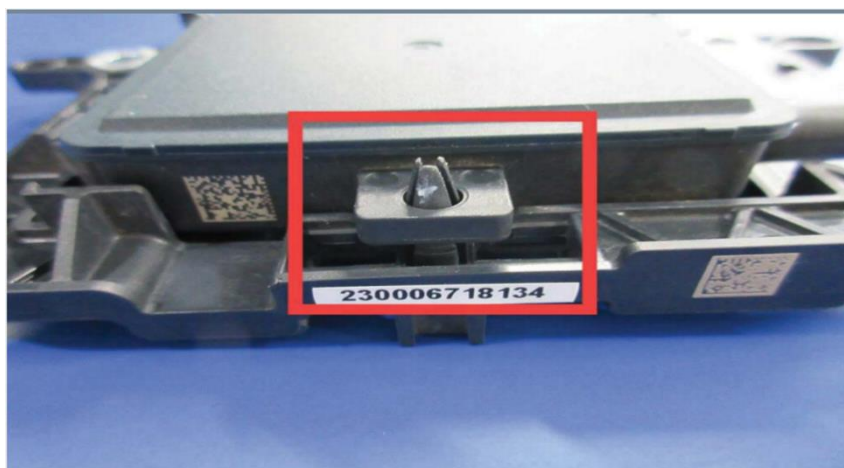
For visual reference, Figure 1 ,2,3 represent the damage to part.

NOTE: Physical inspection required. Any damage may cause radar mounting position to be incorrect. A damaged rear bumper may cause the mounting bracket, and valence to be pulled out of position. These conditions will generate an incorrect mounting position DTC (C14A4).

The Driver Assistance System Module (DASM/ACC) should not be replaced if the DTC is

in a “Stored” status and no physical damage to Part Including Bracket, cover, and Mounting clips, this is normal operation that may require inspection and re-calibration of the sensor again to module that would compromise the function of these systems. If C14A4 is still present, perform the ACC module programming procedure, erase DTCs, and check for DTC to return.
