<b>REFERENCE:</b>	<b>TSB:</b> 08-230-24 <b>GROUP:</b> 08 - Electrical	<b>Date:</b>	November 1, 2024	<b>REVISION:</b>	-
<b>VEHICLES AFFECTED:</b>	<p><b>2022 - 2024 (WL) Jeep Grand Cherokee / Grand Cherokee L</b> <b>2022- 2024 (WS) Grand Wagoneer/Wagoneer</b> <b>This bulletin applies to vehicles built equipped with one of the following radios:</b></p> <ul style="list-style-type: none"> <li>● Uconnect 5 w 8.4" Display (USA) (Sales Code UBF).</li> <li>● Uconnect 5 w 8.4" Display (CAN) (Sales Code UEF).</li> <li>● Uconnect 5 Nav w 8.4" Display (USA) (Sales Code UBL).</li> <li>● Uconnect 5 Nav w 8.4" Display (CAN) (Sales Code UEL).</li> <li>● Uconnect 5 Nav w 10.1" Display (USA) (Sales Code UBN).</li> <li>● Uconnect 5 Nav w 10.1" Display (CAN) (Sales Code UEN).</li> <li>● Uconnect 5 Nav w 12.0" Display (USA) (Sales Code UBQ).</li> <li>● Uconnect 5 Nav W 12.0" Display (CAN) (Sales Code UEQ).</li> <li>● Uconnect 5 w 8.4" Display (MEX) (Sales Code UFF).</li> <li>● Uconnect 5 Nav w 8.4" Display (MEX) (Sales Code UFL).</li> <li>● Uconnect 5 Nav w 10.1" Display (MEX) (Sales Code UFN).</li> <li>● Uconnect 5 Nav w 12.0" Display (MEX) (Sales Code UFQ).</li> </ul>			<p><b>MARKET APPLICABILITY:</b>

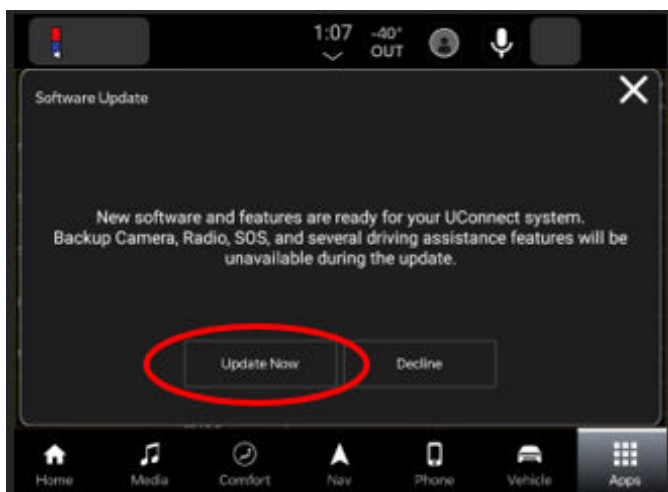
**Fig. 2**  
Software Update Screen

14. Press Update Now [Fig. 3](#).

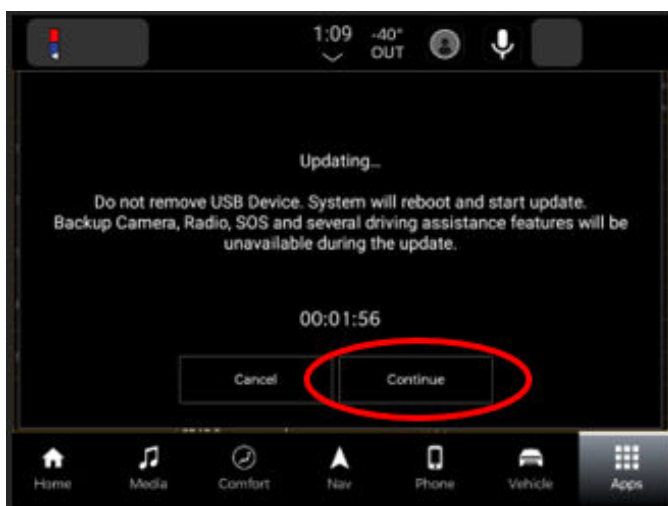
**Fig. 3**  
Timer Screen

15. Press Continue [Fig. 4](#).

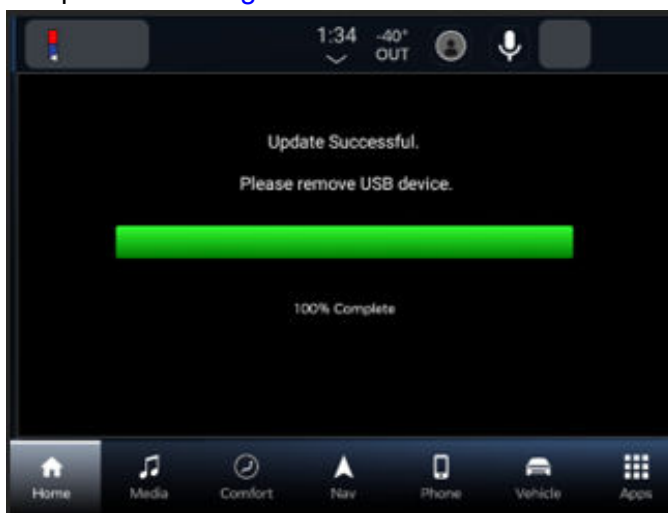
**Fig. 4**  
Progress Screen

16. Wait for software update to complete 100% [Fig. 5](#).
