Technical Service Bulletin (TSB) Right Front Door Glass Snowflaking

REFERENCE:	TSB: 23-040-24 REV. B GROUP: 23 - Body	Date:	October 31, 2024	REVISION:	23-040-24 REV. A
VEHICLES AFFECTED:	2023 (WL) Grand Cherokee / Grand Cherokee L This bulletin applies to vehicles built on or after June 01, 2023 (MDH 0601XX) and on or before September 30, 2023 (MDH 0930XX).			MARKET APPLICABILITY:	
				<input type="checkbox"/> NA <input type="checkbox"/> SA <input type="checkbox"/> EE	<input checked="" type="checkbox"/> MEA <input type="checkbox"/> IAP <input type="checkbox"/> CH
CUSTOMER SYMPTOM:	The customer may comment on or one or more of the following: <ul style="list-style-type: none"> Bubbles or a snowflake pattern on the right front door glass. 				
CAUSE:	Manufacturing defect of the right front door glass leading to contamination in the laminated layers

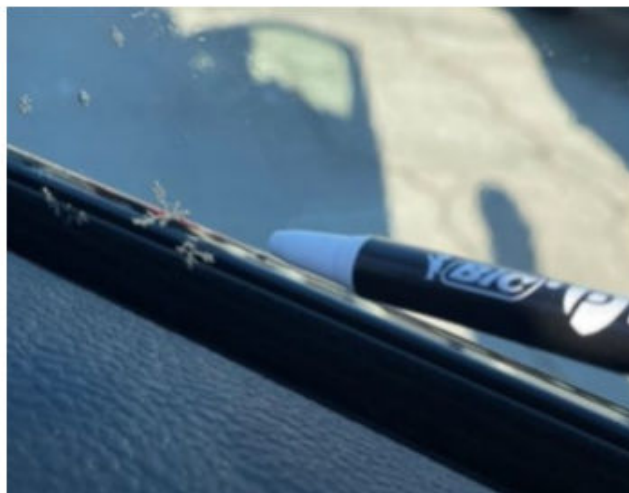
1. Inspect right front door glass for snowflaking/bubbling [Fig. 1](#). Effect is viewable from both inside and outside.

Fig. 1
Door Glass Bubbling

NOTE: Temperatures above 80° F (27° C) will accelerate the defects' appearance.

1. Replace the right front door glass. Refer to the detailed service procedures available in DealerCONNECT> Service Library under: Service Info>23 - Body / Doors - Front / Glass, Door / Removal and Installation.
