# Rotational Clicking Noise From Front Drive Shaft Assembly on Acceleration

**Section** Drive Shaft/Propeller Shaft

YEAR(S)	MODEL(S)	ADDITIONAL INFORMATION
2024	Grand Highlander, Grand Highlander HV

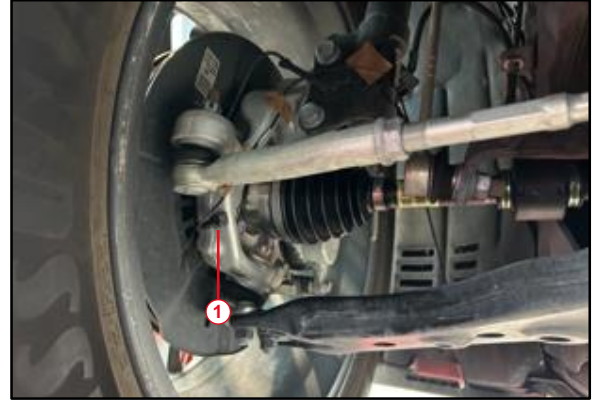
**Figure 1.**

<b>1</b>	<b>ChassisEAR™ on the Front Knuckle Assembly</b>
----------	--

2. Place the vehicle on a lift and install the ChassisEAR™ (or equivalent) on BOTH of the front knuckle assemblies, as shown in Figure 1, to help isolate the source of the noise.
