Radio Receiver Power/Volume Knob Becomes Detached

Service Category Audio/Visual/Telematics

Section Audio/Video

Market USA and Mexico

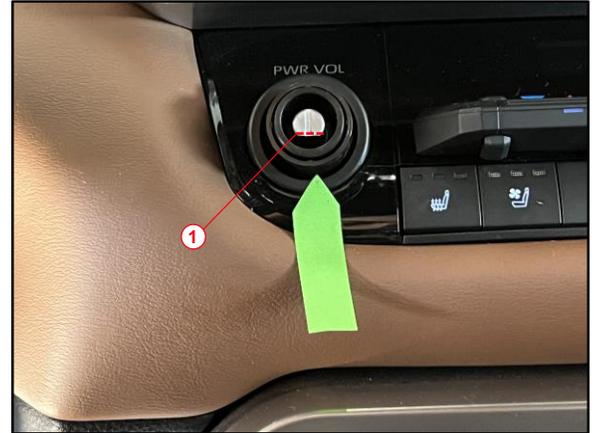
1	Flat Mounting Point of the Radio Receiver Power/Volume Switch
----------	--

3. Mark the flat mounting point of the radio receiver power/volume switch with a piece of tape (or similar), as shown in Figure 1.

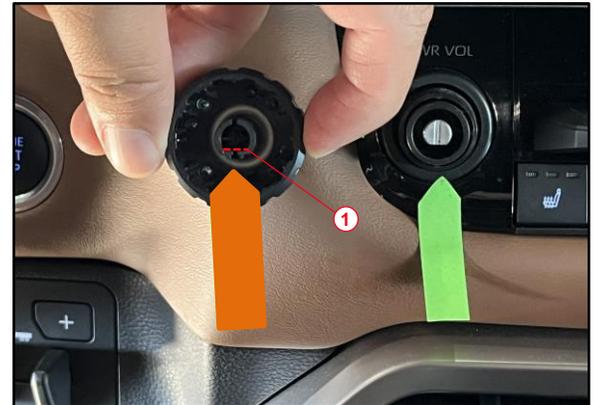
Figure 2.

1	Flat Mounting Point of the New Radio Receiver Power/Volume Knob
----------	--

4. Mark the flat mounting point of the NEW radio receiver power/volume knob with a piece of tape (or similar).

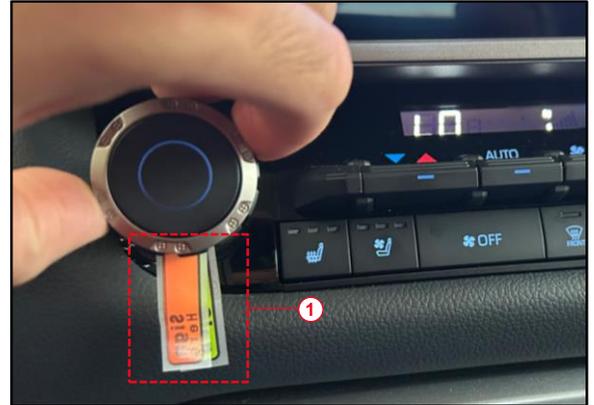
Figure 3. Aligned Flat Mounting Points

1 Aligned Pieces of Tape

- Carefully install the NEW knob using the tape as a guide for aligning the two flat mounting points, as shown in Figure 3.

After confirming correct alignment of the radio receiver power/volume knob, press firmly to ensure proper engagement.

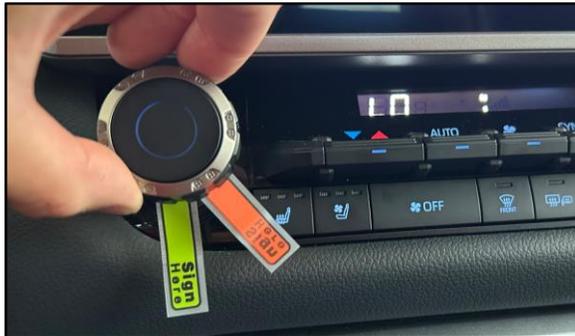
Figure 4. Misaligned Flat Mounting Points

Do NOT attempt to install the knob if the flat mounting points are NOT aligned, such as in Figures 4 and 5. Failure to ensure that the flat mounting points are aligned before attempting the installation could result in damaging the knob and/or the switch.
