# Service Bulletin

Bulletin No.: 18-NA-056

**Subject: Side Object Sensing Alert Module Not Working Correctly and/or Incorrect Side Mirror Notification**

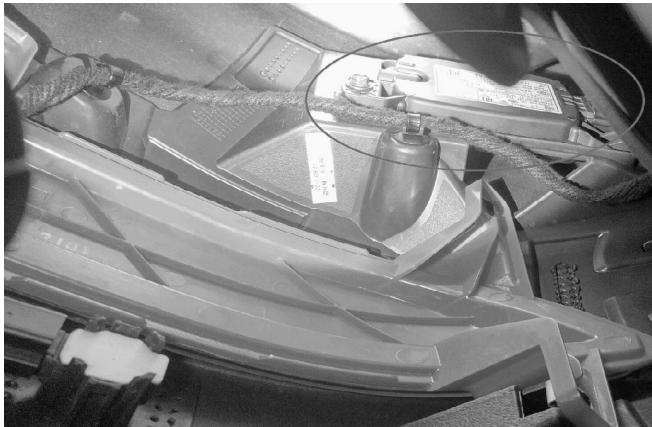
</div> <p><b>Note:</b> Most radar reflections may be found worse on the driver side than the passenger side. <span style="float: right;">4974639</span> This condition may be caused by unwanted radar reflection being detected and triggering the false alerts.</p>
<b>Correction</b>	If the side blind zone has been found not working properly, or if the tape is missing or loose, apply a piece of aluminum butyl tape to the bottom of the side object sensing alert module.
