Service Bulletin

Bulletin No.: 21-NA-192

Subject: Top Not Secure DIC Message, DTC B19E4 SYM64 May be Stored in History in Convertibles

Brand:	Model:	Model Year:		Date Breakpoint:		Engine:	Transmission:
		from	to	from	to		
Chevrolet	Corvette Convertible	2020	2025	—	—	All	All

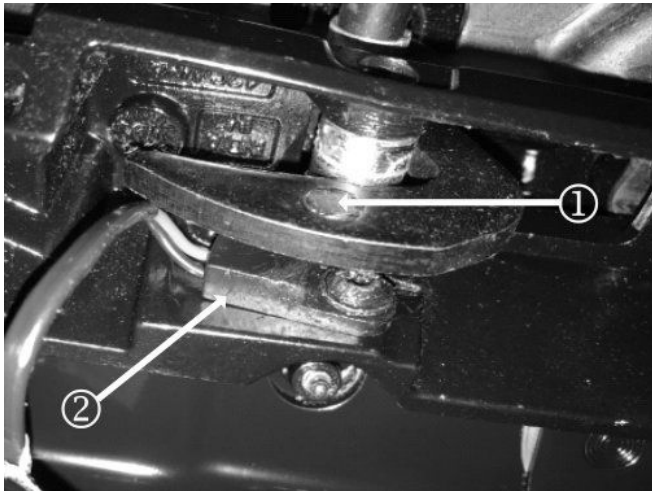
<p style="text-align: right; margin-right: 20px;">5892481</p> <p>Note: This hall effect sensor (2) is looking for the magnet (1) to be in alignment. It has an invisible hemispherical sensor zone. The cause of the condition is ultimately a misalignment of the roof alignment pin to the receiver in the header. This in turn causes a misalignment of the sensor to the magnet over time.</p>
Correction	Follow the Service Procedure below to determine the best course for repair. The condition may require one or more adjustments to be made.

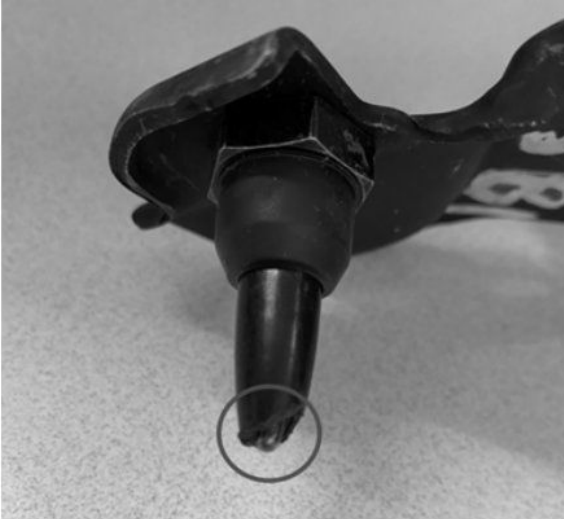
6741889

Additional evidence of a hard-hitting top with poor pin alignment will be a broken pin tip:

1. Remove the windshield upper garnish molding (2). Refer to *Windshield Upper Garnish Molding Replacement (Convertible)* in SI.

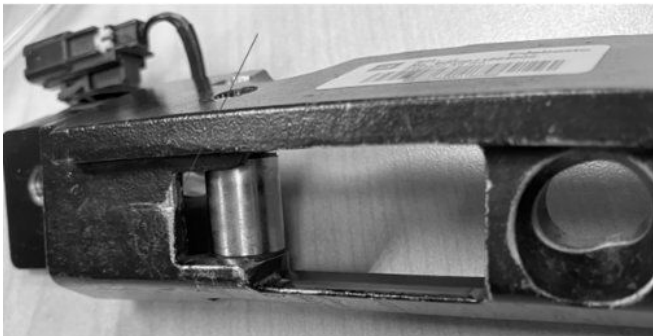
6741891

3. Locate the right side folding top front striker and check for a witness mark as shown in the image above with the red arrow. If there are signs of damage with missing paint, then it is likely the top will need an adjustment to the latch carrier plate. This procedure is described later in this document.

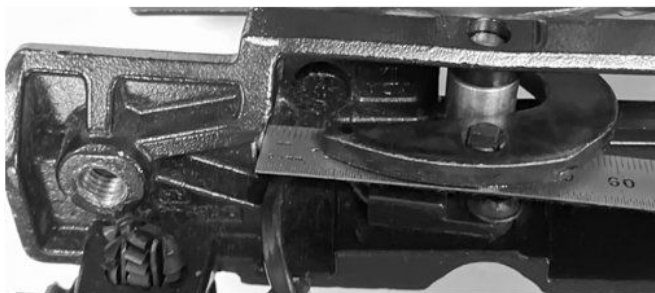
6741894

6. With the top closed, measure the distance from the tip of the latch hook to the nearby inboard vertical edge as shown in the image. You may need to pre-position your ruler if the hook automatically retracts and ask someone to operate the top so you can perform the measurement. The nominal position should be 5 mm when the magnet and hall-effect sensor are aligned. This will be the target position to achieve by performing the following adjustments.
7. Retract the top part way to gain easy access to the front roof panel and remove the headliner. Between top movements, turn off the ignition to conserve 12-volt battery power.
