Service Bulletin

Bulletin No.: 21-NA-270

Subject: Vibration Caused by Tires

Brand:	Model:	Model Year:		VIN:		Engine:	Transmission:
		from	to	from	to		
Chevrolet	Silverado 4500HD/ 5500HD/6500HD	2019	2024

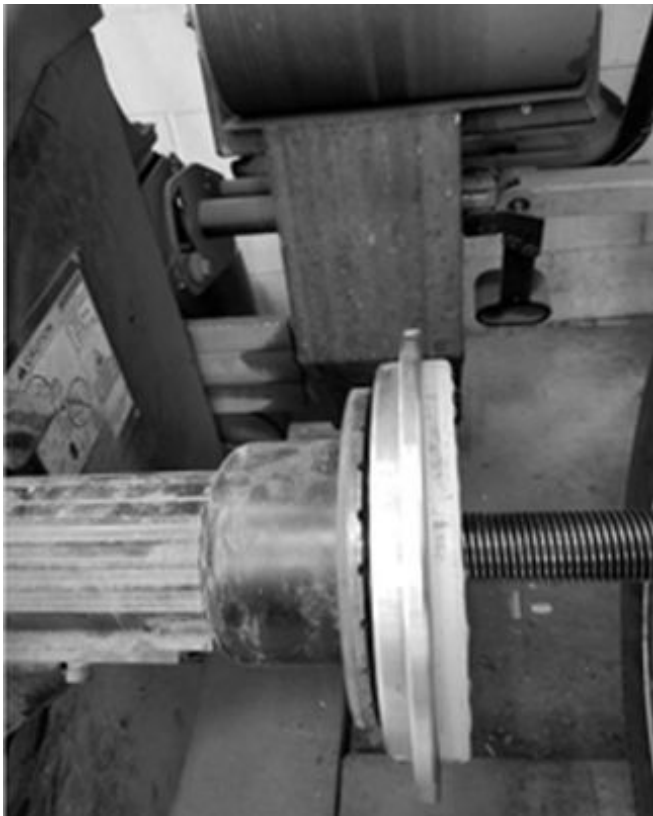
This is the common setup for MD wheels on the Hunter 9700.

Helpful hints when using the 20-2977-2 (8 lug 19.5 inch stud kit).

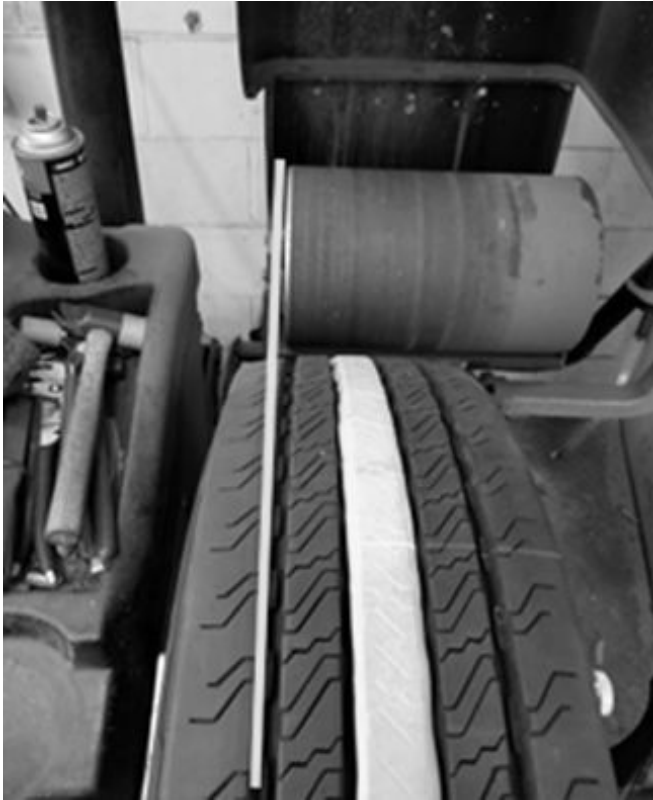
6473695

With this common setup, the Roadforce Roller does not fully contact the tire tread.

Adding masking tape to the centering ring to help with the Center Checking procedure. There is 2 layers of tape (2 times around). This especially helps with stamped steel wheels.

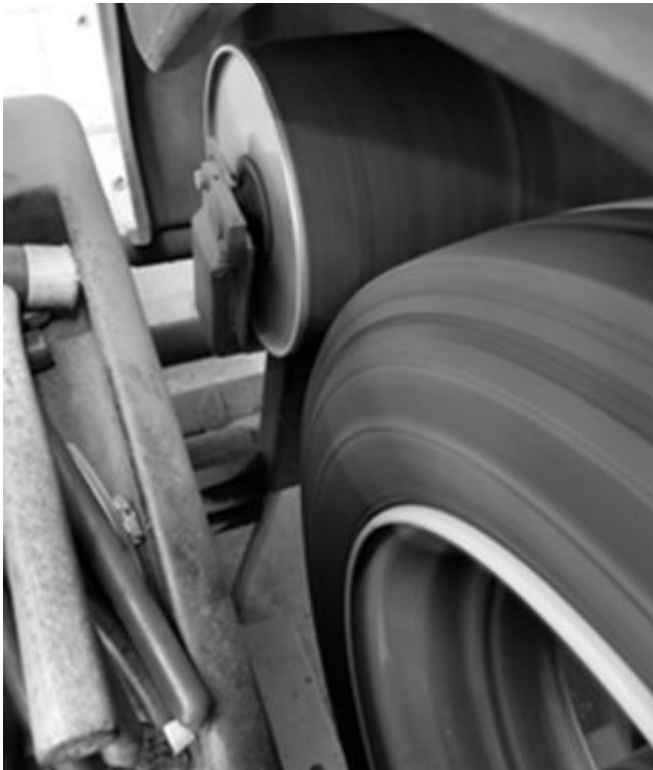
6473697

Here you can see the roller against the tire. With doing this, it reduced the Roadforce 9 Lbs. Nothing was changed with the process or tire/wheel assembly.

Now the tire and rim can be marked. Rotate the tire on the rim and retest. This may help reduce the Roadforce if below 50. Balance the tire and reevaluate the customers concern with the PICO.
