## Creaking Noise When Opening or Closing The Tailgate

| Topic number | LI72.20-P-078560 |
| Function group | 72.20 - Tailgate, rear door |
| Validity | MODEL 294 with CODE 890 up to production date<br>15.10.2024<br><br>MODEL 296 with CODE 890 up to production date<br>15.10.2024<br><br>MODEL 297 with CODE 890 |

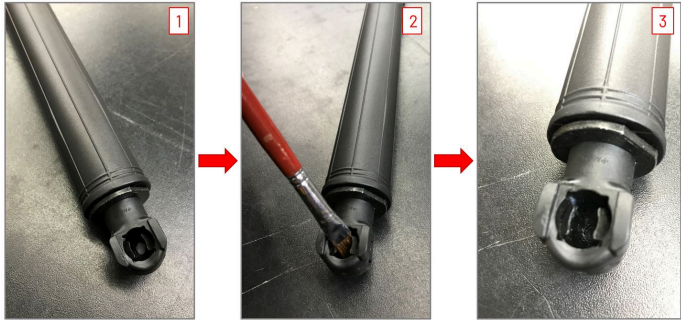
Grease in the upper ball socket (ball socket with larger diameter) of the liftgate control (HKS) drive unit could not be distributed optimally across the ball surface and this can consequently result in increased friction between the ball socket and ball pin.

| Attachments | |
|---|---|
| <a href="#">Bild.JPG</a><br> | Picture - Grease distribution |

Smear existing grease in upper ball sockets of drive unit completely across ball surface using a brush (see picture).

To do so, the HKS drive unit must be removed (see WIS references).
