BR 290 - Rear Spoiler Sporadically Inoperative With Fault Message In The Instrument Cluster

Topic number	LI77.25-P-073749
Version	6
Function group	77.25 - Wind deflector (spoiler)
Date	11/4/24
Validity	All X290 as of beginning of production without code U99/ U94
Reason for change	The software remedy that is referenced in "In progress" is already released. Loose screws can be reworked

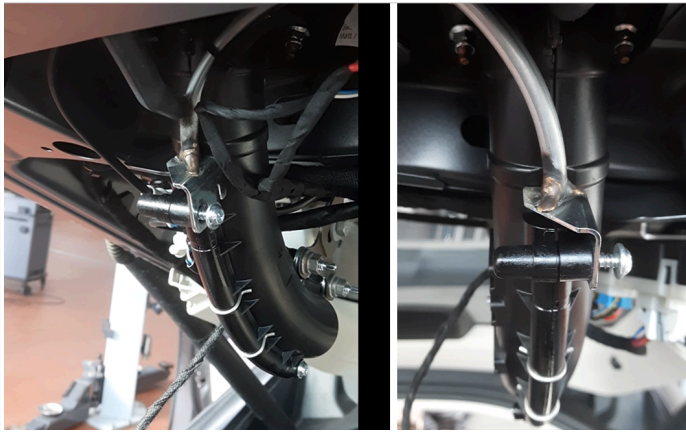
Attachments	
File	Description
Schrauben_Aussteller.jpg	Attachment 1

-> Check screw connection of rear spoiler adjuster (see attachment 1) for tight seating.

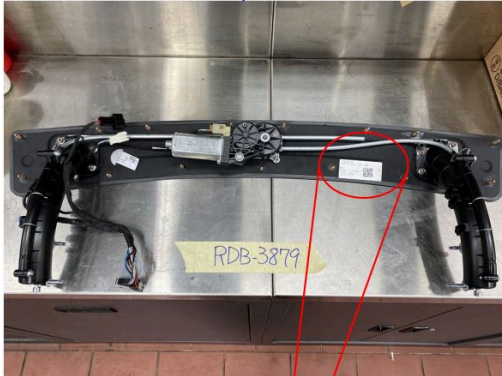
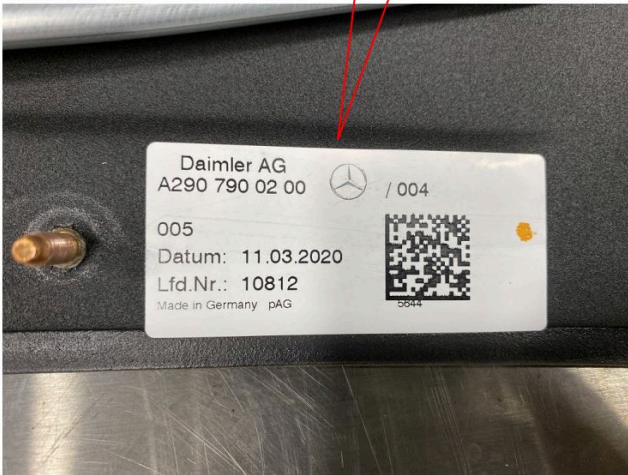
Attachment 2

Photo of rear spoiler driver unit

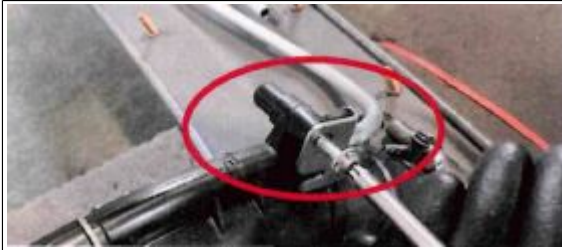
Attachment 3

1. Schraube herausschrauben.JPG

1. Unscrew screw with Torx TX25 screwdriver from the housing guide.
2. Dip screw in Loctite 603 (at least 3 threads)
3. Screw the screw back into the housing guide with 2 Nm torque. (IMPORTANT: Loctite 603 finger-tight after 8 minutes and cured after 24 hours)
4. Initialize rear spoiler after the curing time.
5. Subject the vehicle to a final inspection/test drive and, if the findings report is OK, hand it over to the customer.

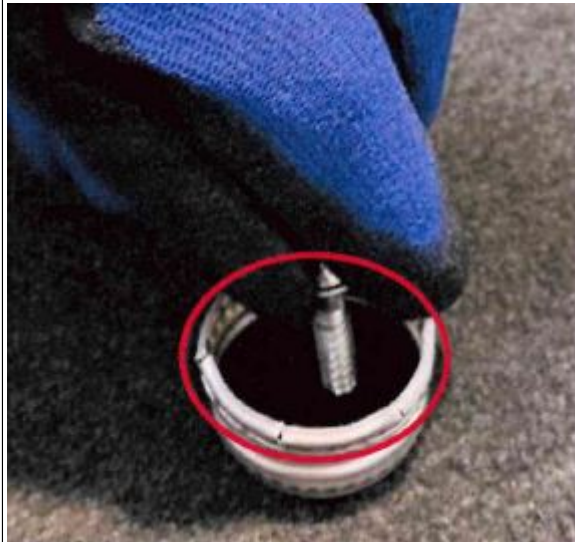
Attachment 4

2. Schraube in Loctite eintauchen.JPG

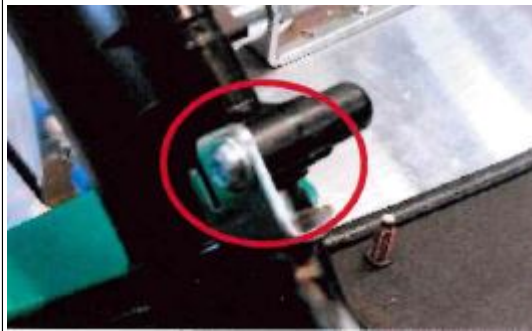
Attachment 5

3. Schraube mit Drehmoment 2 Nm wieder einschrauben.JPG
