# Service Bulletin

Bulletin No.: 24-NA-167

Date: October, 2024

**Subject: Shake and/or Shudder During Steady Speed and/or Light Throttle Acceleration Between 25 and 50 MPH (40 and 80 KM/H)**

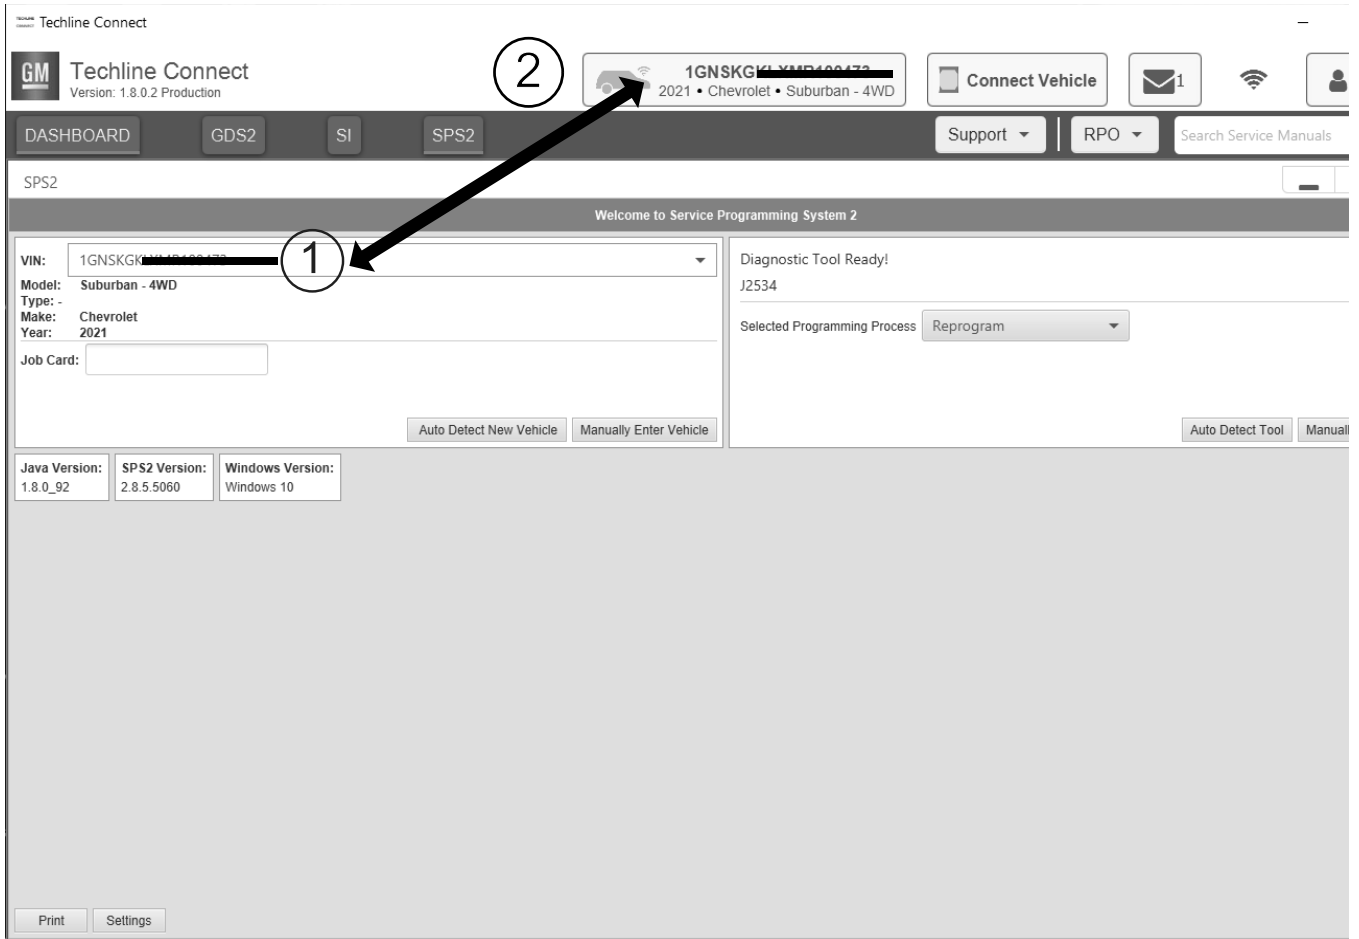
5743643

**Caution:** Be sure the VIN selected in the drop down menu (1) is the same as the vehicle connected (2) before beginning programming.

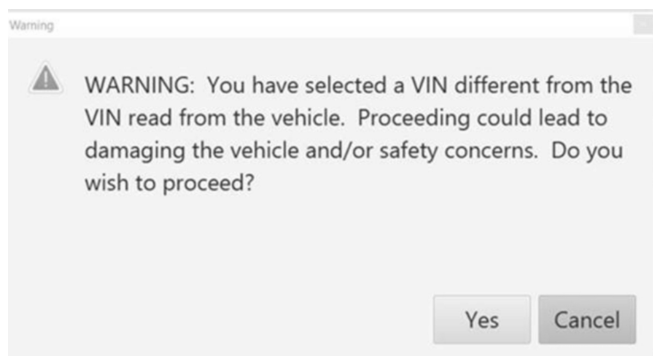
5877000

**Important:** If the vehicle VIN DOES NOT match, the message below will be shown

The dialog box displays the following text: "M4521: You are attempting to reprogram with the same calibration. Select OK to continue, Cancel to Stop!" with "OK" and "Cancel" buttons.

**Important:** If the same calibration/software warning is noted on the TLC Summary screen, select OK and follow screen instructions. After a successful programming event, the WCC is located in the Service Programming System dialogue box of the SPS Summary screen. No further action is required. Refer to the Warranty section of the bulletin.
