Service Bulletin

Bulletin No.: 24-NA-195

Subject: Front Floor Mat Loose / Not Retained

Brand:	Model:	Model Year:		VIN:		Engine:	Transmission:
		from	to	from	to		
Chevrolet	Bolt EUV	2022	2023	—	—	All	All

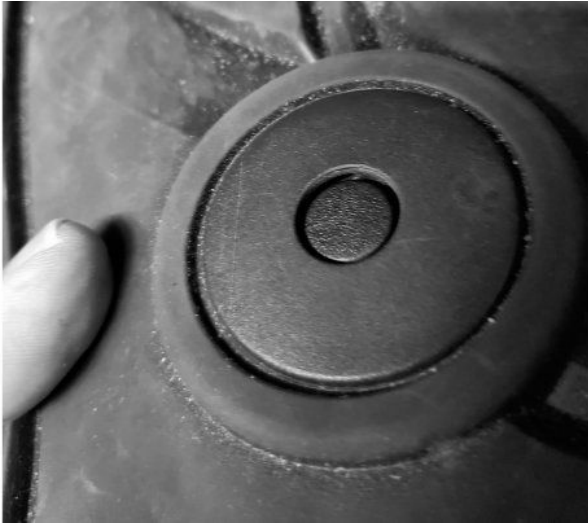
6736268

Involved Region or Country	North America, Brazil, GM Korea Company
Condition	Some customers or technicians, upon installation of the front floor mat, may find the front floor mat is not properly retained nor will lock into floor carpet auxiliary mat retainer.
Cause	The condition may be caused by a floor carpet auxiliary mat retainer that is out of specification.
Correction	Replace the floor carpet auxiliary mat retainer, referring to the Service Procedure below.

1. Remove the front side door sill garnish molding. Refer to *Front Side Door Sill Garnish Molding Replacement* in SI.
2. Move the floor panel carpet as needed to access the back side of the floor carpet auxiliary mat retainers. Refer to *Floor Panel Carpet Replacement* in SI.
3. Release the floor carpet auxiliary mat retainer on the backside of the floor panel carpet.
4. Remove and discard the floor carpet auxiliary mat retainer from the topside of the floor panel carpet.
5. Align the NEW floor carpet auxiliary mat retainer to the cutout on the topside in the carpet.

6. Clip the floor carpet auxiliary mat retainer on the backside of the floor panel carpet. After reinstalling the front floor mat, check that it has been locked into place and the retention system is working. Make certain it cannot move and does not interfere with the accelerator or brake pedals.
7. Install the floor panel carpet as needed. Refer to *Floor Panel Carpet Replacement* in SI.
8. Install front side door sill garnish molding. Refer to *Front Side Door Sill Garnish Molding Replacement* in SI.
