# Service Bulletin

Bulletin No.: 24-NA-206

**Subject: Radio Stays on for Approximately One Minute After Vehicle is Shut Off and Door is Opened**

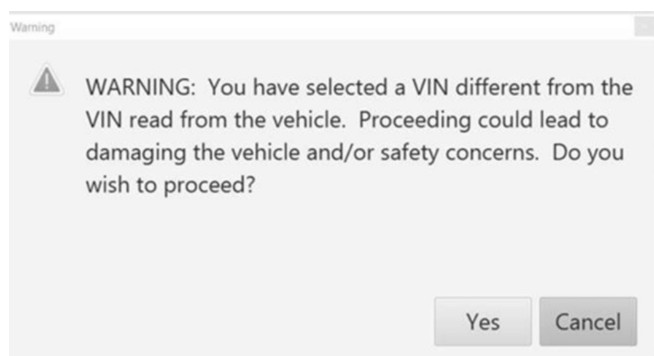
5877000

**Important:** If the vehicle VIN DOES NOT match, the message below will be shown.

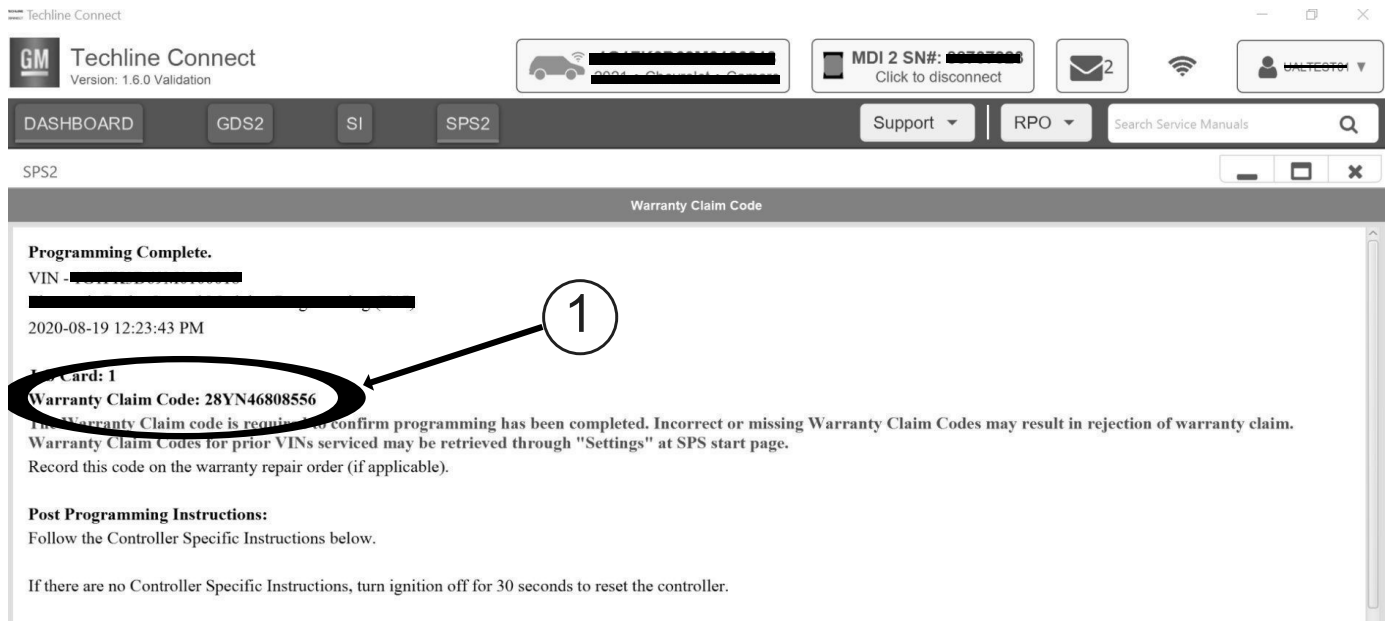
5644478

**Note:** The screenshot above is an example of module programming and may not be indicative of the specific module that is being programmed. Module selection and VIN information have been blacked out.

**Important:** To avoid warranty transaction rejections, you **MUST** record the warranty claim code provided on the Warranty Claim Code (WCC) screen shown above on the job card. Refer to callout 1 above for the location of the WCC on the screen.

- Record the SPS Warranty Claim Code on the job card for warranty transaction submission.
