REFERENCE:	TSB: 08-232-24 GROUP: 08 - Electrical	Date:	November 7, 2024	REVISION:	–
VEHICLES AFFECTED:	2025 (DT) RAM 1500 Pickup This bulletin applies to vehicles equipped with a Wireless Charging Pad (Sales Code RFX) and Dual Wireless Charging Pad (Sales Code CMS).	MARKET APPLICABILITY:		<input checked="" type="checkbox"/> NA	<input checked="" type="checkbox"/> MEA
				<input checked="" type="checkbox"/> SA	<input checked="" type="checkbox"/> IAP
				<input type="checkbox"/> EE	<input type="checkbox"/> CH
CUSTOMER SYMPTOM:	Customers may comment on the following: <ul style="list-style-type: none"> Keyfob intermittently is not detected when the keyfob is placed at or near the wireless charger. 				
CAUSE:	Radio Frequency (RF) interference

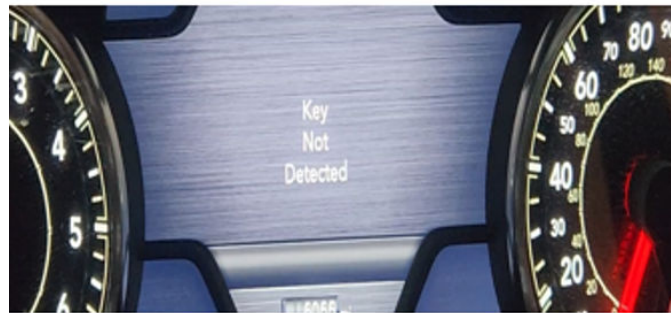
Fig. 1
Key Not Detected

When the ignition is OFF, and the keyfob is near an active wireless charger, interference can occur leading to the keyfob not being detected by the vehicle [Fig. 1](#). The keyfob needs to be at least 203 mm (8 in.) away from the wireless charger and/or do not put the phone on the wireless charger before the ignition is ON.
