**Subject: Diagnostic Tip for Malfunction Indicator Lamp (MIL) Illuminated – DTC P0300, P0301, P0302, P0303, P0304, P0305, P0306, P0307 and/or P0308 Set**

Brand:	Model:	Model Year:		Build Date:		Engine:	Transmission:
		from	to	from	to		
Chevrolet	Corvette	2023	2024	—	—	LT6	—

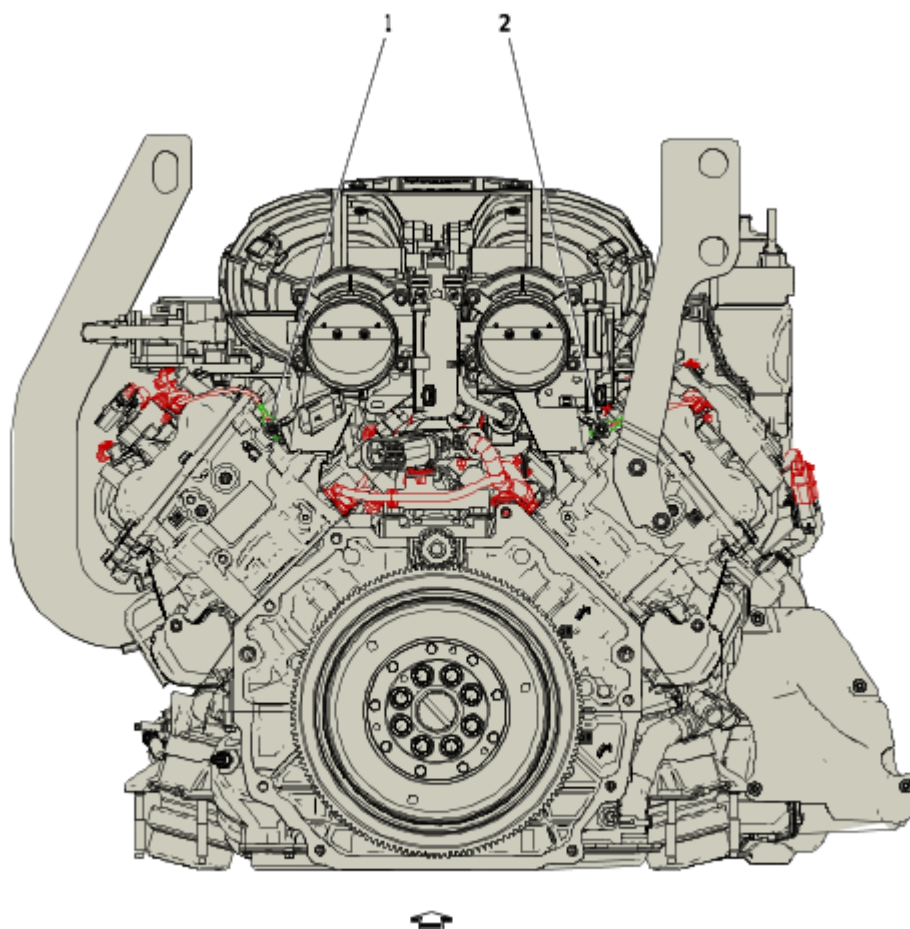
6002834

<b>In- volved Re- gion or Country</b>	North America, Europe, Middle East, Israel, Palestine, Japan, Philippines, Australia/New Zealand
<b>Con- di- tion</b>	<p>Some customers may comment that the MIL lamp is/was illuminated. Technicians may comment on one or more of the following DTCs set in the Engine Control Module (ECM):</p> <ul style="list-style-type: none"> <li>• P0300: Engine Misfire Detected</li> <li>• P0301: Cylinder 1 Misfire Detected</li> <li>• P0302: Cylinder 2 Misfire Detected</li> <li>• P0303: Cylinder 3 Misfire Detected</li> <li>• P0304: Cylinder 4 Misfire Detected</li> <li>• P0305: Cylinder 5 Misfire Detected</li> <li>• P0306: Cylinder 6 Misfire Detected</li> <li>• P0307: Cylinder 7 Misfire Detected</li> <li>• P0308: Cylinder 8 Misfire Detected</li> </ul> <p>Technicians may also notice that the misfires are on multiple cylinders and can be more specific to one bank.</p>
<b>Cause</b>	This condition may be caused by a loose ignition coil ground located at the rear of either the right or left cylinder head:

- Odd numbered cylinder ignition coils are grounded at G181 (bank 1).
- Even numbered cylinder ignition coils are grounded at G182 (bank 2)

Inspect both ignition coil grounds to ensure they are clean, fully seated on the head and torqued to specification.  
⇒ Torque the fasteners to 10 Nm (89 Lb. in).
