STAR ONLINE PUBLICATION

Case Number: S2423000046

Symptom/Vehicle Issue: Buzz Squeak Rattle From Right Rear Headliner Area.

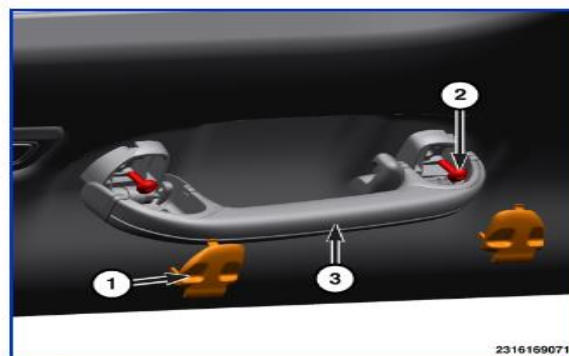
Fig 1.

Customer Complaint/Technician Observation: Customer may complain of hearing a rattle above second row right side seat. The rattle will be beside the grab handle of the headliner over the 2nd row seat. The root cause is the grab handle bracket and sunroof reinforcement ring making contact.

- 1 - Fastener Covers
- 2 - Fasteners
- 3 - Headliner Grab Handle

Remove the grab handle (Fig 1). Then remove the grab handle bracket (Fig 2). Add a piece of flock tape between the grab handle bracket and the body. Then reinstall grab handle bracket and handle. Refer to Service Library 23 - Body / Interior / HANDLE, Grab / Removal and Installation.
