STAR ONLINE PUBLICATION

Case Number: S2408000116

Symptom/Vehicle Issue: Malfunction Indicator Lamp (MIL) on, Electronic Throttle Control (ETC) Lamp Flashes, Rough Idle

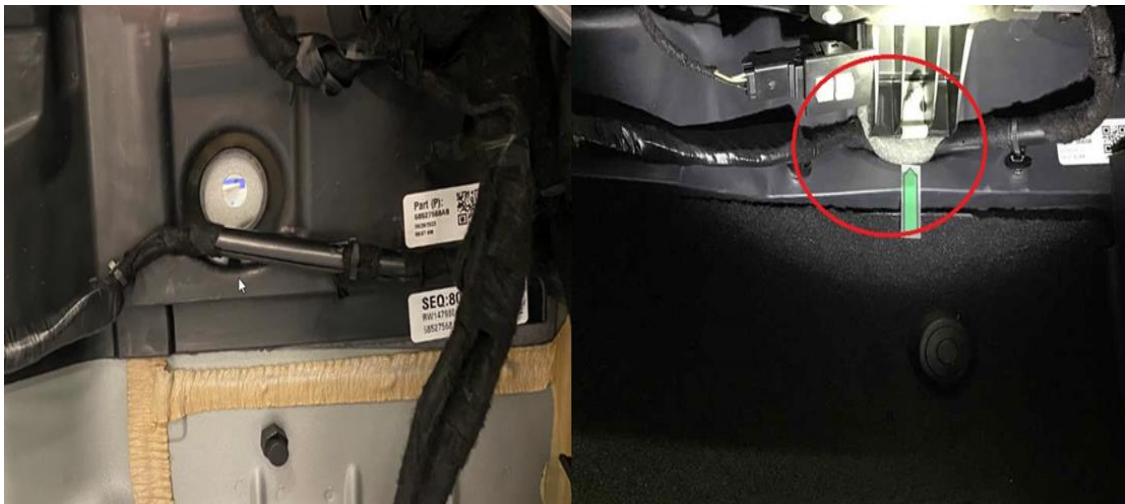
Customer Complaint/Technician Observation: The customer complains of the mil lamp on, ETC lamp flashing and that the start stop system is no longer functioning with a rough idle complaint. The technician observed the vehicle is setting Diagnostic Trouble Codes (DTCs) P0652 Sensor Reference Voltage 2 Circuit Low, P0642 Sensor Reference Voltage 1 Circuit Low.

Repair Procedure: Inspect the harness routing around the HVAC panel attachment leg on the passenger side of the HVAC housing to identify a potential for any harness chaffing or pinching conditions. The harness contains the TPS circuits that may trigger one or both above DTCs. Repair and isolate the harness as needed to complete. Test the operation to validate the repairs.
