GROUP	MODEL
Product Improvement	See Model List On Page 1
NUMBER	DATE
PI2002Y/Z (Rev 3, 11/07/2024)	April 2021

PRODUCT IMPROVEMENT CAMPAIGN

ENGINE REPLACEMENT INSTRUCTIONS FOR DTC P1326 (PI2002Y/Z)

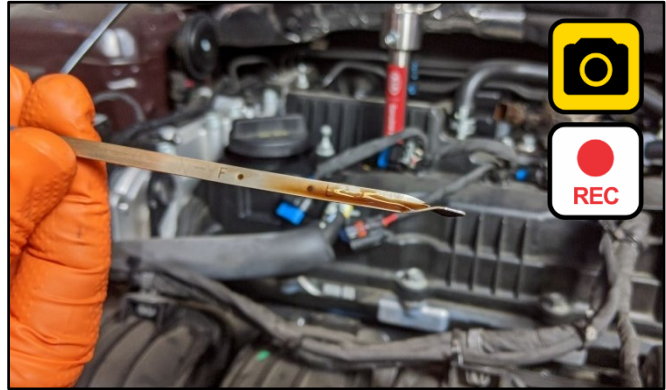
1. Start video showing vehicle and move in towards the dash VIN tag.
2. Measure and record oil dip stick level.
3. Note oil dip stick reading on the RO.
4. Take a picture of the oil reading on dipstick.

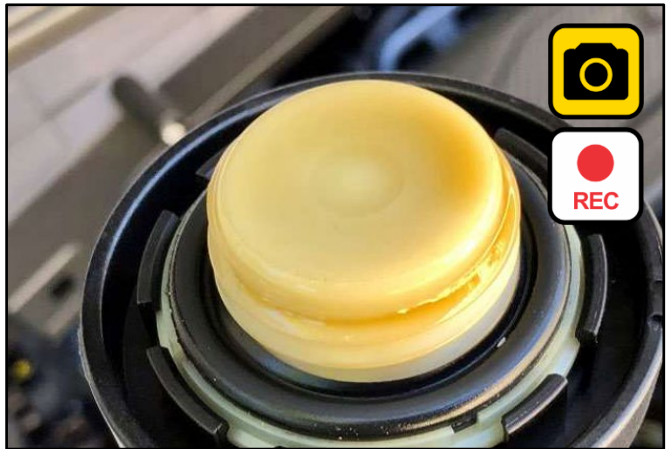
5. Inspect the inner/bottom of the oil cap and inside oil filler opening.

6. Take a picture of both, the bottom of the oil cap and oil filler opening.

Record/Note findings: No oil, oil sludge, varnish, burnt oil smell condition(s) found.

If NO oil is registered on the dipstick, or oil lacquering, oil sludge and/or oil varnish is present (NG), then the engine is therefore suspect to maintenance neglect. Review of the vehicle's maintenance history is required.

If suspect, proceed to the 'Oil Level Measurement' instructions below and submit with the Techline case.

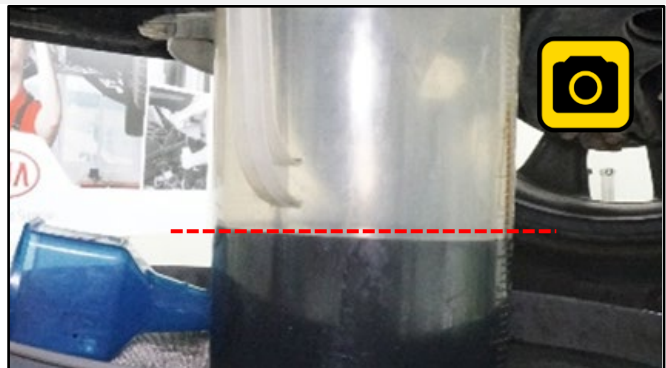
**Oil Level Measurement: (Main Flowchart → PWA Request) NO OIL READING ON DIPSTICK**

1. Remove oil filler cap, remove oil drain plug and drain oil into the measuring container SST067BUCK and check oil level.
2. Record oil level reading on the RO.
3. Take photo of the drained oil container using KDS and attach to warranty claim PWA request.

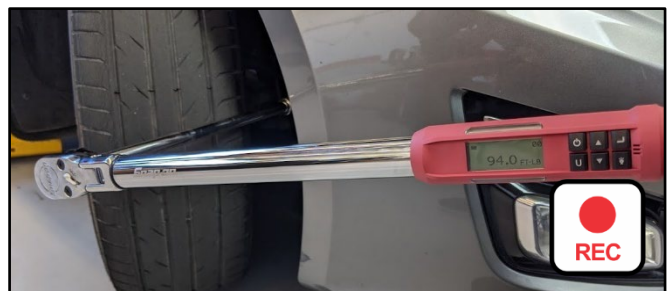
6. Show the engine being cranked and torque specification exceeding 94 lb.ft. torque.
