2011-2013MY  
Sportage (SL)  
w/Theta 2.4L MPI

PI2103Y/Z (Rev 1, 11/07/2024)

ENGINE REPLACEMENT INSTRUCTIONS  
FOR DTC P1326 (PI2103Y/Z)

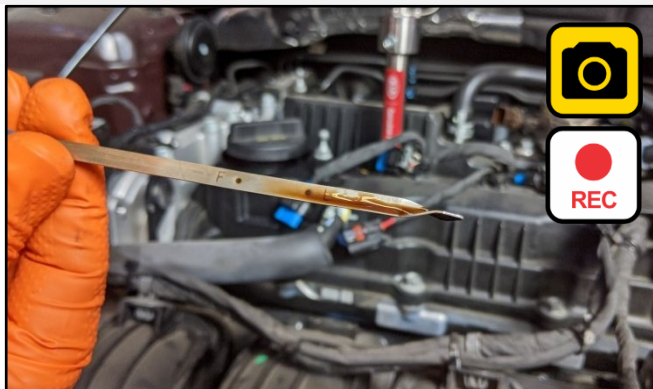
1. Start video showing vehicle and move in towards the dash VIN tag.
2. Measure and record oil dip stick level.
3. Note oil dip stick reading on the RO.
4. Take a picture of the oil reading on dipstick.

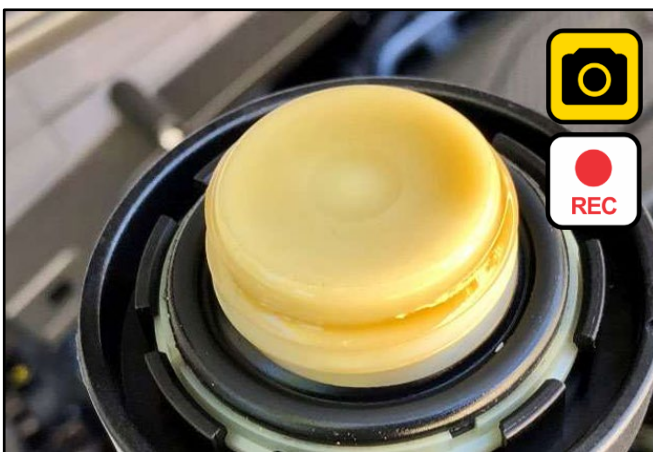
**Record/Note findings:** No oil, oil sludge, varnish, burnt oil smell condition(s) found.

**If NO oil is registered on the dipstick, or oil lacquering, oil sludge and/or oil varnish is present (NG), then the engine is therefore suspect to maintenance neglect.** Review of the vehicle's maintenance history is required.

**If suspect,** proceed to the 'Oil Level Measurement' instructions below and submit with the Techline case.

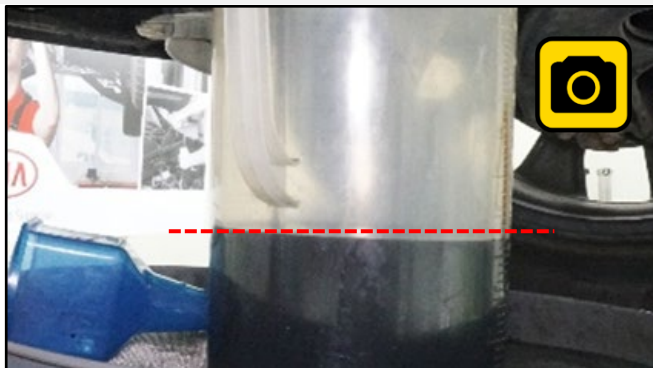
**Oil Level Measurement: (Main Flowchart → PWA Request) NO OIL READING ON DIPSTICK**

1. Remove oil filler cap, remove oil drain plug and drain oil into the measuring container SST067BUCK and check oil level.
2. Record oil level reading on the RO.
3. Take photo of the drained oil container using KDS and attach to warranty claim PWA request.
