GROUP	MODEL
Subsequent Repair Action	2014-2016MY Optima (TF HEV) w/2.4L MPI
NUMBER	DATE
PI2104Y/Z (Rev 1, 11/07/2024)	July 2023

ENGINE REPLACEMENT INSTRUCTIONS FOR DTC P1326 (PI2104Y/Z)

This bulletin provides information related to the Technical Service Bulletin previously published in (PI2104) titled "Knock Sensor Detection System - ECU Logic Improvement" for 2014-2016MY Optima (TF HEV) vehicles equipped with Theta 2.4L MPI engine, produced from December 11, 2013 through July 22, 2015. Specifically, this bulletin provides instructions on which procedures to follow if, after installation of the KSDS, any one of the subject vehicles below return to the dealer with Diagnostic Trouble Code (DTC) P1326 (Knock Signal Range/Performance).

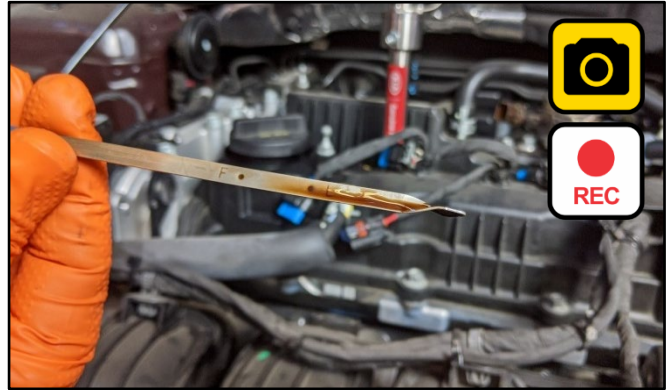
1. Start video showing vehicle and move in towards the dash VIN tag.
2. Measure and record oil dip stick level.
3. Note oil dip stick reading on the RO.
4. Take a picture of the oil reading on dipstick.

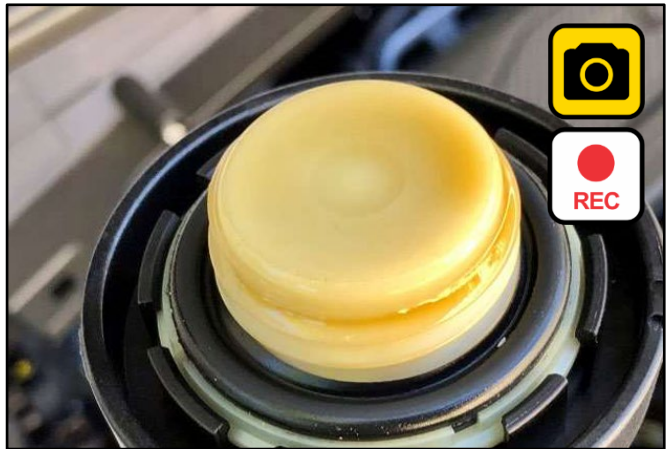
5. Inspect the inner/bottom of the oil cap and inside oil filler opening.

6. Take a picture of both, the bottom of the oil cap and oil filler opening.

Record/Note findings: No oil, oil sludge, varnish, burnt oil smell condition(s) found.

If NO oil is registered on the dipstick, or oil lacquering, oil sludge and/or oil varnish is present (NG), then the engine is therefore suspect to maintenance neglect. Review of the vehicle's maintenance history is required.

If suspect, proceed to the 'Oil Level Measurement' instructions below and submit with the Techline case.

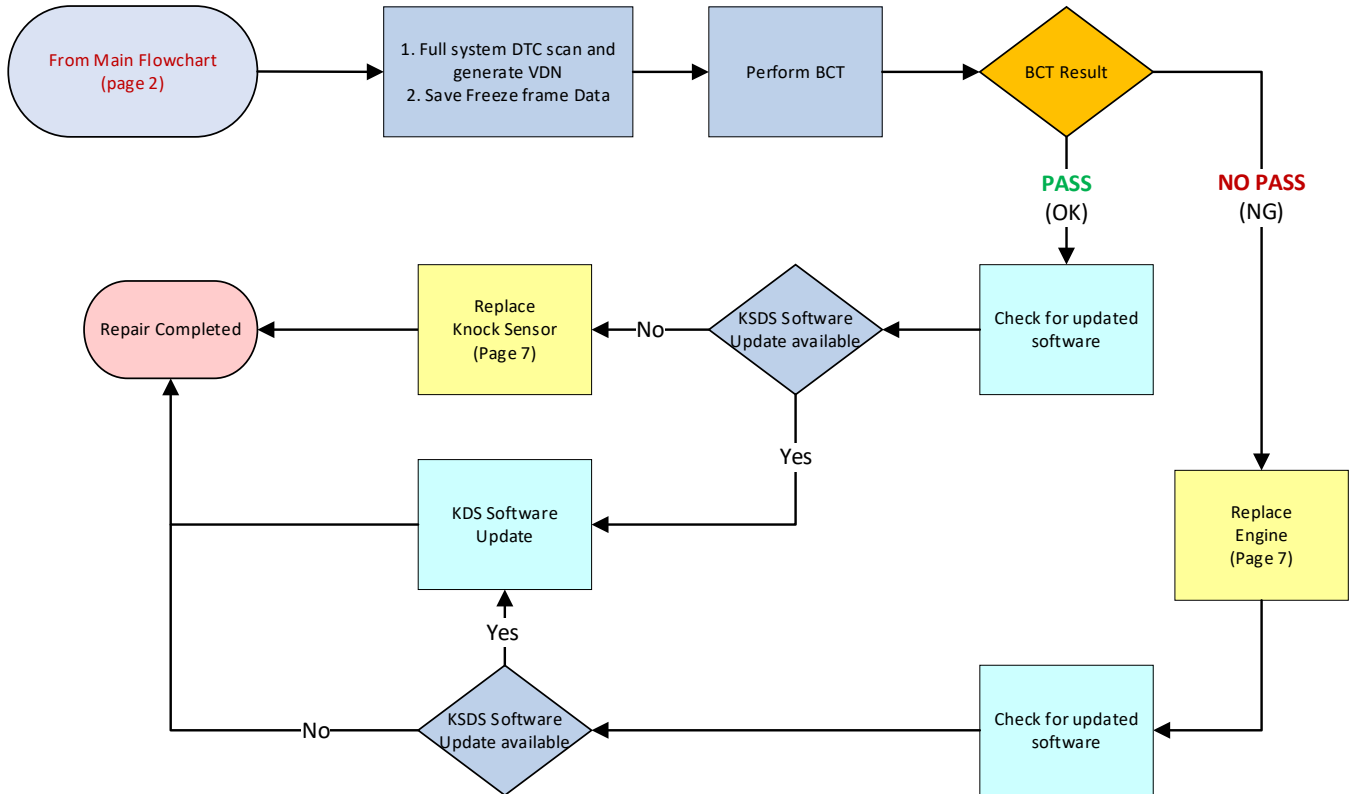
A. DTC P1326 Stored

Create PI2104Y Claim - No Techline PWA Required

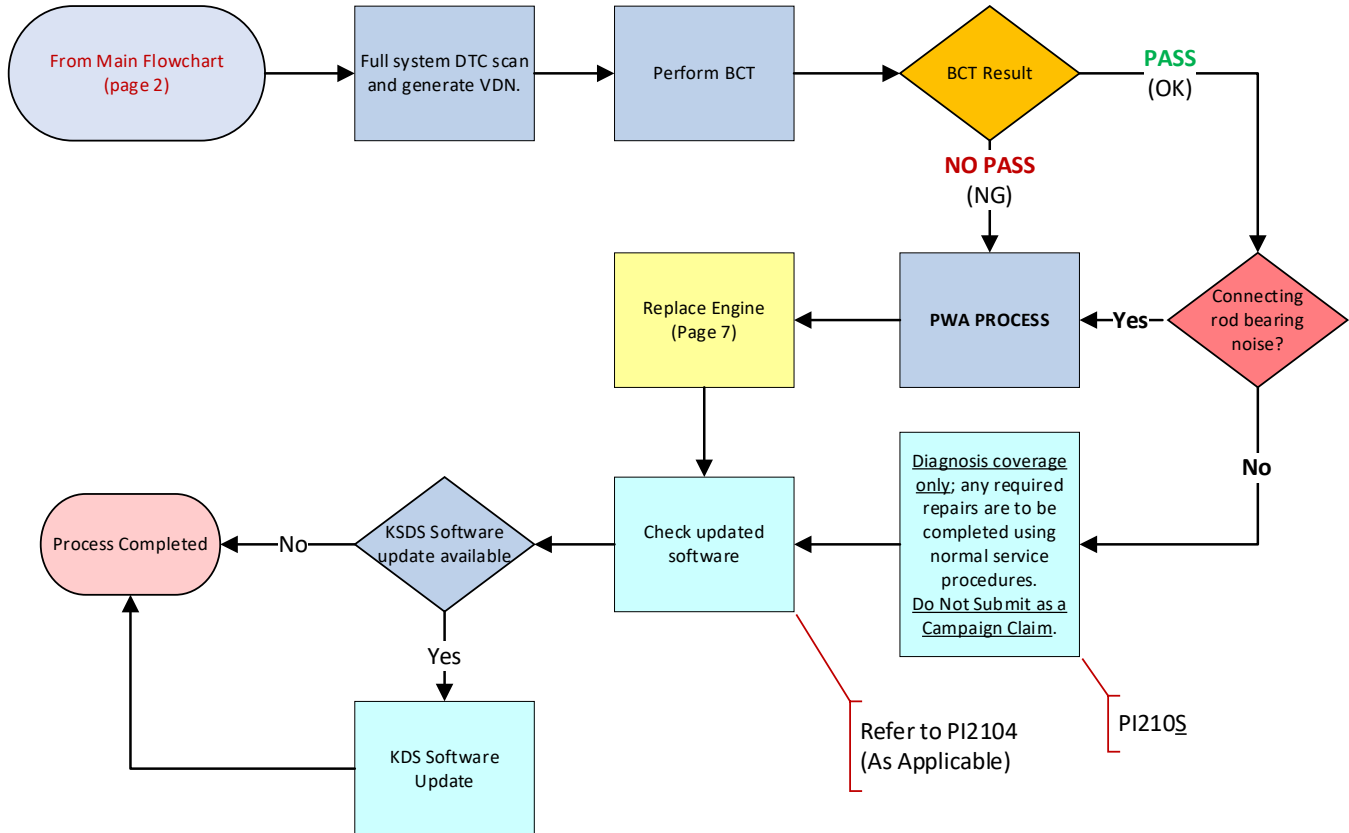
B. Engine Noise

Techline PWA Required; Diagnosis Only Campaign Possible

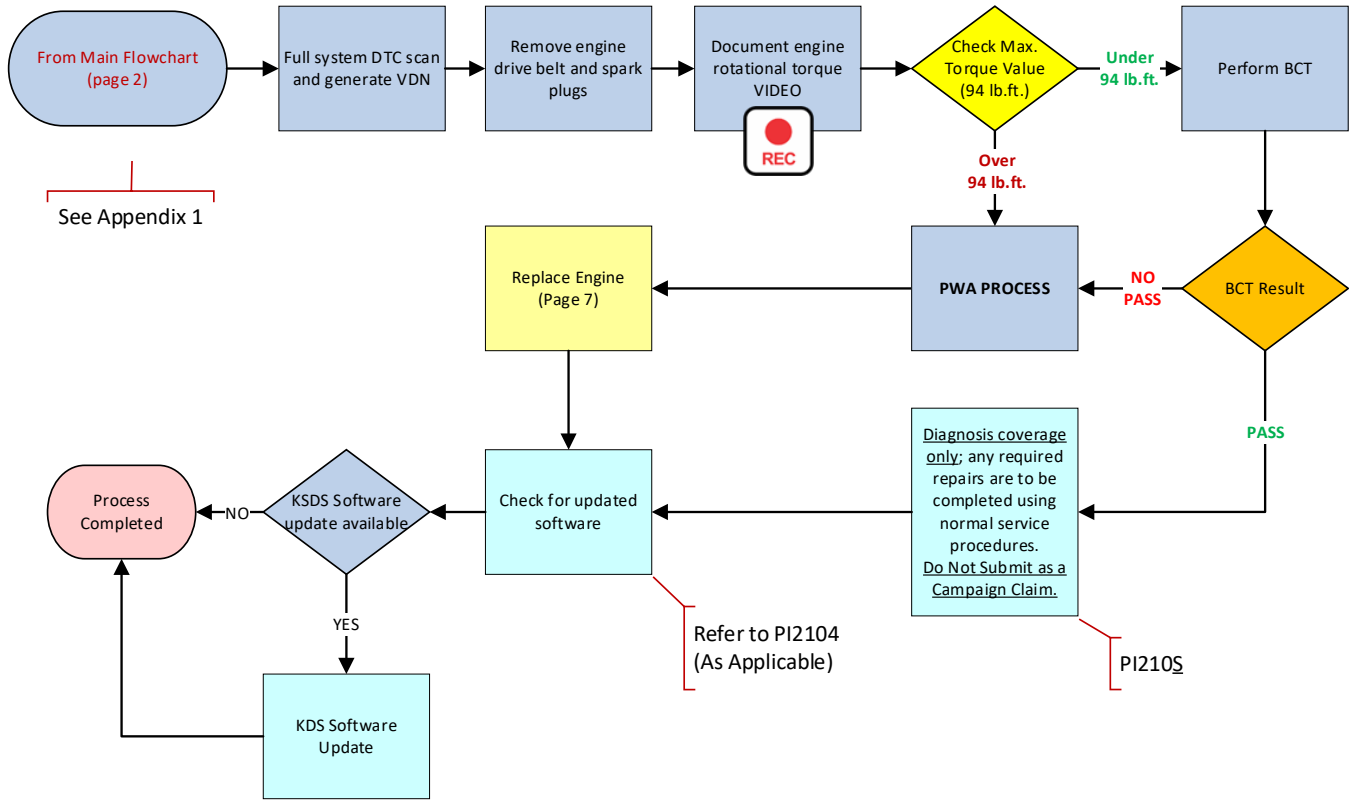
C. Engine No Crank

Techline PWA Required; Diagnosis Only Campaign Possible
