GROUP	MODEL
Subsequent Repair Action	2017-19MY Soul (PS) w/Nu 2.0L GDI
NUMBER	DATE
PI2107Y/Z (Rev 1, 11/07/2024)	May 2022

ENGINE REPLACEMENT INSTRUCTIONS FOR DTC P1326 (PI2107Y/Z)

This bulletin provides information related to the Technical Service Bulletin previously published (PI2107) titled "Nu 2.0L GDI - Knock Sensor Detection System ECU Logic Improvement". Specifically, this bulletin provides instructions on which procedures to follow if, after installation of the KSDS, any one of the subject vehicles below return to the dealer with Diagnostic Trouble Code (DTC) P1326 (Knock Signal Range/Performance).

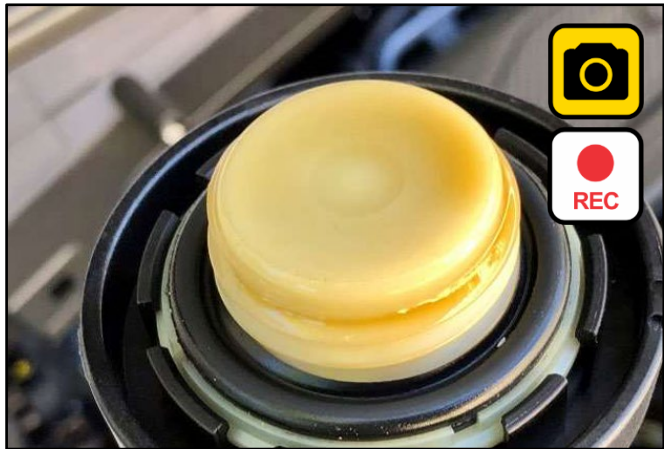
Record/Note findings: No oil, oil sludge, varnish, burnt oil smell condition(s) found.

If NO oil is registered on the dipstick, or oil lacquering, oil sludge and/or oil varnish is present (NG), then the engine is therefore suspect to maintenance neglect. Review of the vehicle's maintenance history is required.

If suspect, proceed to the 'Oil Level Measurement' instructions below and submit with the Techline case.
