Service Bulletin

Bulletin No.: 19-NA-255

Subject: Wax Coating on Frame Peeling, Metal Shows Corrosion/Rusting

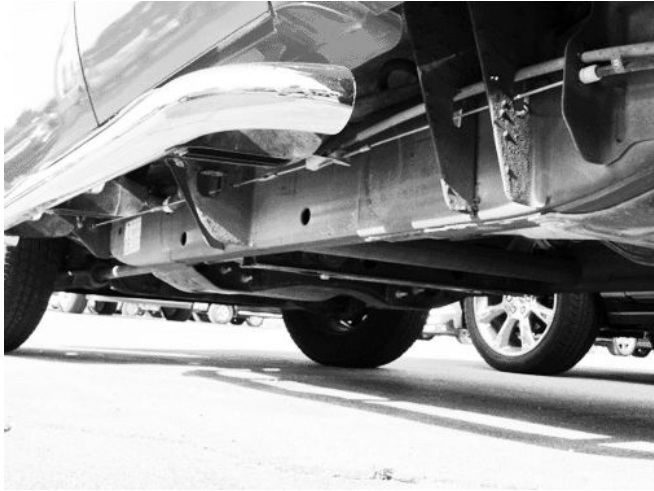
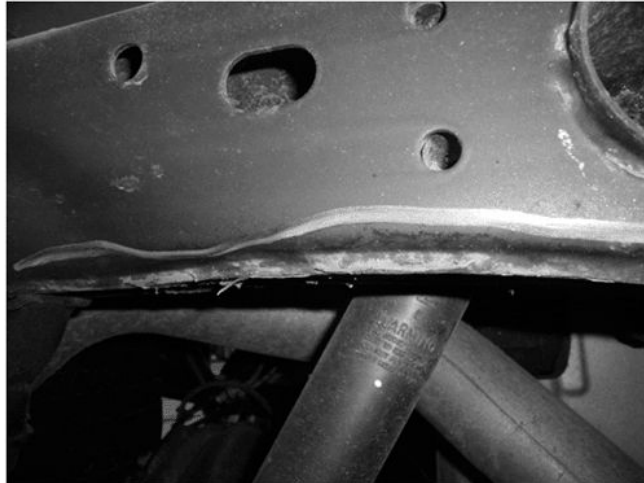
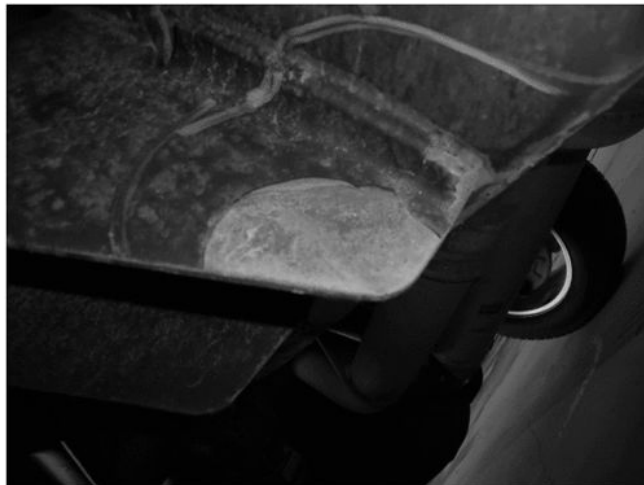
<p>Involved Region or Country</p>	<p>North America, Europe, Middle East, Israel, Palestine, Chile, Columbia, Ecuador, Paraguay, Peru, Uruguay, Japan, S Korea, China, Taiwan, Thailand, Africa and Egypt, Russia, Uzbekistan, S. Africa</p>
<p>Condition</p>	<p>Some customers may comment that areas of the frame wax coating are peeling off and rust/corrosion is visible on the metal in these areas. Several examples of this condition are shown in each group of graphics below.</p> <p>Truck Example Photos</p>

<p>Cause</p>	<p>The cause of this condition may be that the frame supplier may not have properly prepped the metal before the wax coating was applied.</p>
<p>Correction</p>	<p>Note: A combination of specialized metal coating products manufactured by Lloyds and Daubert have been found to be the most suitable products to provide corrosion control and protection to address this type of repair. Our recommendation is to prep the metal surface using *Lloyd's Pure Prep™ Metal Surface Preparation P/N 25418, then topcoat with both *Lloyds Kryptonite™ Metal Treatment* - P/N 36500 High Temp Satin Black 455 ml (16 oz), and *Daubert Non-Rust® P/N X-121B One Coat Rust Preventative Coating. It is strongly recommended they be applied according to the manufacturer's procedures.</p> <p>*We believe this source and their products to be reliable. There may be additional manufacturers of such products/materials. General Motors does not endorse, indicate any preference for, or assume any responsibility for the products or material from this firm or for any such items that may be available from other sources.</p> <p>Prep the frame and apply the Lloyds and Daubert coatings following the steps in the Service Procedure below:</p>

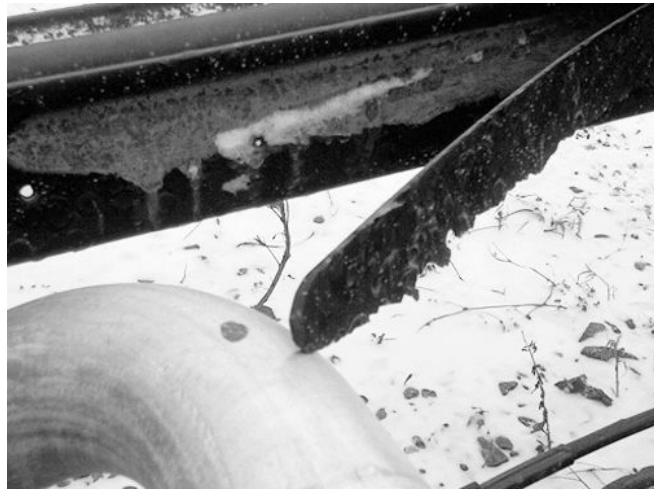
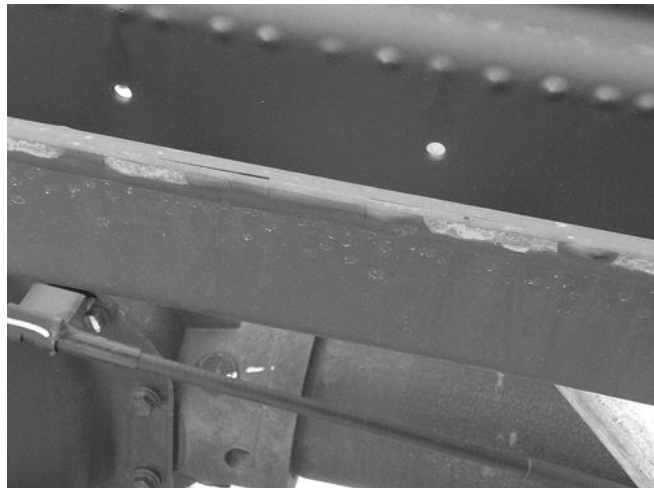
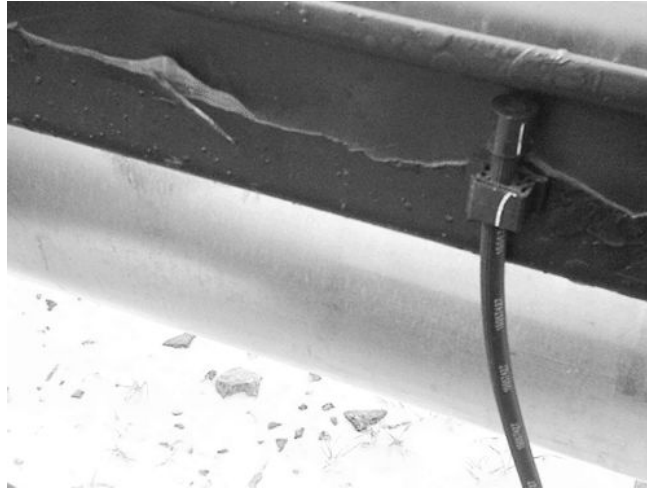
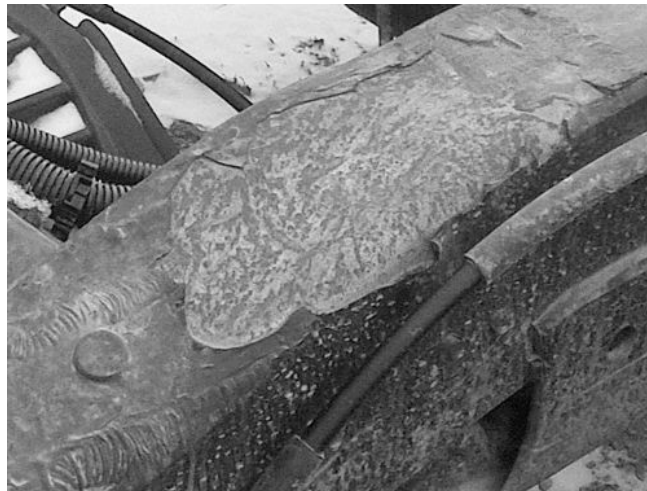
Van Example Photos
