Service Bulletin

Bulletin No.: 22-NA-026

Subject: Information on Brake Pulsation, Noise and/or Visible Pitting Condition to Brake Rotor Surface

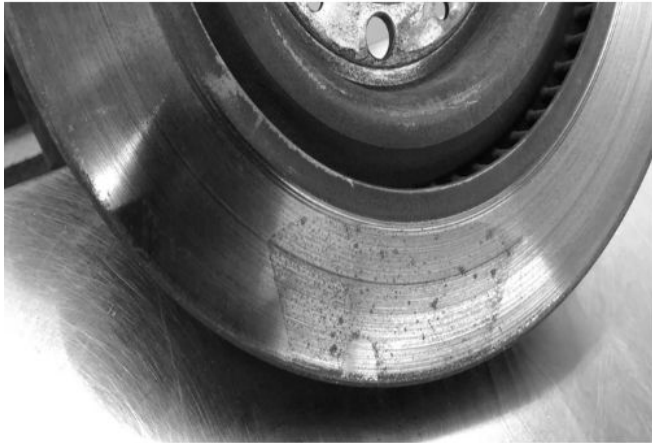
5969661

Involved Region or Country	North America, Europe, Middle East, Japan, Australia/New Zealand
Additional Options (RPO's)	Equipped with Performance Brakes (RPO J55 or J56)
Condition	<p>Note: This condition may more commonly appear after the vehicle sits for an extended period of time, especially in high humidity.</p> <p>Some customers may comment on feeling a brake pulsation or hearing a noise when applying the brakes. They may also comment on seeing a pitting condition with the brake rotor's surface.</p> <p><u>Following the information below will be helpful with reducing the surface corrosion.</u></p>
Cause

To help restore optimal braking performance and reduce noise, complete the Procedure noted below.

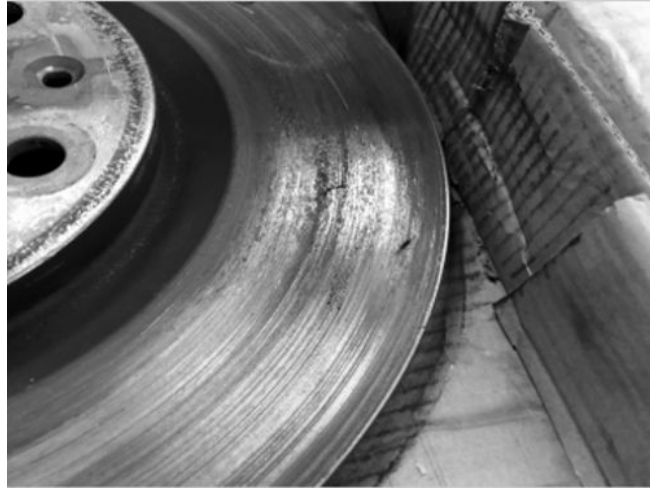
The cause of this condition may be corrosion pad spotting and surface grooving on the brake rotor surface. 5969664
