Paint damage on door paneling in area of door handle

Topic number	LI72.00-P-071544
Version	1
Function group	72.00 - General
Date	11/15/24
Validity	BR 292 with code 889 BR 253 up to manufacturing data July 2020 with code 889
Reason for change

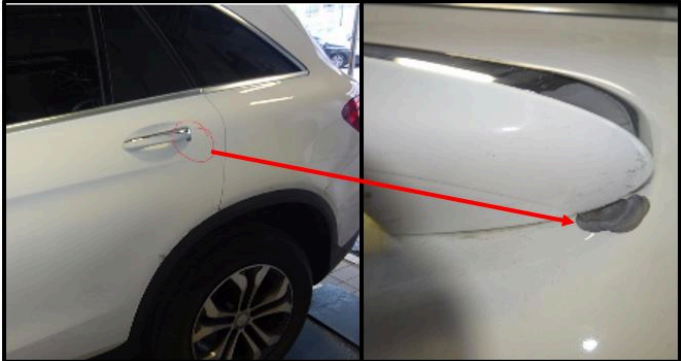
Paint damage on door paneling in area of door handle (see picture 1).

Attachments	
File	Description
Bild 1.JPG	Fault profile - rear door as example

Possible tolerance complaint regarding the door handle

1. Paint the affected area of the door paneling using the spot repair procedure in accordance with the manufacturer's specifications.
2. Replace door handle, ensuring that the door handle bearing bracket is installed correctly (see picture 2).
